General Service Bulletin (GSB):	All - Wheel Drive PTU Sealing			
GSB Overview:	This bulletin is intended to assist with the diagnosis and repair of Al wheel Drive Power Transfer Unit (PTU)-related fluid leaks.			
NOTE: This information is not intended to replace or supersede any warranty, parts and service policy, Work Shop Manual (WSM) procedures or technical training or wiring diagram information.

2007-Current Vehicles with a 6F50/55 Transmission	
and 2008-2012 Vehicles with an Aisin AW21 Transmission	_Page 2
2009-2012 Escape with a 6F35 Transmission	_Page 4
2010-2012 Fusion with a 6F35 Transmission	_ Page 6
2013-Current Vehicles with 6F35 Transmission	Page 8

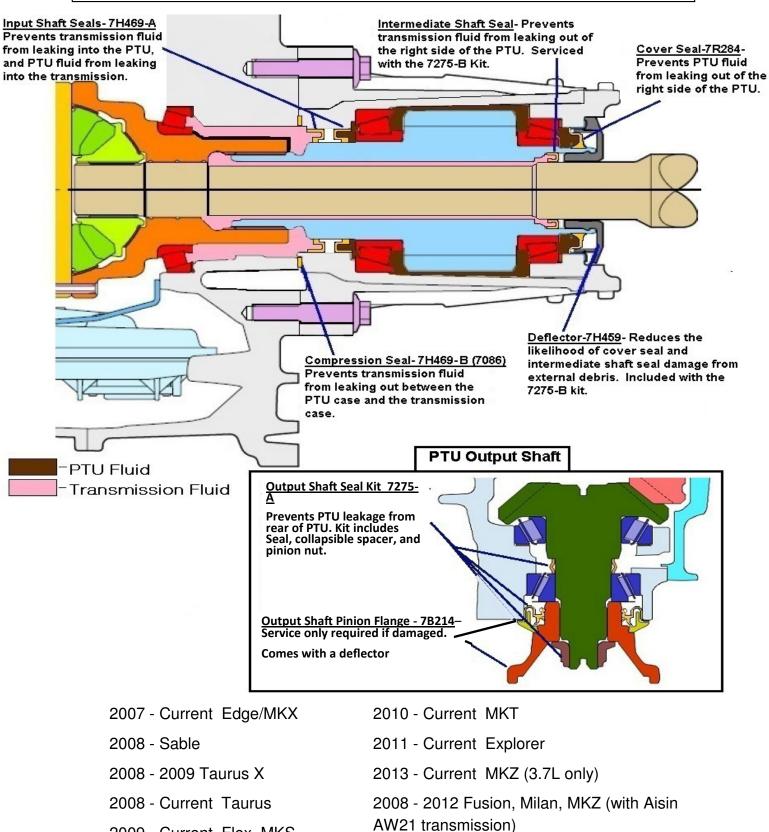
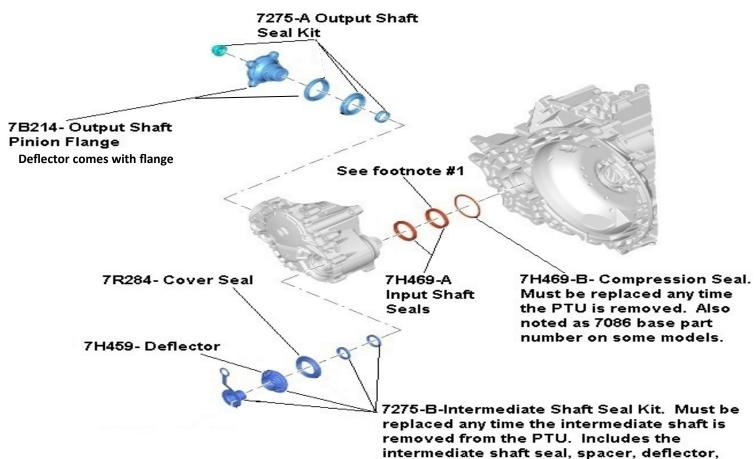
2009 - Current Flex, MKS

Seal Name	Base Part Number	Fluid Leak	Location of Leak	PTU Removal Required for Replacement	Other PTU Seals Re- quired for Re - placement	Labor Operation
Intermediate Shaft Seal	7275B kit		Right side of the PTU	No	None	7275B
Cover Seal	7R284 (3)		Right side of the PTU	No	7275B Kit	7275C
Deflector	7H459		None	No	7275B Kit	7275B
Input Shaft Seal	7H469		Transmission fluid leaks into PTU $^{\scriptscriptstyle (2)}$	Yes	7086, 7275B Kit	7003B+ 7003B6
Output Shaft Seal	7275A kit		Rear of PTU	No	None	7275A
Compression Seal	7086/7H469B		Between PTU and Transmission	Yes	7275B Kit	7003B

(1) This seal omitted from vehicles with Aisin AW21 transmission.

(2) Typically results in fluid coming out of PTU vent.

(3) See Catalog. Part of 7275B kit on some vehicles.

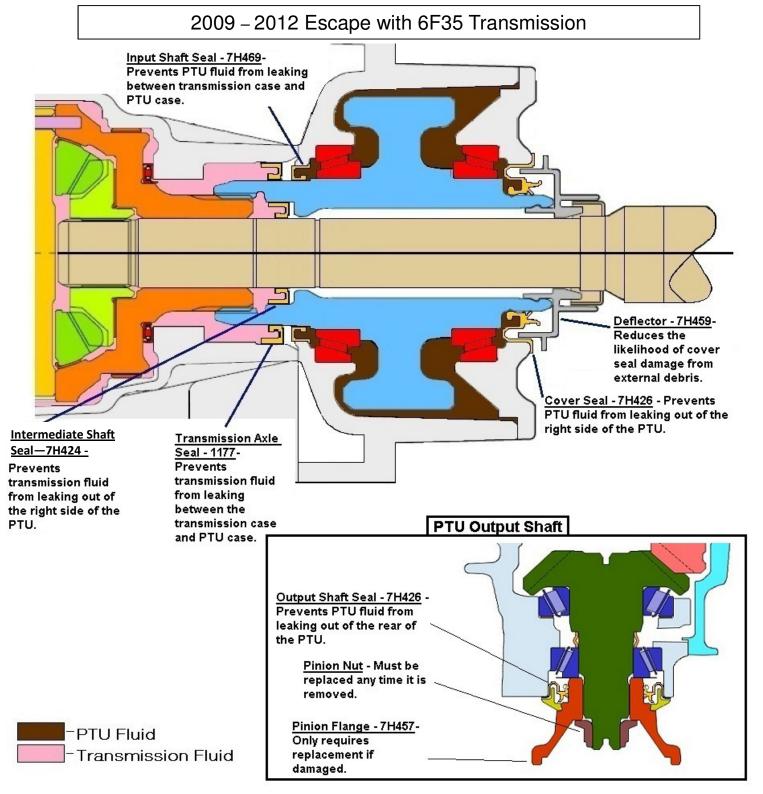
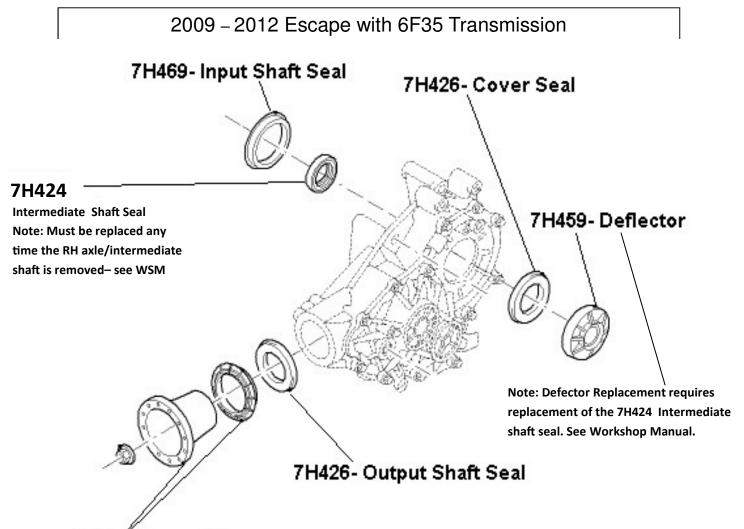
2009 - 2012 Escape 2.5L, 3.0L

Seal Name	Base Part Number	Fluid Leak	Location of Leak	PTU Removal Required for Replacement	Other PTU Seals Required for Replacement	Labor Operation
Intermediate Shaft Seal	7H424		Right side of PTU	Yes	None	7003B+ 7003B3
Cover Seal	7H426		Right side of PTU	Yes	7H459+7H424	7003B+ 7003B4
Deflector	7H459		None	No	7H424	7003B + 7003B4
Input Shaft Seal	7H469		Between PTU and Transmission <sup>(1)</sup>	Yes	7H424	7003B+ 7003B6
Output Shaft Seal	7H426		Rear of PTU	No	None	7275A
Transmission Axle Seal	1177		Between PTU and Transmission	Yes	7H424	7003B

1 - PTU disassembly required to replace the input shaft seal. Refer to WSM, Section 308-07.

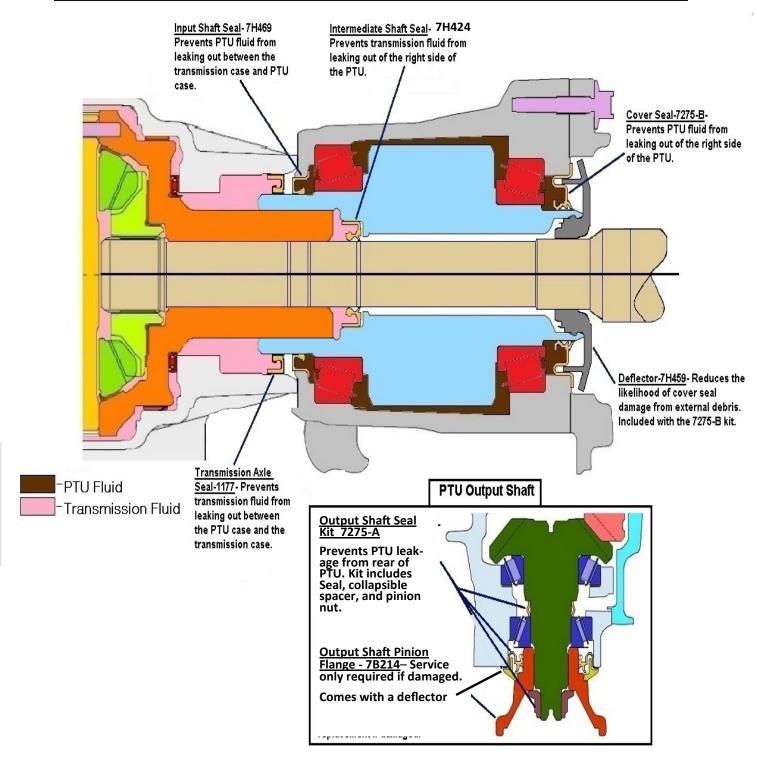
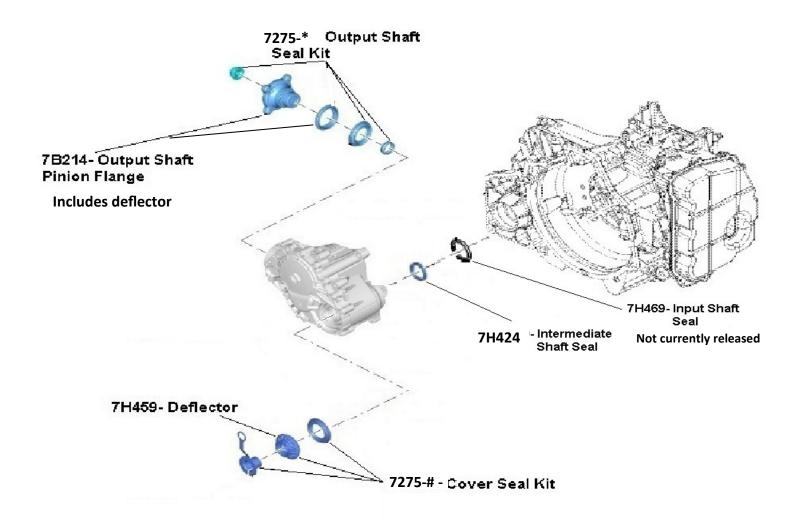
#### 2010 - 2012 Fusion 2.5L, 3.0L

Seal Name	Base Part Number	Fluid Leak	Location of Leak	PTU Removal Required for Replacement	Other PTU Seals Required for Replacement	Labor Operation
Intermediate Shaft Seal	7H424		Right side of PTU	Yes	None	7003B
Cover Seal	7275-# kit		Right side of PTU	Yes	7H424	7003B +7275C
Deflector	7H459		None	Yes	7H424	7003B +7275C
Input Shaft Seal	7H469		Between PTU and Transmission <sup>(1)</sup>	Yes	7H424 + 7275-# kit	7003B
Output Shaft Seal	7275-* kit		Rear of PTU	No	None	7275A
Transmission Axle Seal	1177		Between PTU and Transmission	Yes	7H424	7003B

(1) - PTU disassembly required to replace the input shaft seal. Refer to WSM, Section 308-07.

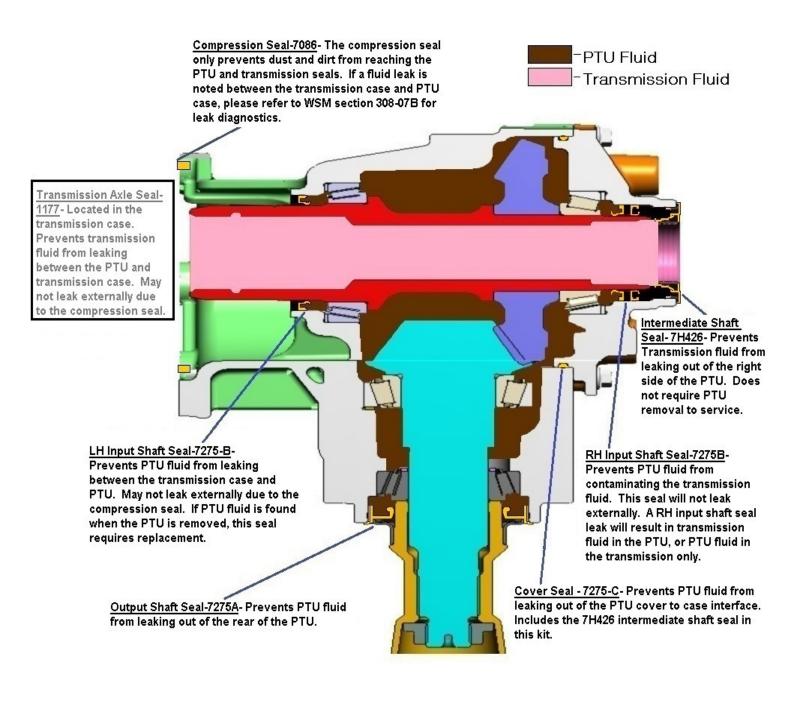
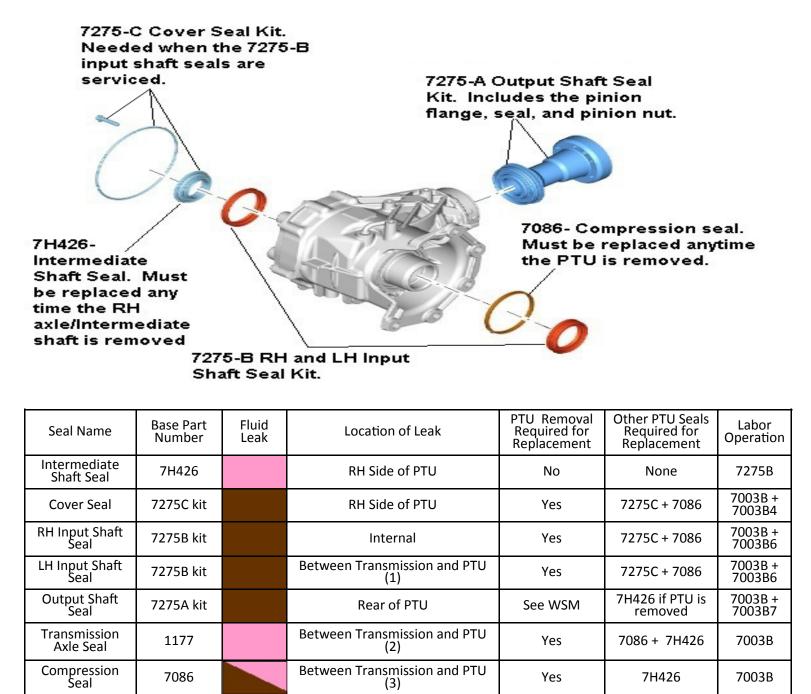
- 2013 Current Escape 1.6L GTDI, 2.0L GTDI
- 2013 Current Fusion 1.6L GTDI, 2.0L GTDI
- 2013 Current MKZ 2.0L GTDI (not used on 3.7L MKZ)
- 2015 Current MKC 2.0L GTDI, 2.3L GTDI
- 2015 Current Edge 2.0L GTDI

(1) The LH input shaft seal may not result in an external leak. If PTU fluid is found after PTU removal, replace the LH input shaft seal.

(2) The transmission axle seal may not result in an external leak. If transmission fluid is found after PTU removal, replace the transmission axle seal.

(3) The compression seal only prevents dirt and debris from reaching the PTU and transmission seals. However, it may temporarily seal a leak in this location. If a leak is noted between the transmission and PTU, refer to WSM, Section 308-07.
