General Service Bulletin (GSB):	6.4L Oil Cooler Service Tips
This GSB will assist in diagnosing the root cause of an oil cooler performance concern.	Some 6.4L oil coolers become restricted after replacement due to improper inspection prior to replacement and/or improper flushing of the cooling system.
NOTE: This information is not intended to replace or supersede any warranty, parts and service policy, Work Shop Manual (WSM) procedures or technical training or wiring diagram information.

6.4L Oil Cooler Service Tips

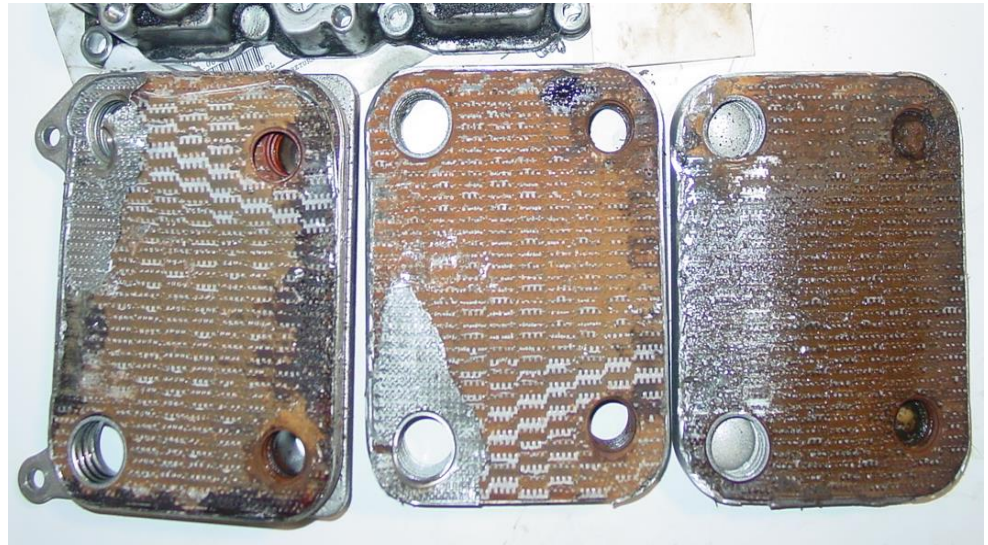
Issue: Oil cooler restriction due to debris, rust, or scale in the cooling system: (Figure 1)

Figure 1. Restricted internal oil cooler passages

- Each of the components listed above must be inspected to ensure cleanliness.

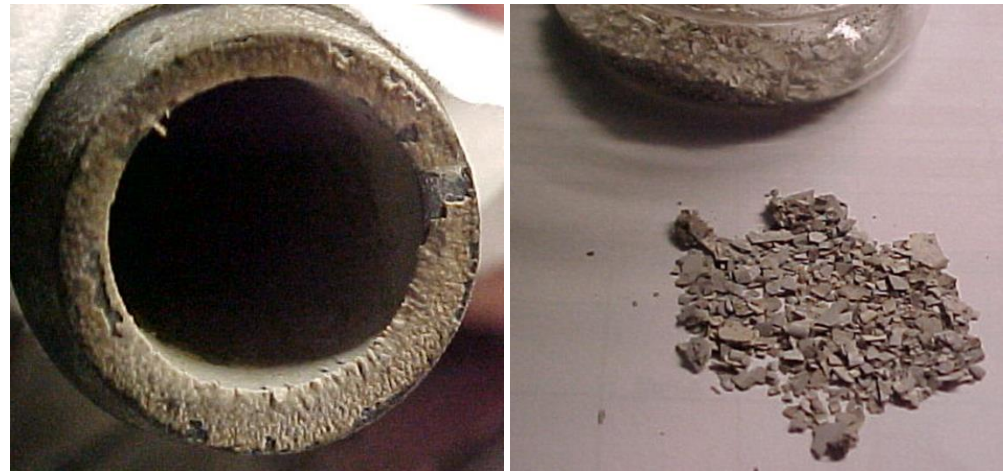
- Buildup within the components can break free and migrate to the oil cooler causing it to become restricted. (Figure 2)

Figure 2. Scale buildup inside oil cooler

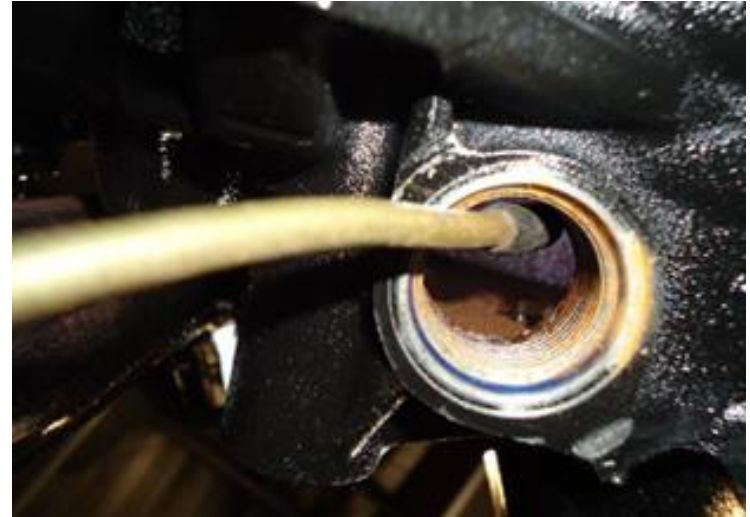
Figure 3: Inspection through block drain using flexible borescope.

- Inspect the internal coolant passages of the block. This can be performed when the block plugs are removed during the Cooling System Flushing procedure. Refer to WSM, Section 303-03. Note: This step may require the use of a borescope. *(Figure 3)*
- When performing the flush procedures, capture a sample of the flush drain water in a clear jar and inspect for any rust, scale, sediment, or debris.
- Once flushing is completed, re-inspect the block. If the block appears clear and contamination is still identified during flushing, the remaining cooling system components will require inspection using similar methods to the block inspection.
