General Service Bulletin (GSB):	Adaptive Cruise Control & Collision Warning Radar Alignment Process
GSB Overview:	Information on set up and completion steps for proper horizontal alignment of the cruise control module (C-CM) radar sensor
NOTE: This information is not intended to replace or supersede any warranty, parts and service policy, Work Shop Manual (WSM) procedures or technical training or wiring diagram information.

Adaptive Cruise Control & Collision Warning Radar Alignment Process

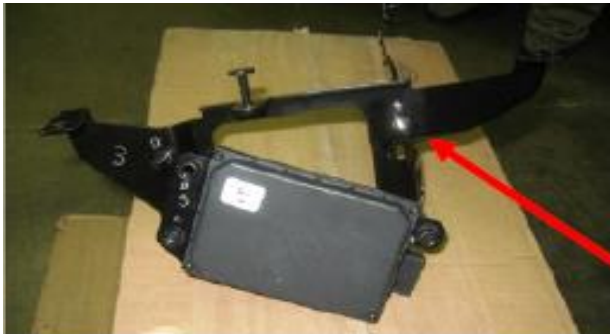
- Check DTCs, tires, Cruise-Control Module (C-CM) attachment/vertical alignment. (Refer to Workshop Manual [WSM] section 419-03)
- If any DTCs are found in an On-Demand Self-Test of the C-CM (i.e. return after clearing), the Horizontal Alignment Procedure may not run or may abort.
- If the C-CM (radar sensor) is detached from the bracket on one or more nylon ball socket joints, it must be reattached and leveled per the WSM prior to performing the Horizontal Alignment procedure. (New grommets are available for service – p/n W790214-S900)

Detached ball socket with sensor hanging free.
