| General Service Bulletin (GSB): | Transmission Control Module (TCM) or SOBDM-C Servicing Procedure |
| GSB Overview: | This General Service Bulletin will highlight the TCM service procedure and cover a non-warrantable condition. |

- Applies to 2013 and newer model year Fusion/MKZ Hybrid and C-Max Hybrid vehicles.
- Highlight important steps from the Transmission Control Module (TCM) Workshop Manual (WSM) removal procedure that will help prevent moisture / debris contamination of the connectors and fuse. The TCM is sometimes referred to as the SOBDM-C.
- Review a non-warrantable TCM replacement condition.

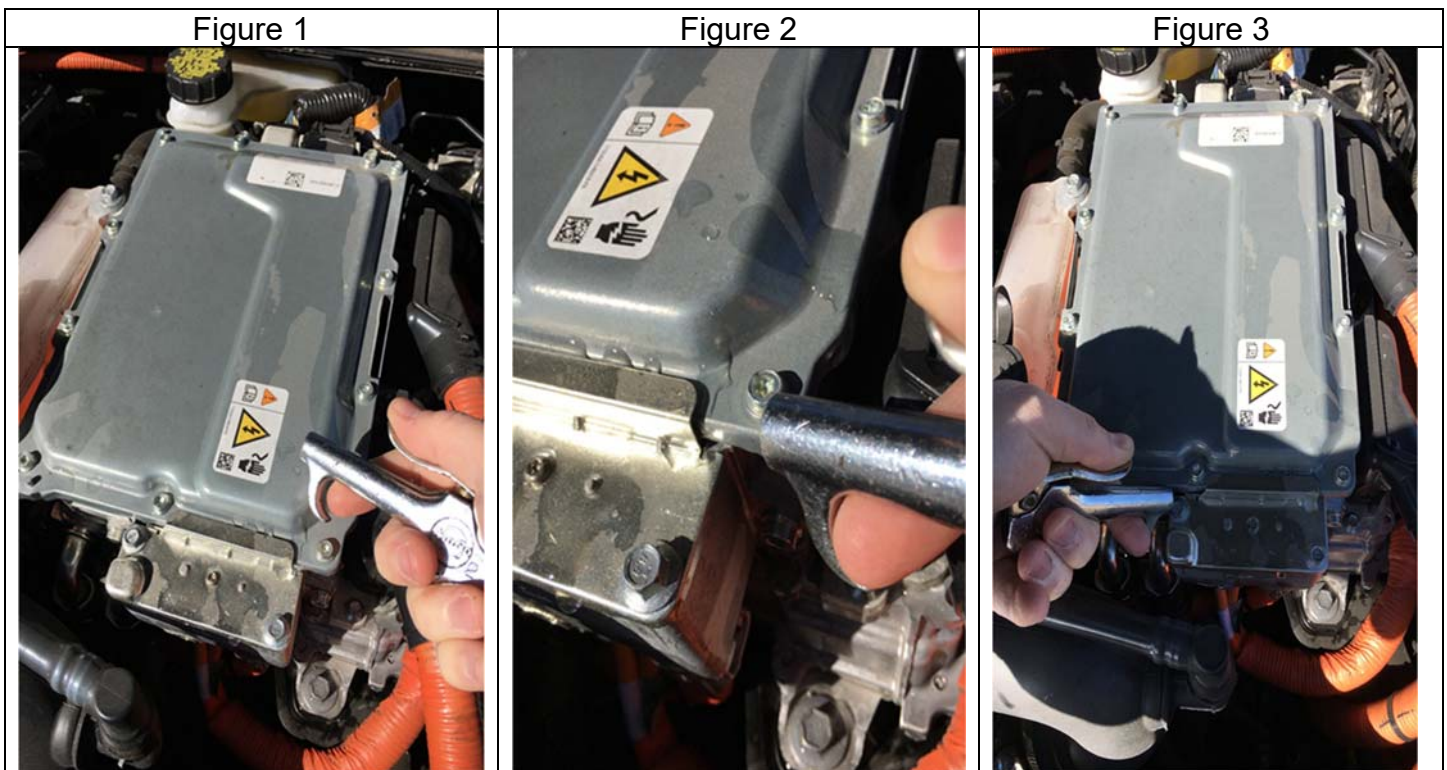
- The top horizontal surfaces of the TCM before removing the TCM fuse cover. (Figure 1)
- Between the TCM fuse cover and the main top cover where the fuse cover overlaps the main top cover. (Figures 2 - 3)

Important - Use compressed air to remove all moisture and debris from;

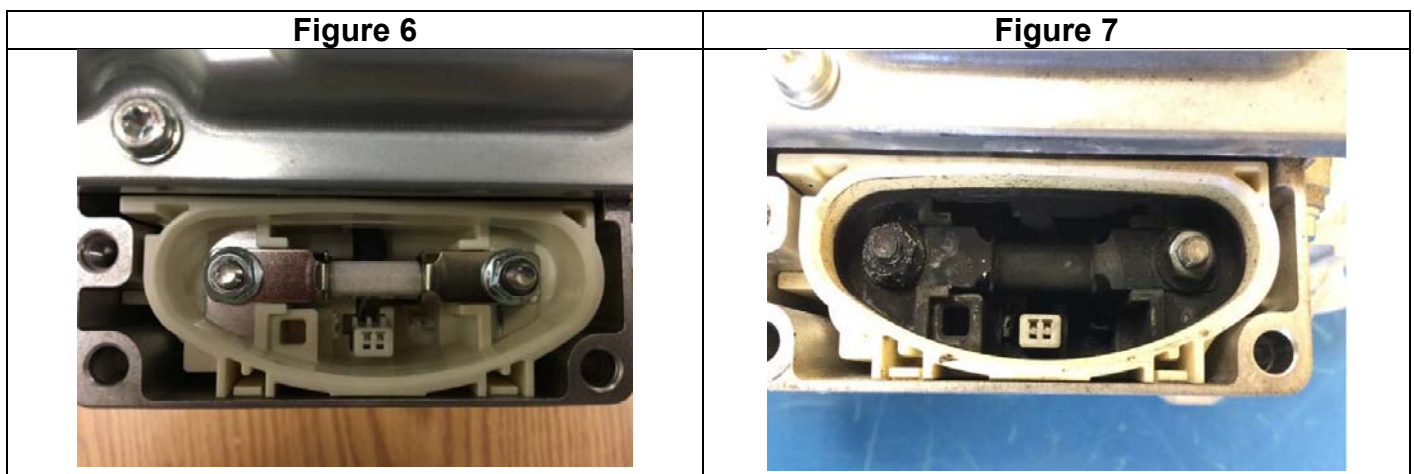
If these actions are **NOT** completed moisture or debris may enter the TCM which may cause it to fail after reassembly. Figure 6 shows an example of a non-damaged TCM fuse. Figure 7 shows an example of a fuse that has been damaged by moisture intrusion. Damage caused by not properly sealing the TCM connectors is not warrantable.

The issue shown in Figure 7 could result in no communication with the TCM, the air conditioning being inoperative, no start, or other issues. Please refer the Workshop Manual for complete information on the TCM operation and diagnostics.
