JLRTB02058NAS2

# TECHNICAL BULLETIN

Tapping Noise From A-Pillar Area

| MODEL: | MODEL YEAR: | VIN: | ASSEMBLY PLANT: |
|---|---|---|---|
| Defender (LE) | 2020-2022 | 000584-091510 | Nitra (Slovakia) |

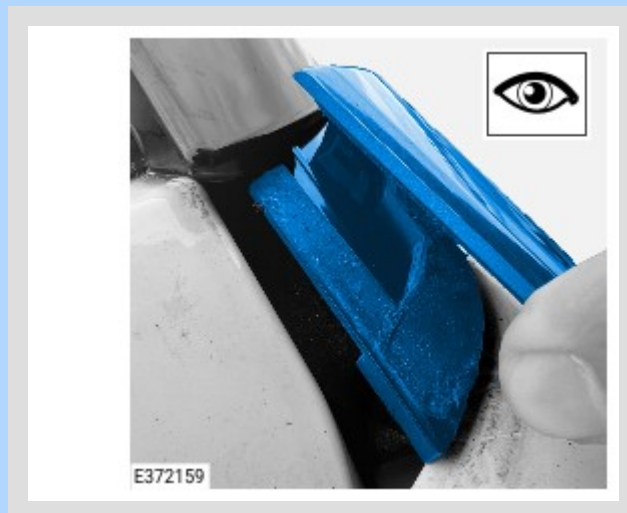
11.

Inspect the windshield moulding bolt cover for delaminating.

- If the windshield moulding bolt cover **IS** delaminated, it must be replaced.
- If the windshield moulding bolt cover **IS NOT** delaminated, do not discard it.

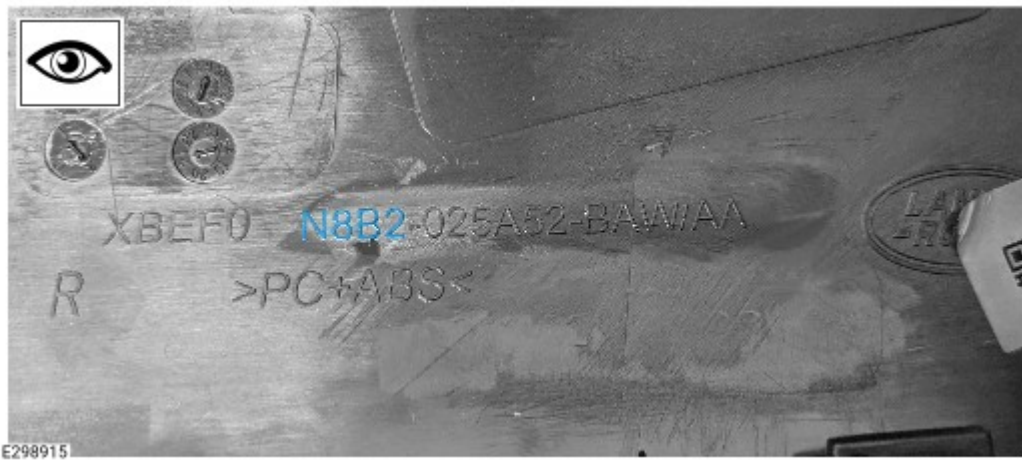
Examine the engineering part number of the upper and lower moulding.

- If the part number is L8B2, **continue with this bulletin.**
- If the part number is N8B2, **do not continue with this bulletin.** Refer to **JLRTB02133** to complete the repair.

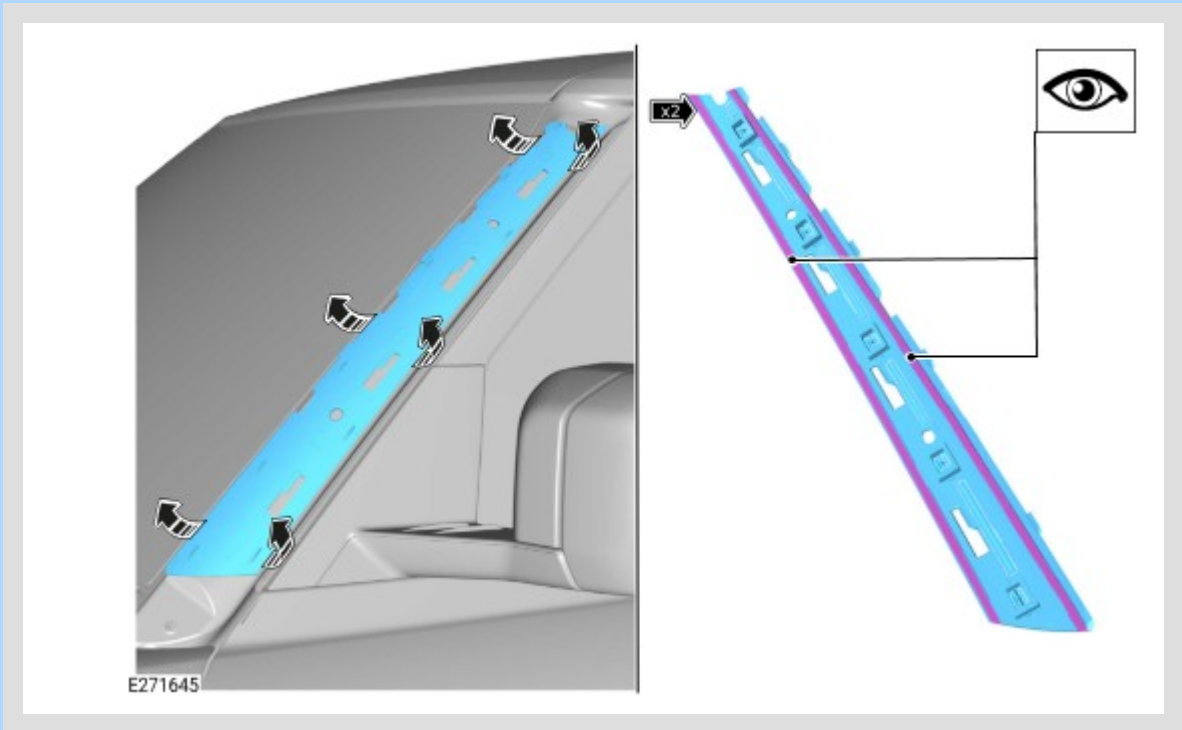
Check that the 2 strips of double sided tape are fully adhered to the body.

- By hand, pull along both edges of the windshield moulding carrier while visually inspecting the tape for adhesion.
  - If both strips of double sided tape **are** fully adhered to the body, **continue to step 16.**
  - If any of the strips of double sided tape **are not** fully adhered to the body, **renew the windshield moulding carrier as part of a separate warranty claim (see TOPIx Workshop Manual section 501-11: Glass, Frames and Mechanisms - Removal and Installation - Windshield moulding Carrier).**

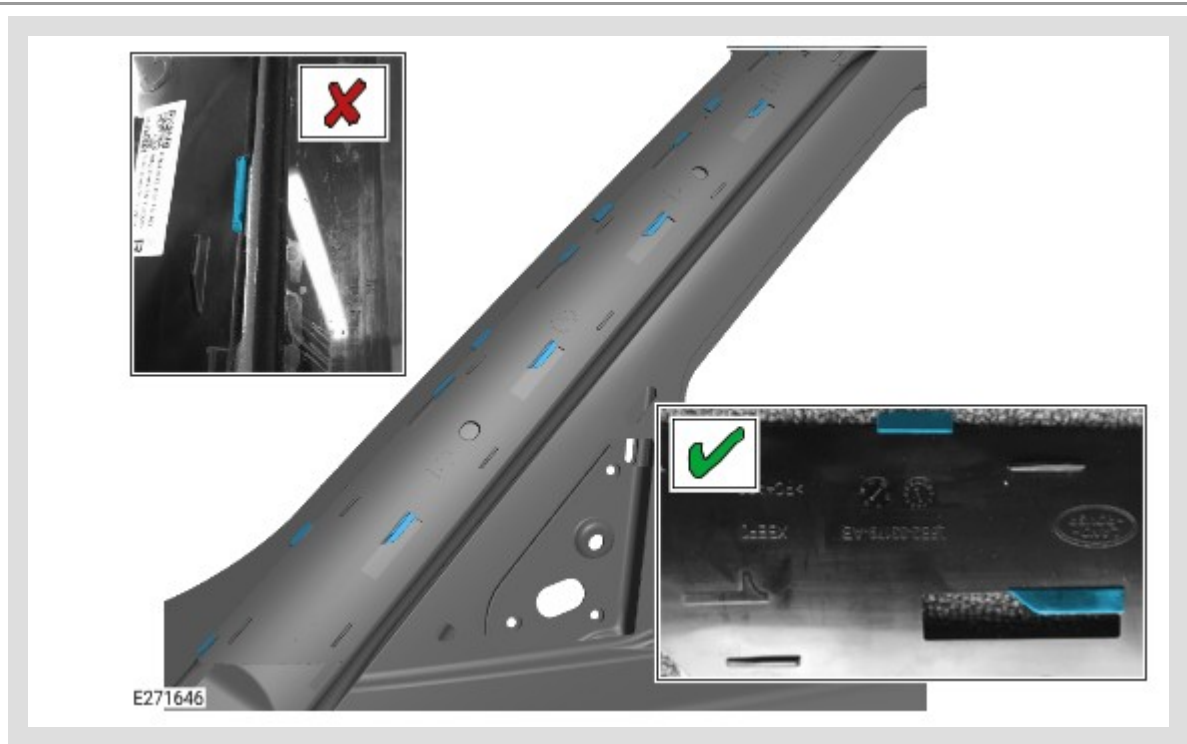
Visually inspect the windshield moulding carrier for damage to the clip features shown in the illustration.

- If the clip features **are not** damaged, as shown in the image with a **GREEN "**, **continue to step 17.**
- If any of the clip features **are** damaged, as shown in the image with a **RED 'X'**, **renew the windshield moulding carrier as part of a separate warranty claim (see TOPlx Workshop Manual section 501-11: Glass, Frames and Mechanisms - Removal and Installation - Windshield moulding Carrier).**

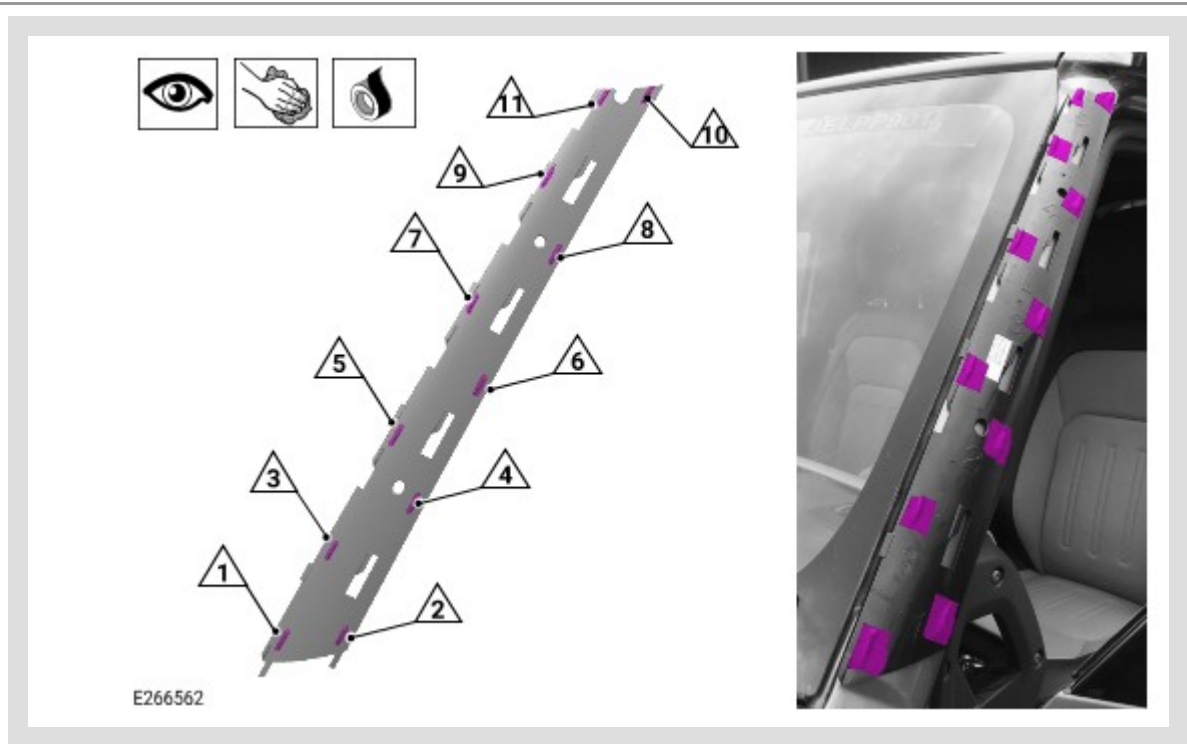
Locate the 11 windshield moulding retaining ribs, as shown highlighted in the illustration.

- Clean the area around each windshield moulding retaining rib.
- Apply felt tape to cover each of the 11 windshield moulding retaining ribs, as shown in the illustration.

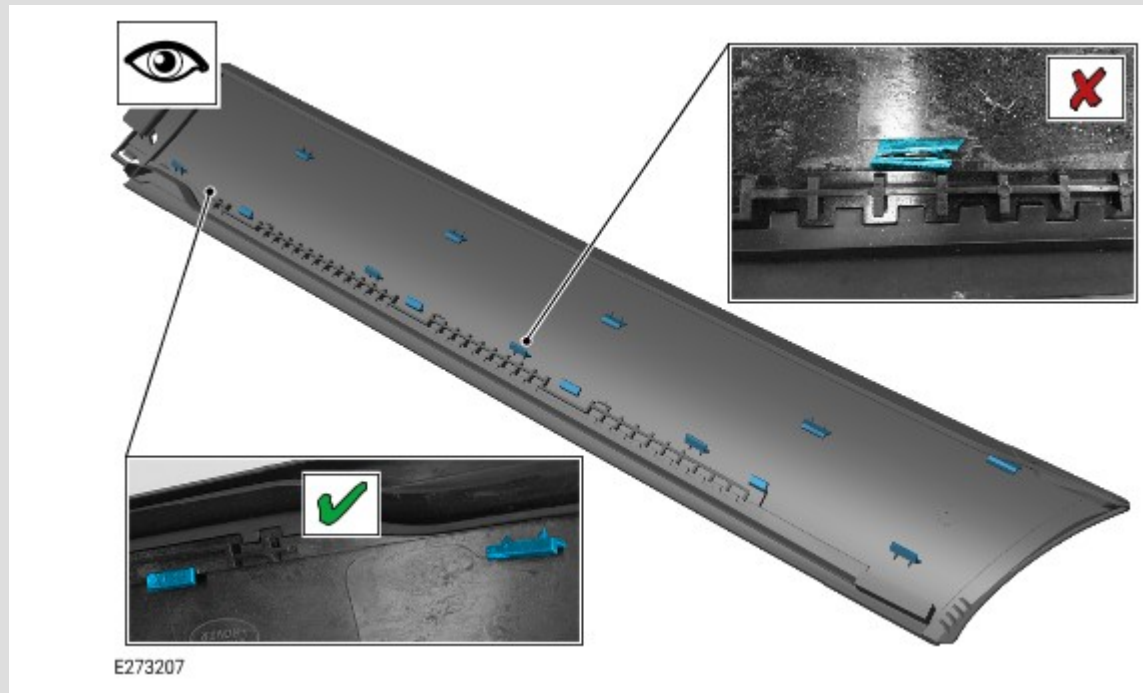
Inspect the windshield moulding for damaged clip features.

- If the clip features **are not** damaged, as shown in the image with a **GREEN "**, **continue to step 15.**
- If any of the clip features **are** damaged, as shown in the image with a **RED 'X'**, **a new windshield moulding must be ordered and claimed as part of a separate warranty claim before continuing to step 15.**

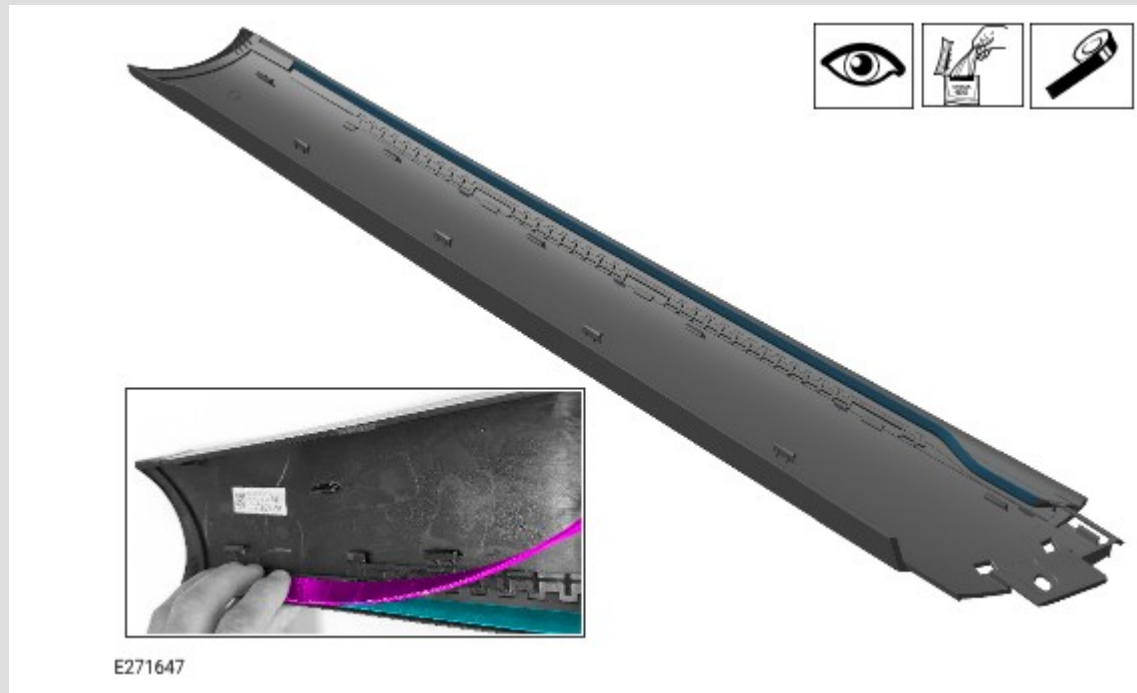
Inspect the rubber seal on the windshield moulding for damage. If the seal is damaged a new windshield moulding is required before continuing with this step, this must be claimed as a separate warranty claim.

- Using a suitable surface cleaner, clean the inside edge of the rubber seal, as shown highlighted in the illustration.
- Cut a length of 3M PX5008 adhesive tape to the following dimensions:
  - **10 mm x 620 mm**

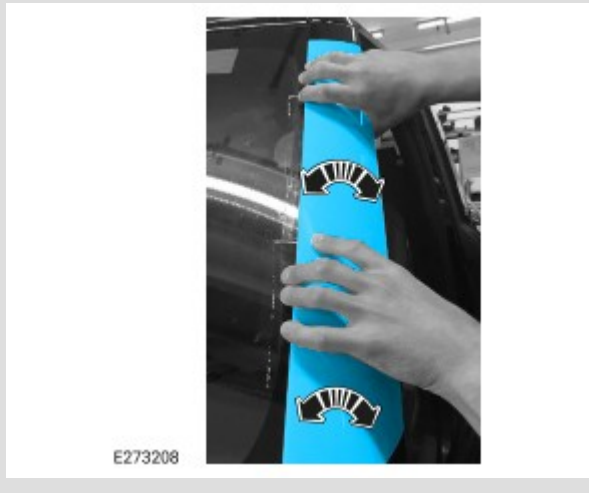
Check all of the windshield moulding clips are correctly located by rotating the windshield moulding in the directions shown in the illustration.

- If excessive movement and/or an excessive gap between the windshield moulding and the windshield **is** evident, **remove the windshield moulding and repeat step 16.**
- If excessive movement and/or an excessive gap between the windshield moulding and the windshield **is not** evident, **continue to step 18.**

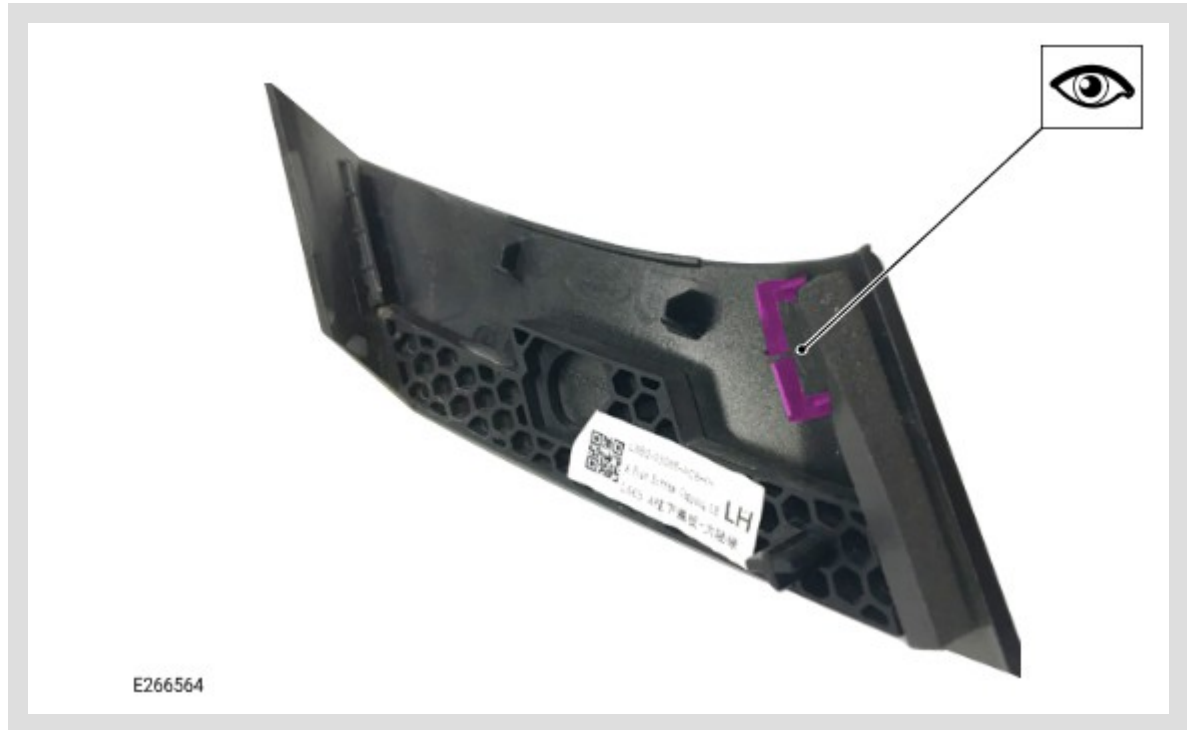
Inspect the retaining clip on the windshield moulding bolt cover.

- If the retaining clip **is** broken, as shown highlighted in the illustration, **install a new windshield moulding bolt cover during the next step and claim it as part of a separate warranty claim.**
- If the retaining clip **is not** broken, **install the original windshield moulding bolt cover during the next step.**
