JLRTB02133NAS

# TECHNICAL BULLETIN

501-08

Tapping Noise From A-Pillar Area

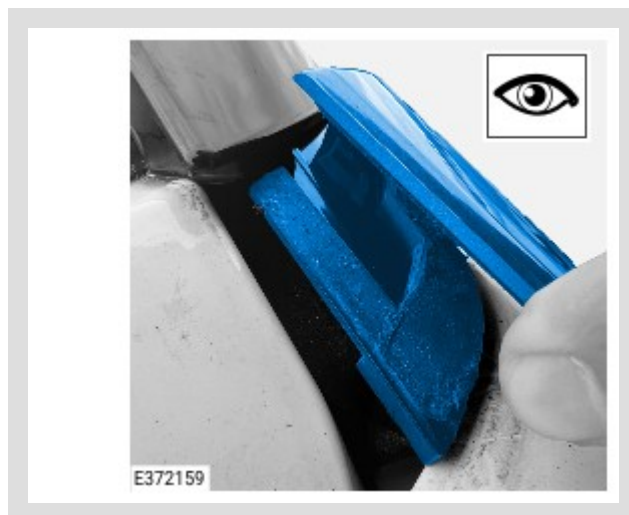
11.

Inspect the windshield moulding bolt cover for delaminating.

- If the windshield moulding bolt cover **IS** delaminated, it must be replaced.
- If the windshield moulding bolt cover **IS NOT** delaminated, do not discard it.

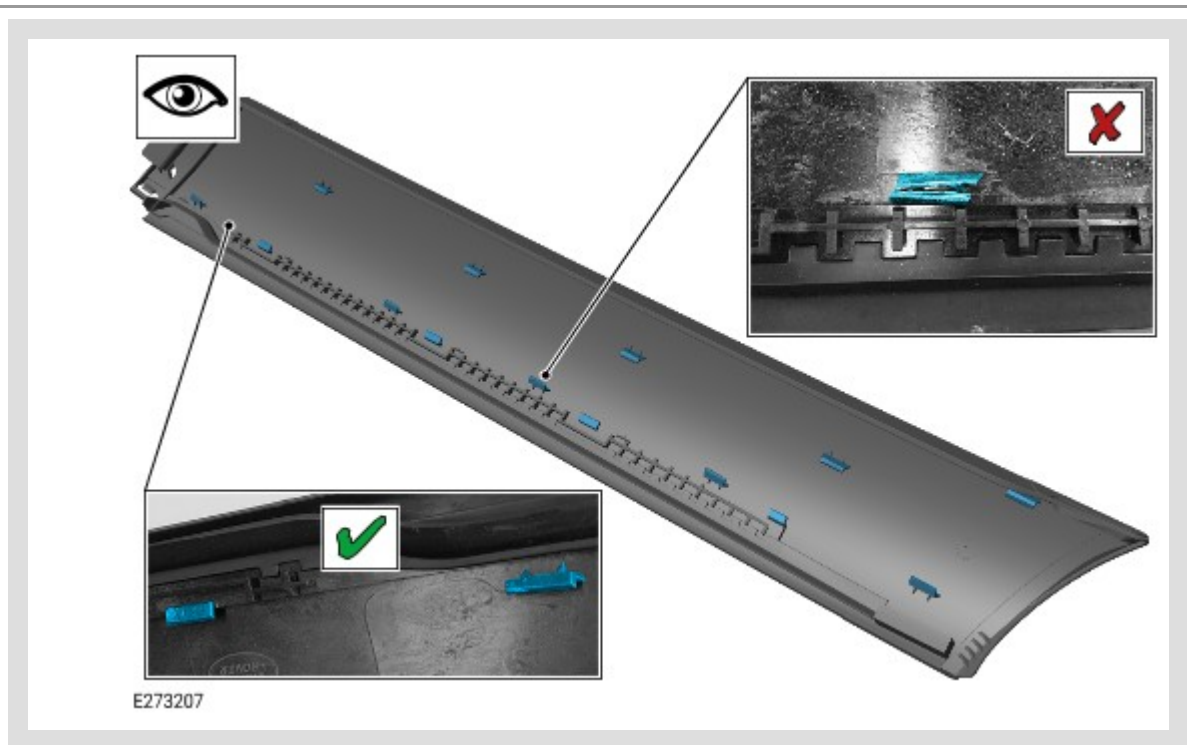
Inspect the windshield moulding for damaged clip features.

- If the clip features **are not** damaged, as shown in the image with a **GREEN "**, **continue to step 15.**
- If any of the clip features **are** damaged, as shown in the image with a **RED 'X'**, **a new windshield moulding must be ordered and claimed as part of a separate warranty claim before continuing to step 15.**

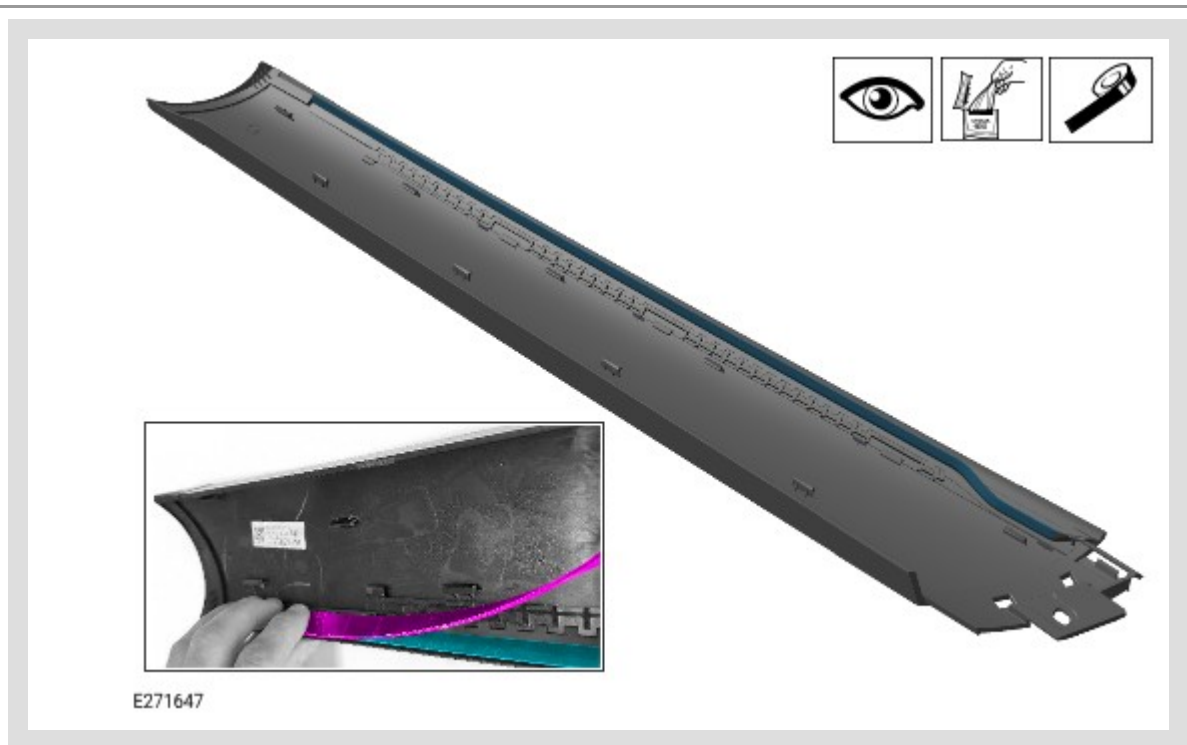
Inspect the rubber seal on the windshield moulding for damage. If the seal is damaged a new windshield moulding is required before continuing with this step, this must be claimed as a separate warranty claim.

- Using a suitable surface cleaner, clean the inside edge of the rubber seal, as shown highlighted in the illustration.
- Cut a length of 3M PX5008 adhesive tape to the following dimensions:
  - **10 mm x 620 mm**

The 3M PX5008 adhesive tape must be aligned with the edge of the rubber seal.

Gradually remove the adhesive backing and install the 3M PX5008 adhesive tape in small sections at a time. Firm pressure must be applied along the entire length of the rubber seal for the adhesive to bond correctly.
