Service Bulletin

Bulletin No.: PIT6399A

Subject: Unable to perform RKE Remote Quick Learn From Radio Settings Menu

Brand:	Model:	Model Year:		VIN:		Engine:	Transmission:
		from	to	from	to		
Chevrolet	Tahoe	2025		ALL	ALL	ALL	ALL

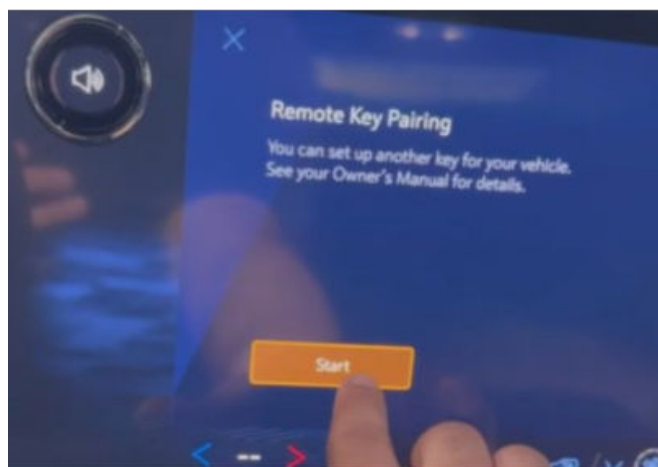
6960001

Involved Region or Country	North America
Additional Options (RPO)	9C1 Special Service Vehicle
Condition	A customer may indicate that the Remote Key Fob Pairing / Learn option is inoperative when selecting key pairing in the radio vehicle menu. See Below
Cause	Software anomaly

Reprogram the K9 Body Control Module with the latest software in Techline Connect .
