Running Board Staining or Discoloration – Black Finish (Night Package)

| Topic number | LI88.30-P-079882 |
| Function group | 88.30 - Detachable components, underride guard |
| Validity | BR465 with SA Code T86 |

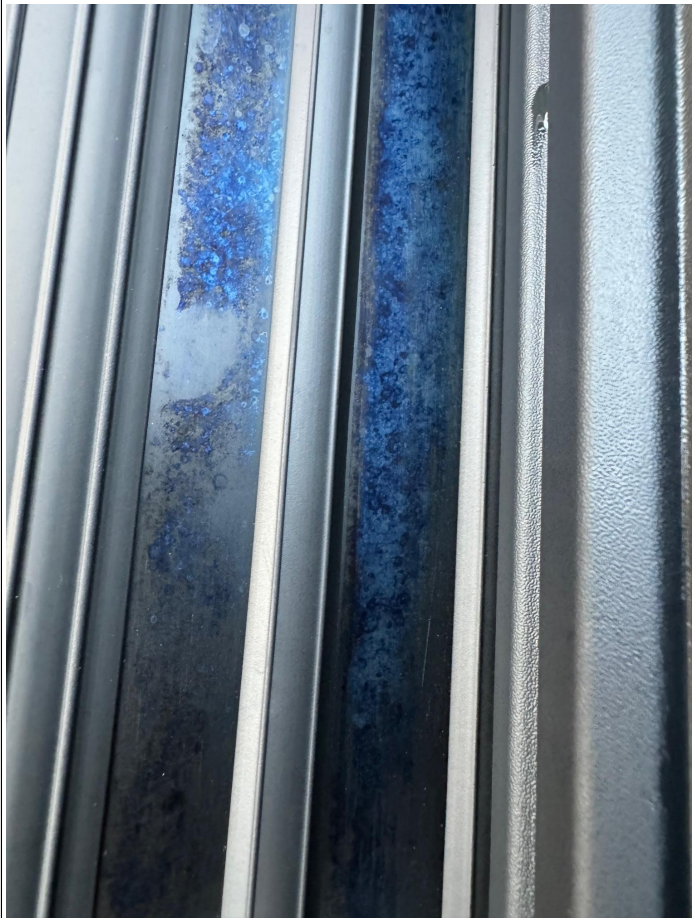
| Attachments | |
|---|---|
| IMG_0137.jpg | Figure 1 |

Customer reports discoloration, staining, or blotchy marks on the black running boards for vehicles equipped with Night Package (SA Code T86). The condition is cosmetic and may appear as uneven dark or bluish staining on the running board surface. (see Figure 1)

Discoloration is caused by environmental influences or the use of strongly alkaline cleaning agents. These substances can chemically affect the surface finish of the black running boards, resulting in visible staining.

Polish the affected running board using Mercedes-Benz polishing paste A000 986 43 74.

- Buff the surface until staining is completely removed.

If the staining cannot be removed after polishing:

- Replace the running board (isolated cases only).
