223 S63e - Popping Sound From Rear When Driving

| Topic number | LI35.31-P-080609 |
| Function group | 35.31 - Rear axle center assembly |

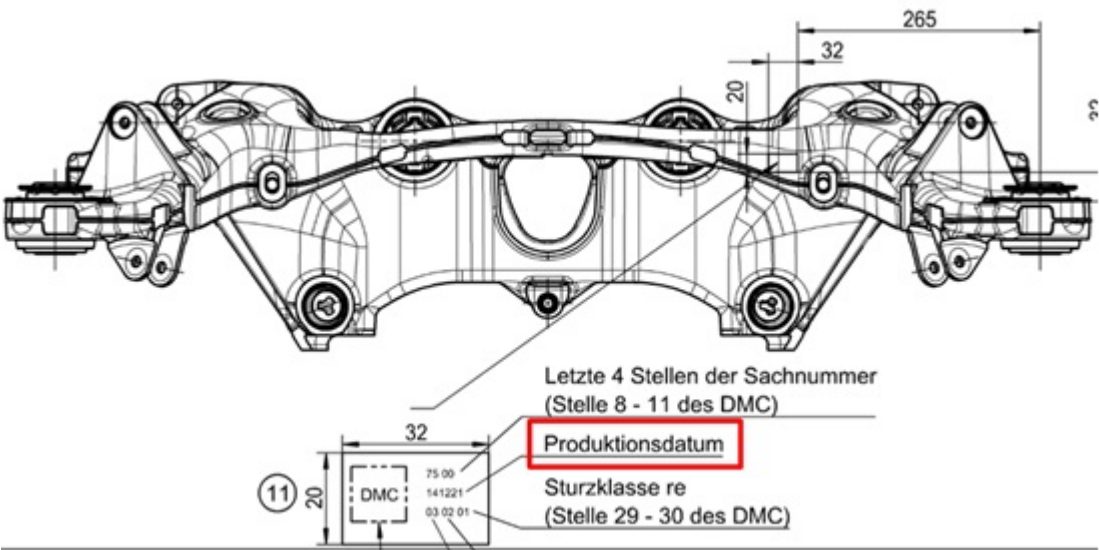
Consistent popping sound from rear of vehicle.

Rear subframe manufactured on or after December 2025.

Verify the noise is emanating from the rear subframe mounts and matches the sound file attached. The dealer may choose to use NVH to verify which mount.

Replace all rear subframe mounts according to WIS and the attached procedures with Loctite.
