SIB 18 01 25

DISCOLORIZATION OF EXHAUST SYSTEM REAR SILENCER

2026-05-11

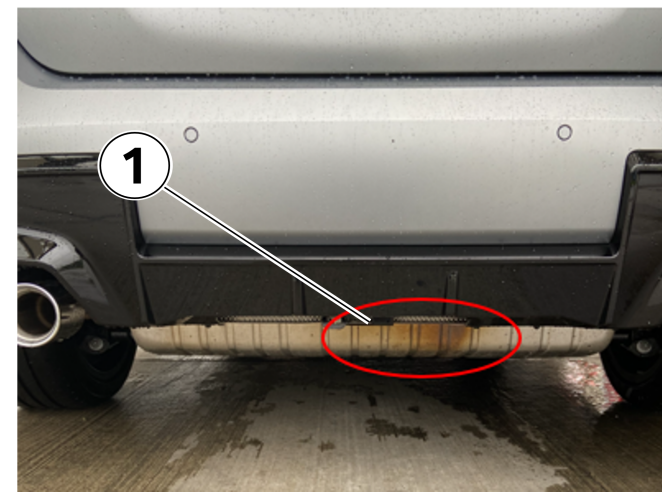
The rear silencer is discolored.

Tarnishing of the metal (1) on the rear silencer is caused by the heating and cooling of the exhaust.

Inform the customer this is a normal occurrence when the metal of the exhaust system gets to operating temperatures.

It does not affect the functionality, or the durability of the exhaust system.

This is not rust/corrosion.
