## PRODUCT CAMPAIGN BULLETIN

**APPLICABILITY:** 2026MY Forester

**NUMBER:** WRF-26R

**SUBJECT:** Safety Recall and Stop Sale: Forester  
Power Moonroof Glass Adhesion

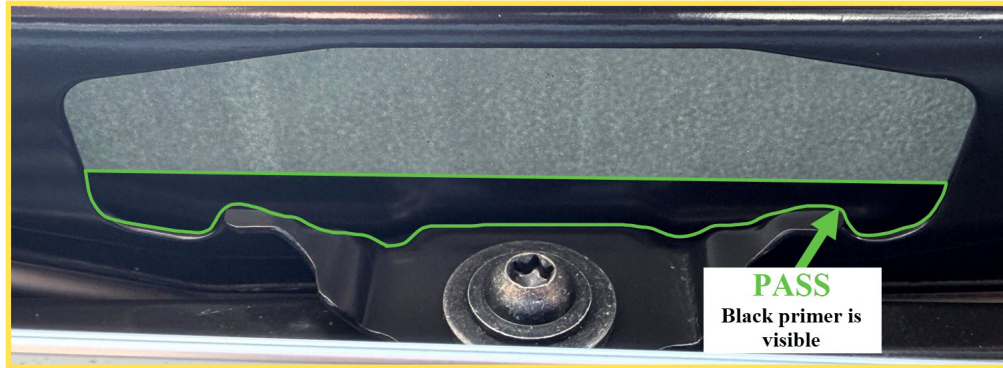
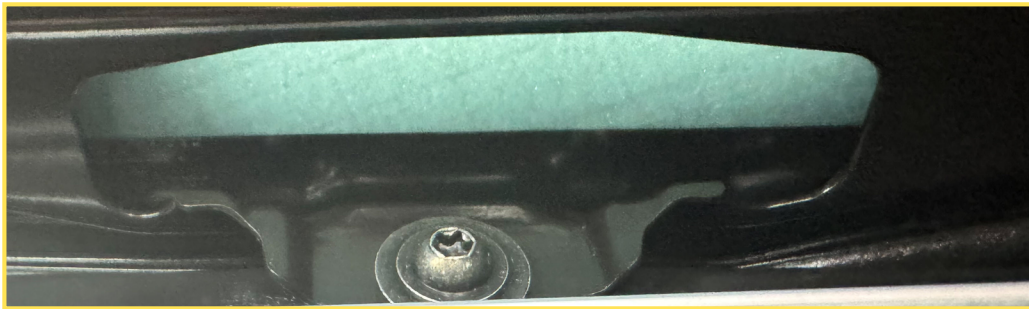
Additional examples of acceptable primer application on the sunroof lid assembly.

These photos were taken with light shining through the sunroof from outside the vehicle.

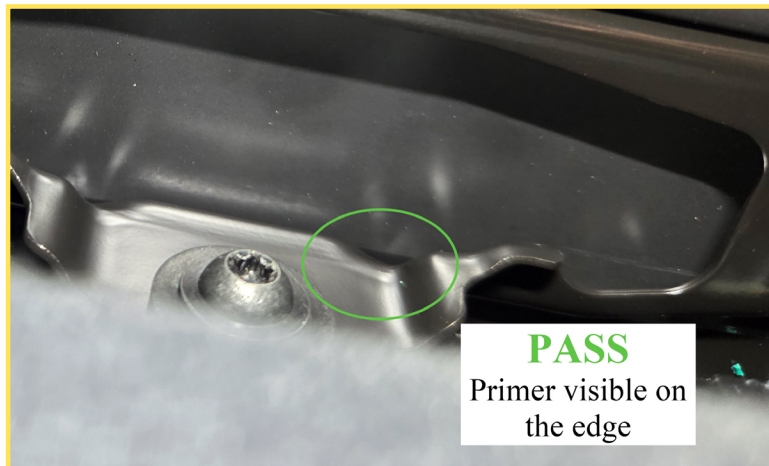
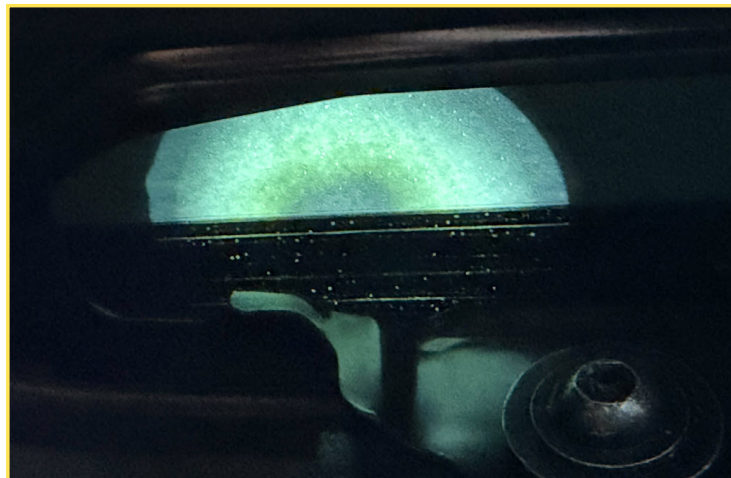
These photos were taken with light coming from inside the vehicle.
