# Fifth Gen Cascadia Turn Signal/DRL

Affected Models:  
Fifth Generation Cascadia

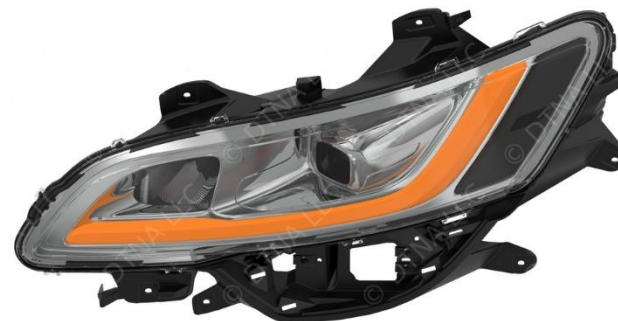
[HEADLAMP - LED, LEFT HAND DRIVE, HEATED, LEFT HAND | A66-20649-006 | Excelsior Parts - DTNA](#)

**Concern:** Some Fifth Gen Cascadias may exhibit turn signal flashing white and/or out of sync with other turn signal lamps on the vehicle; random flashing sequence

**Root Cause:** Solder delamination on PCB

**Correction:** Fix as failed. Replace the headlamp assembly.
