## Underfloor Paneling is Loose or Sags

| Topic number | LI61.25-P-047933 |
| Function group | 61.25 - Substructure frame |
| Validity | W212 |

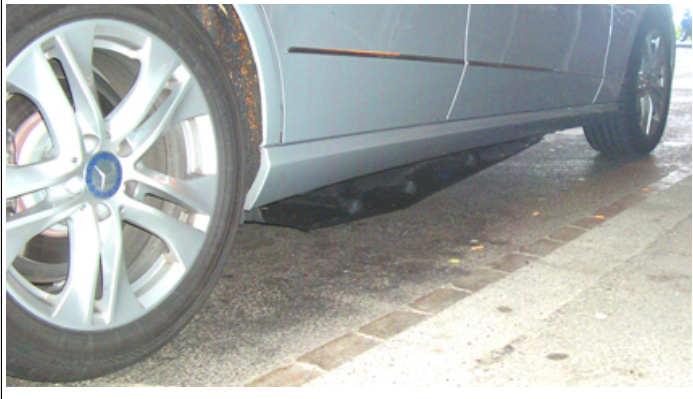
The underfloor paneling is loose or sags (picture 1).

| Attachments | |
|---|---|
| Bild 1.jpg | Underfloor paneling sags |

Mounting clips broken or not correctly engaged.

Replace all mounting clips with collar nuts with shims (picture 2):

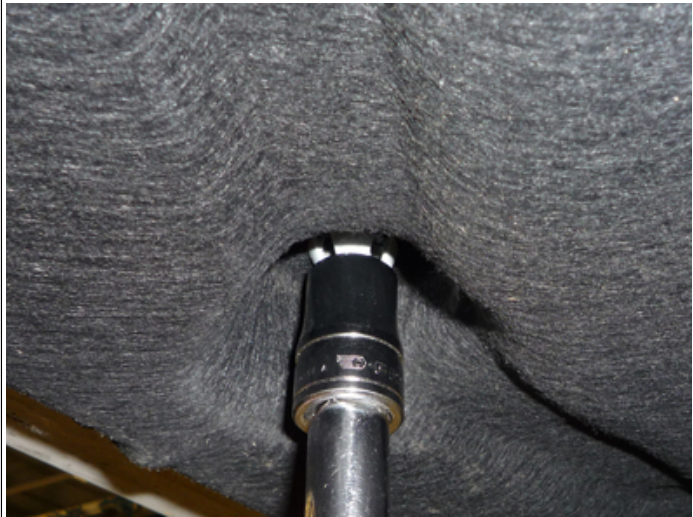
| Attachments | |
|---|---|
| <a href="#">Bild 3.jpg</a> | Loosen mounting clips |

1. Loosen all mounting clips. Use a 13 mm socket for this (picture 3).
2. Unscrew all mounting clips.

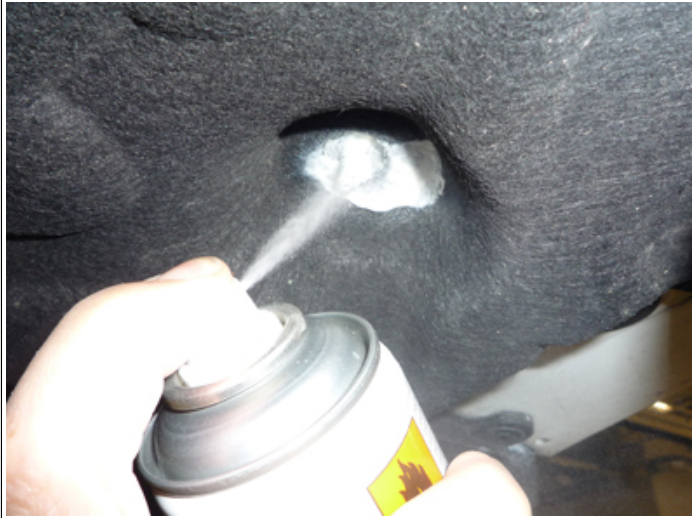
| Attachments | |
|---|---|
| <a href="#">Bild 4.jpg</a> | Wax threaded pins |

3. Treat all threaded pins with preservation wax (picture 4).
- During spraying, the underfloor paneling must be pressed upwards against the vehicle underfloor.
4. Install a spacer washer on each threaded pin between underbody and underbody paneling.
- Each time, carefully lift the underfloor paneling from the underfloor (picture 5).
  - During installation, ensure that the side with the engagement lobes points downwards.
  - After installation, the spacer washer must be in full contact with the underfloor (picture 6).

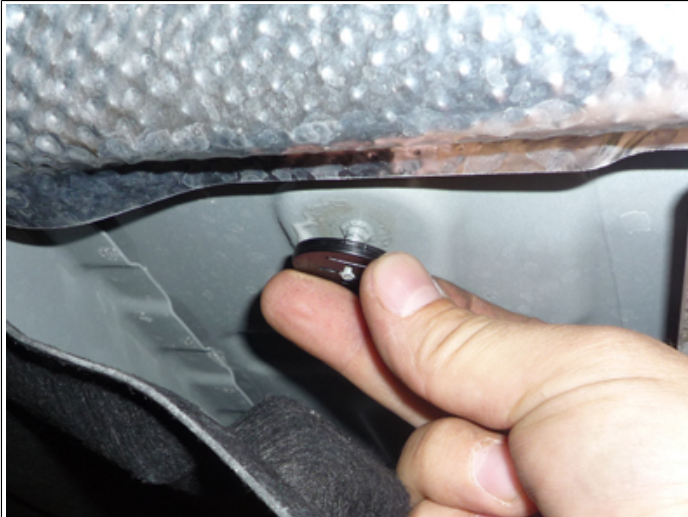
| Attachments | |
|---|---|
| <a href="#">Bild 5.jpg</a> | Installation of spacer washer |

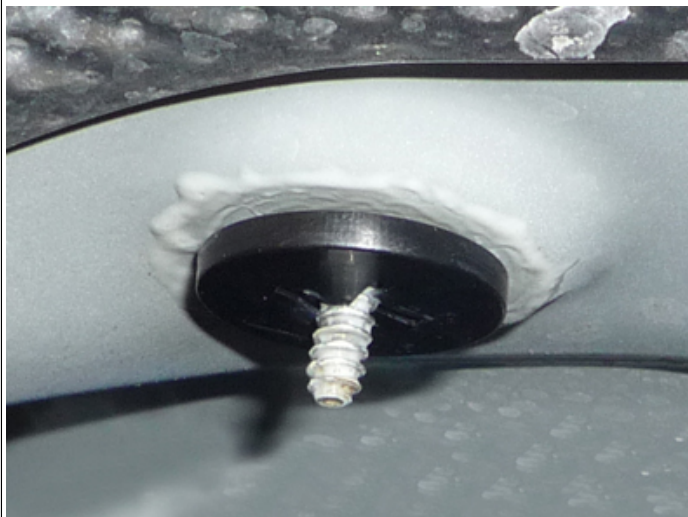
Bild 6.jpg

Correctly installed spacer washer

Information: The spacer washers prevent the underbody paneling from coming into contact with the vehicle underbody, thus preventing possible corrosion effects

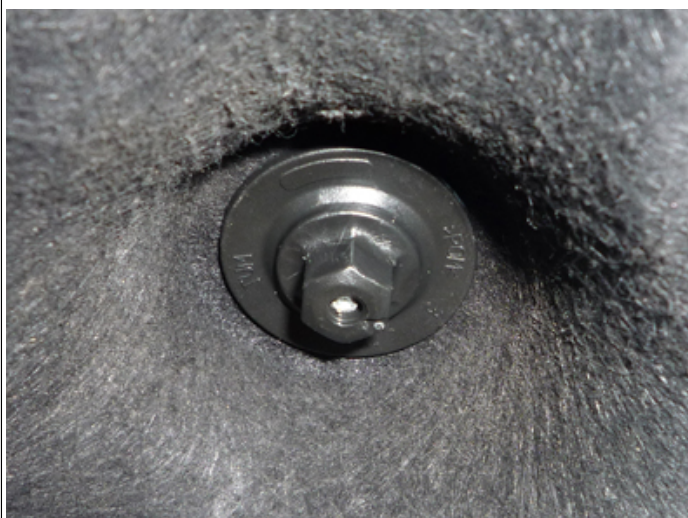
Bild 7.jpg

Installed collar nut

Information: The threaded pin does not extend beyond the collar nut due to its length (picture 7).

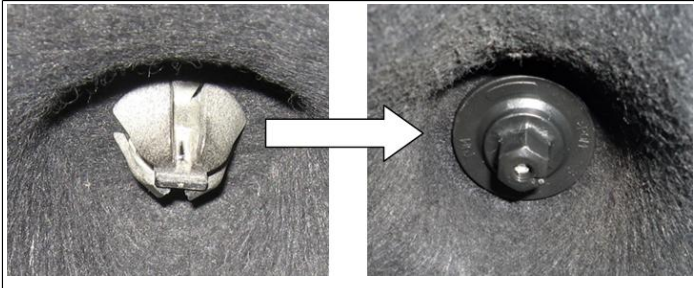
Bild 2.jpg

Replacement of mounting clip with collar nut
