## SSPE1 – Battery Label Concern - affecting 2026 CX-50 Hybrid vehicles

### CONDITION OF CONCERN

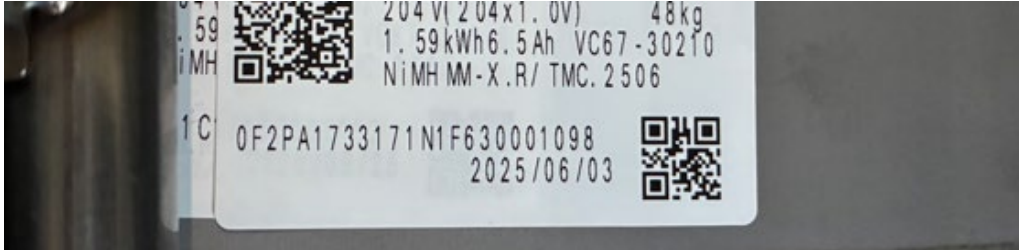
**BATTERY - PHOTO IS CUT OFF - UNACCEPTABLE**

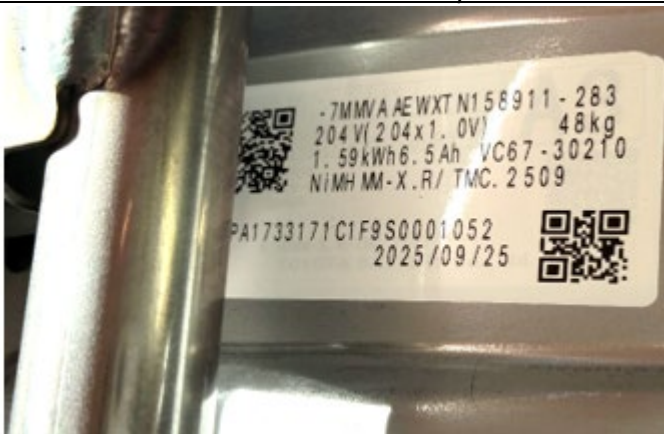
**LABEL IS ON TOP OF OTHER LABEL, CANNOT READ QR CODES - UNACCEPTABLE**

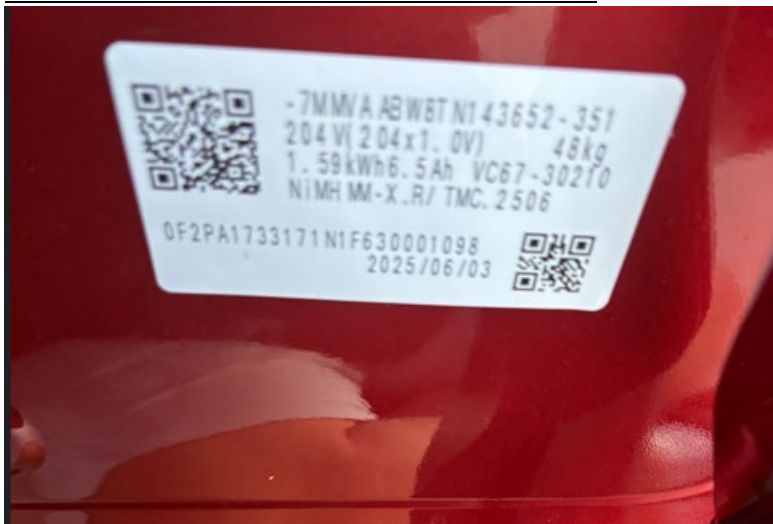
**BLURRY AND OFF CENTER - UNACCEPTABLE**

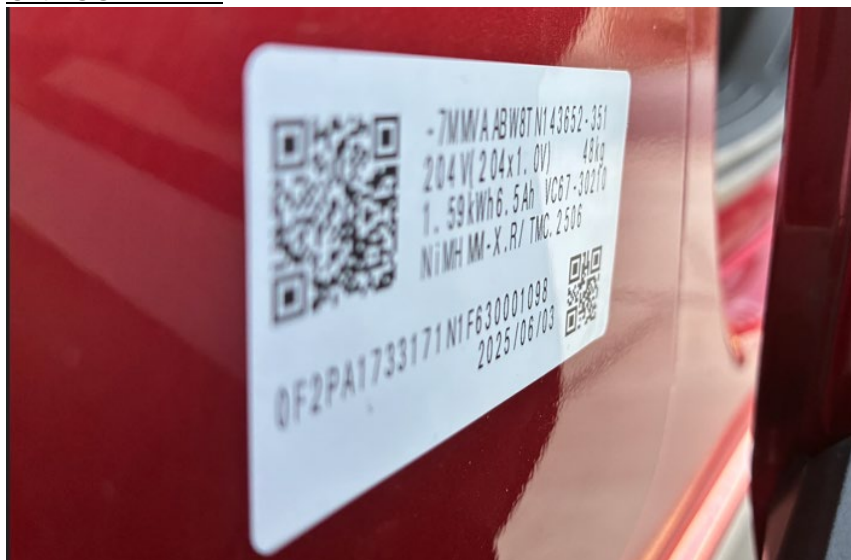
UNACCEPTABLE

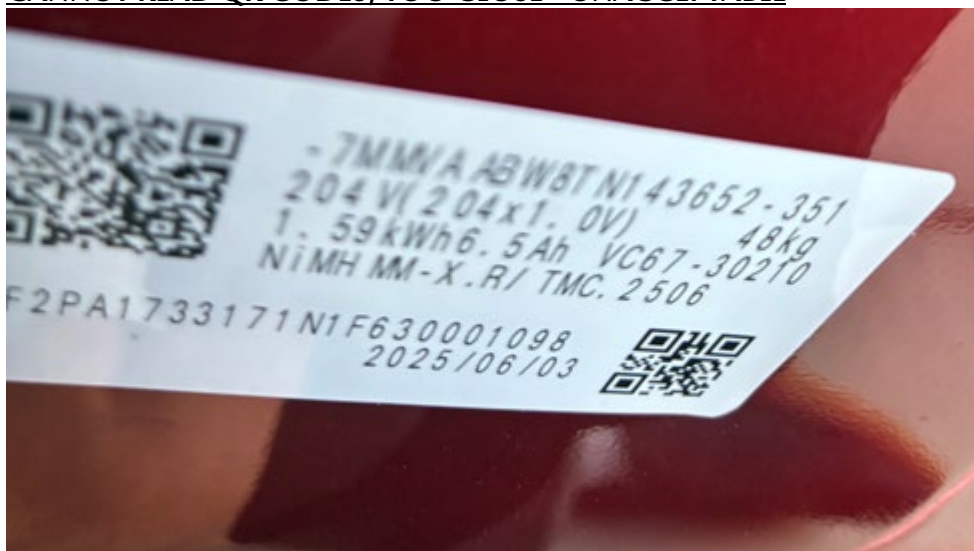
CANNOT READ QR CODES, TOO CLOSE - UNACCEPTABLE
