# Service Alert

INFOTAINMENT CENTER DISPLAY AND CONNECTED VEHICLE  
IMPROPER OPERATION

Service Alert No.: SA-015/26

2026 CX-5

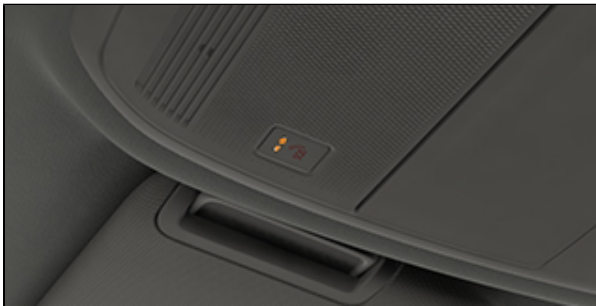
2. Beep sound near the SOS button and SOS button amber or red LED.

- This condition is related to Item 1 above. Refer to TSB 16-004/26. **Did the TSB repair the customer's concern?**
  - **YES:** The TSB resolved the concern — repair complete.
  - **NO:** Proceed with standard MGSS troubleshooting.

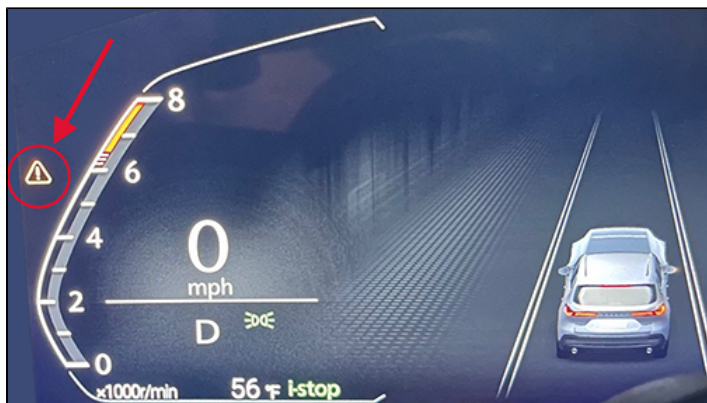
3. Instrument Cluster Master Warning Light may be illuminated.

- Emergency Call Unit Malfunction Notification.
  - Center Display Home screen --> All Apps --> Maintenance --> Notifications
- This condition is related to Item 1 above. Advise the customer that Mazda is aware of the condition and is currently working on a resolution. As soon as a resolution becomes available, this Service Alert will be promptly updated and re-released.

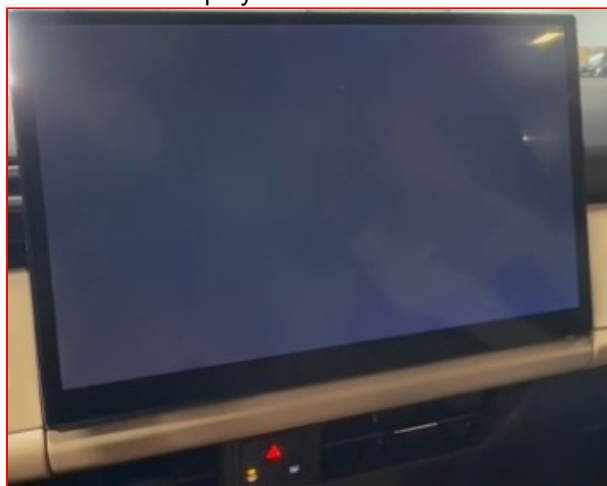
4. The center display screen is blank.

**NOTE:** The rear view camera display while in “Reverse” remains operational during this condition.

- This condition is related to Item 1 above. Refer to TSB 16□004/26. **Did the TSB repair the customer's concern?**
  - **YES:** The TSB resolved the concern — repair complete.
  - **NO:** Proceed with standard MGSS troubleshooting.

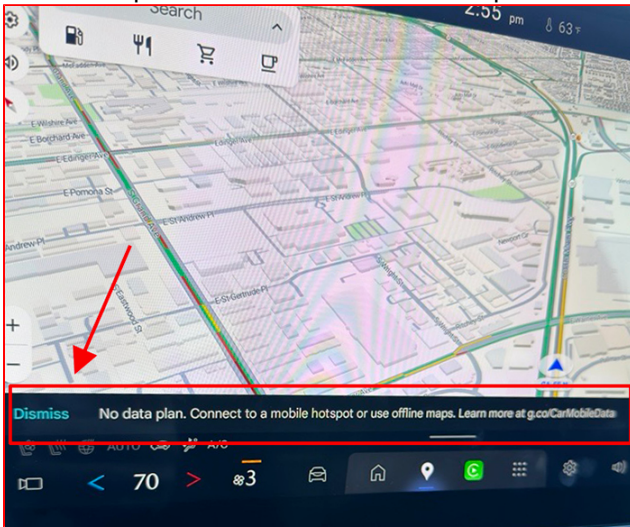
5. No data plan. Connect to a mobile hotspot or use offline maps. Learn more at [g.co/CarMobileData](https://g.co/CarMobileData) message.

- This message is incorrect.
- It does not affect system operation.
- Dismissing the message may temporarily clear it.
- Please ignore this message at this time.
- This condition is related to Item 1 above. Advise the customer that Mazda is aware of the condition and is currently working on a resolution. As soon as a resolution becomes available, this Service Alert will be promptly updated and re-released.

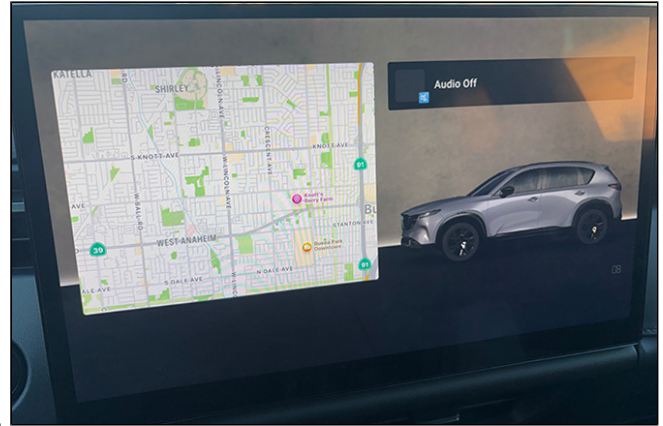
8. Infotainment Center Display Home Screen Partial Boot Up.

- Top icons are not displayed.
- Bottom climate controls are not displayed.
- Google Voice is inoperative.

Confirm that the Cockpit Domain Controller (CDC) is updated to the latest software version.

Navigate to MGSS → Mazda Connect/Connected Vehicle → MAZDA CONNECT Updates → MAZDA CONNECT 3.

- Software update is available: Update the software, then confirm the repair.
- Software update is not available: Proceed with standard MGSS troubleshooting.
