# Warranty Field Campaign

| Campaign Number: c7263 | Revision: | Released Date: 19-May-2026 |
| BES CM2450 EV111B Battery Bracket Replacement Campaign | | Expiration Date (U.S. and Canada): 14-May-2031 |

# **C7263, Attachment B - BES CM2450 EV111B Battery Bracket Replacement Campaign**

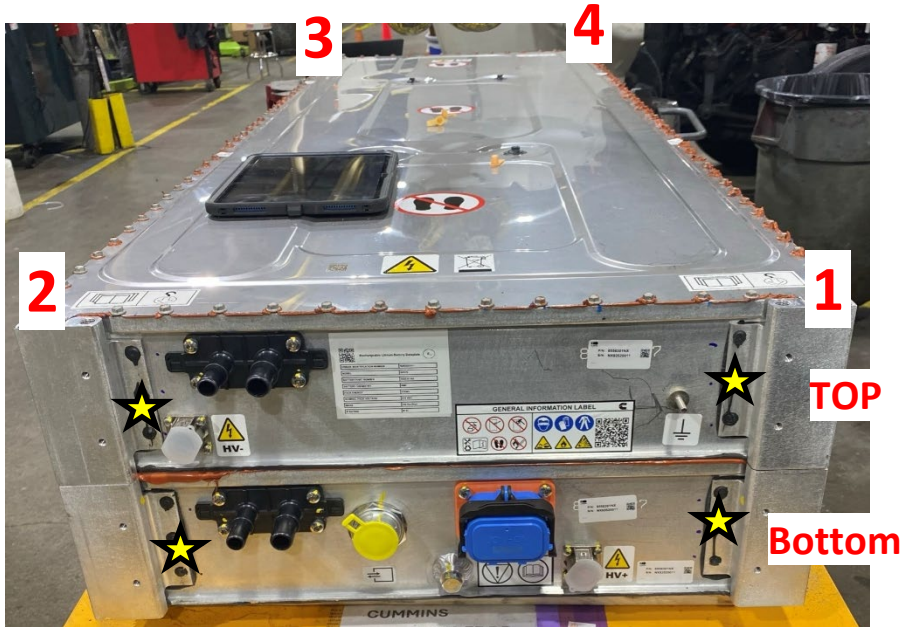
# Step 1: Corner Bracket Separation Inspection

**Inspect** all 4 corners of the battery pack for separation between the battery pack casing and the corner brackets and note the ones that have fail

Confirm separation by using a feeler gauge (0.008") **between the Adhesive and corner bracket** or **the Adhesive and the battery pack** and document the corners with separation based on the corner numbering shown to the left

Separation on the Top and/or Bottom brackets of the same corner should be considered as 1 failed corner. (IE: the Max failed corners per pack only be 4)

Any battery packs with corner bracket separation will need to be replaced with a new/repared battery pack that will be supplied through coordination with the **Accelera Campaign Support Team**

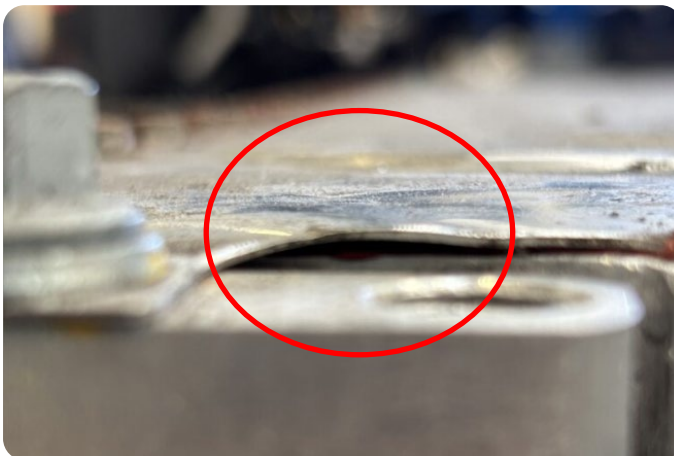
Failure Example 1

Inspect the top 4 corners of the battery pack for damage to the lid that looks like the examples below

Apply Loctite PL Marine Fast Cure Adhesive Sealant to the top corner of the pack to cover the opening

Apply an adequate amount to fully cover the opening

\*Caution – Do not inject sealant directly into opening

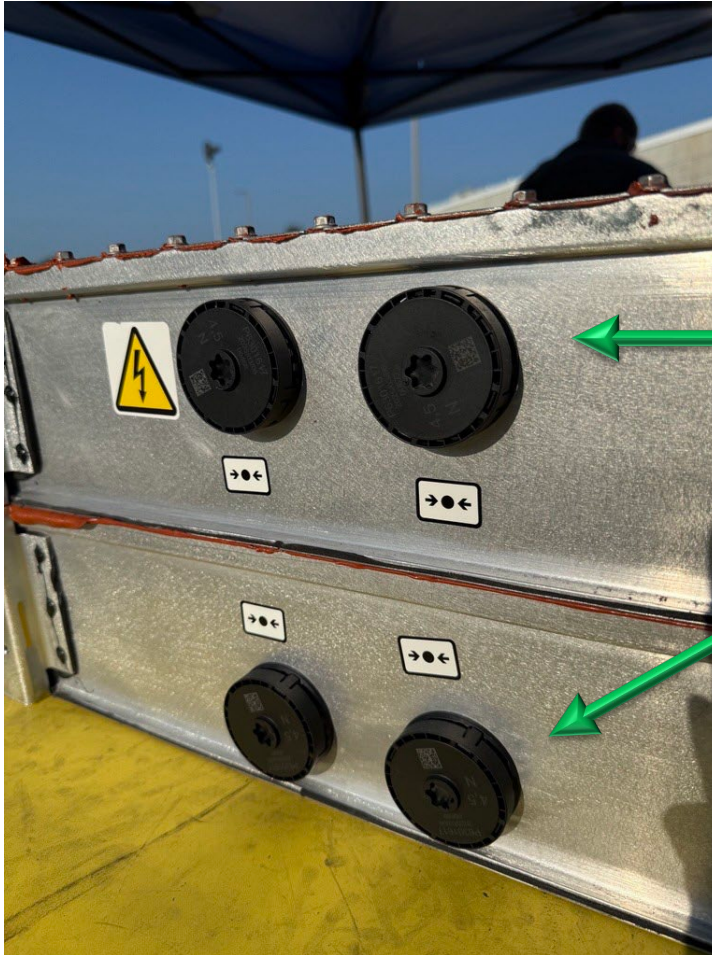
# Step 5: Vent Port Tightening

If the port is loose at the start of the check, you should hear/feel a click when it reseats

Hand tighten each of the 4 vent ports on the rear of the pack
