## 247 (GLA/GLB) - Rearview Camera Noise Optimization

| Topic number | LI54.71-P-080349 |
| Function group | 54.71 - Camera and radar-assisted assistance systems |
| Validity | 247 (GLA & GLB) with all of the following:<br><br>- Model Year 2024 and later (Option code 804, 805, 806, etc...)<br><br>- Option code 459 or 485 (Steel spring variants) |

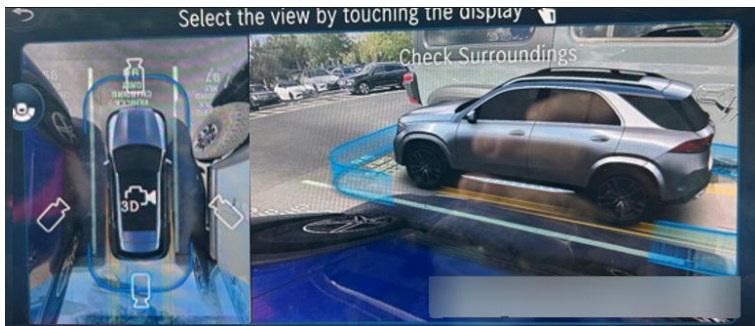
## View PRIOR to SCN Coding:

After both control units have been SCN coded, the "Movable 3D View" feature in the head unit will no longer be available. With this change there will be two distinct differences:

- 1) The "3D" icon when in the top down vehicle view, will no longer be present on the head unit.
- 2) The digital rendering of the vehicle with the ability to spatially move around the vehicle is no longer possible. This view is replaced with 2D static images of the left and right sides.
