GENERAL MOTORS  
DCS 7513  
URGENT - DISTRIBUTE IMMEDIATELY

Subject: N262558300 - Service Update  
Incorrect BCM Calibration Data File

Models: 2026 Chevrolet Silverado 1500  
2026 GMC Sierra 1500

## N262558300 Incorrect BCM Calibration Data File

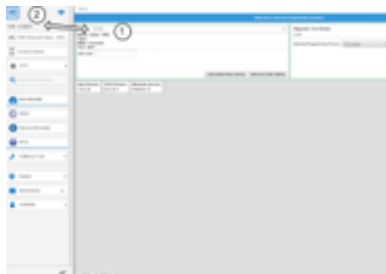
7001095

**IMPORTANT:** The service technician always needs to verify that the VIN displayed in the TLC left side drop down menu (1) and the top center window (2) match the VIN plate of the vehicle to be programmed prior to using Service Programming System 2 (SPS2) for programming or reprogramming a module.

1. Reprogram the Body Control Module. Refer to *K9 Body Control Module: Programming and Setup* in SI. Carefully read the programming and setup document for further instruction.

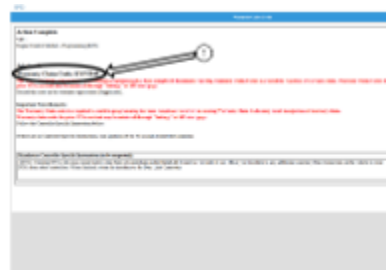
7001097

**Important:** To avoid warranty transaction rejections, you **MUST** record the warranty claim code provided on the Warranty Claim Code (WCC) screen shown above on the job card. Refer to callout 1 above for the location of the WCC on the screen.

2. Record SPS Warranty Claim Code on job card for warranty transaction submission. Refer to *25-NA-281 Information on SPS Warranty Claim Code Submission and Retrieval* in SI.
