**Technical Service Bulletin (TSB)**  
**Park Assist Sensor 3 and 4 Harness Swap**

| REFERENCE: | TSB: 08-222-26<br>GROUP: 08 - Electrical | Date: | May 27, 2026 | REVISION: | — |
| VEHICLES AFFECTED: | 2027 (RU) Chrysler Pacifica / Voyager<br>This bulletin applies to vehicles built on or after February 24, 2026 (MDH 0224XX) and on or before March 30, 2026 (MDH 0330XX) equipped with Parksense FR/RR Park Assist W/STOP (Sales Code XH4). | | | MARKET APPLICABILITY:<br><div><input checked="" type="checkbox"/> NA<input type="checkbox"/> MEA</div> <div><input type="checkbox"/> SA<input type="checkbox"/> IAP</div> <div><input type="checkbox"/> EE<input type="checkbox"/> CH</div><br><b>NOTE:</b> This bulletin applies to the North America markets. | |

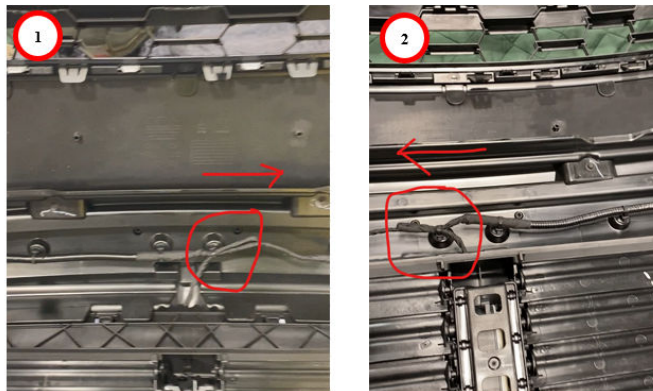
**Fig. 1**  
**Park Assist Sensor Wire Harness Connector**

| CAUSE: | Park assist sensor harness connectors #3 and #4 are swapped. | | | | |

- 1 - Correct wire harness connector routing to park assist sensor #3 and #4.  
2 - Incorrect wire harness connector routing to park assist sensor #3 and #4.

This bulletin provides information regarding the wire harness connectors for Park Assist Sensors #3 and #4. The harnesses for these sensors are visually identical and may have been interchanged during vehicle assembly.

If diagnosis indicates a concern related to Park Assist Sensors #3 or #4, or associated wiring, visually inspect the harness connections to verify correct installation before proceeding with further repair [Fig. 1](#).

If the connectors are found to be swapped, release the harnesses from the retaining clips as necessary, disconnect, and reinstall each connector to the correct sensor location. Ensure harnesses are properly secured after repositioning.
