TT9472  
May 18, 2026  
Page 1 of 4

SUBJECT: Torque Converter Lug Leaks

MODELS All Original Equipment Manufacturer (OEM) Chassis Equipped with Cummins® B Series  
AFFECTED: 6.7L Engines and Allison Transmission, Inc. 1000 Series™ and 2000 Series™ Transmissions

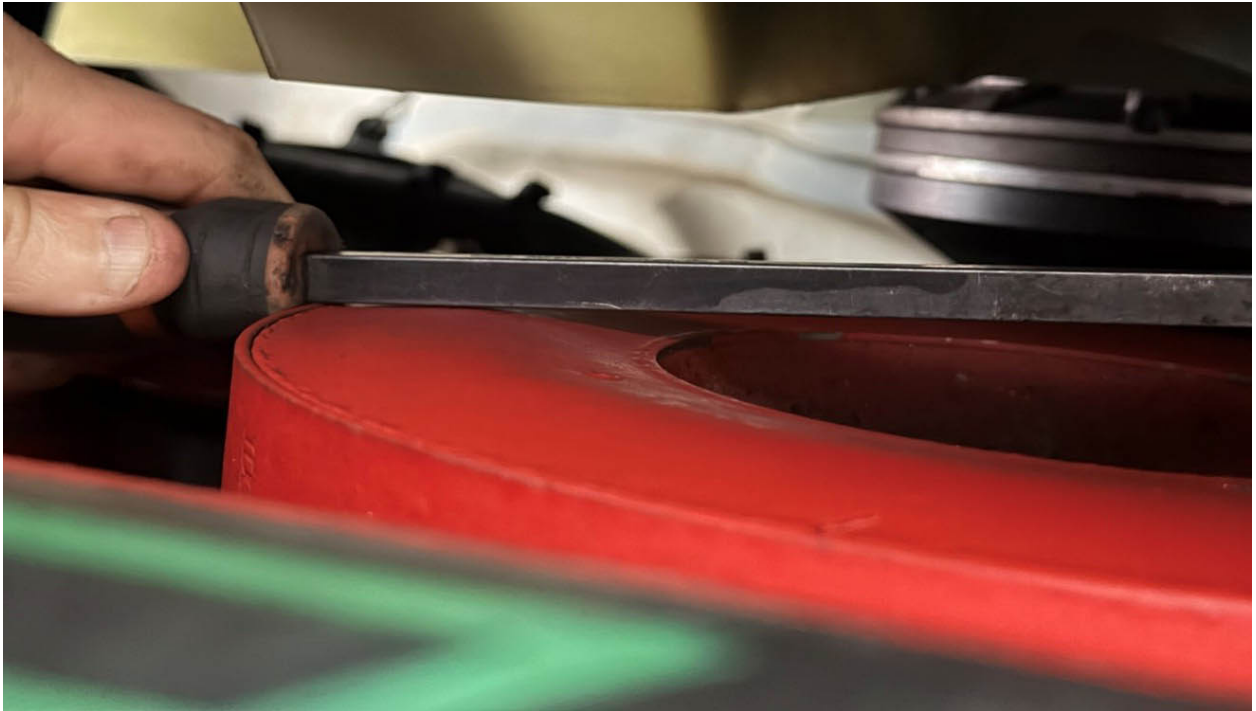
7001387

**Figure 1. Example of a Swollen Engine Vibration Damper**

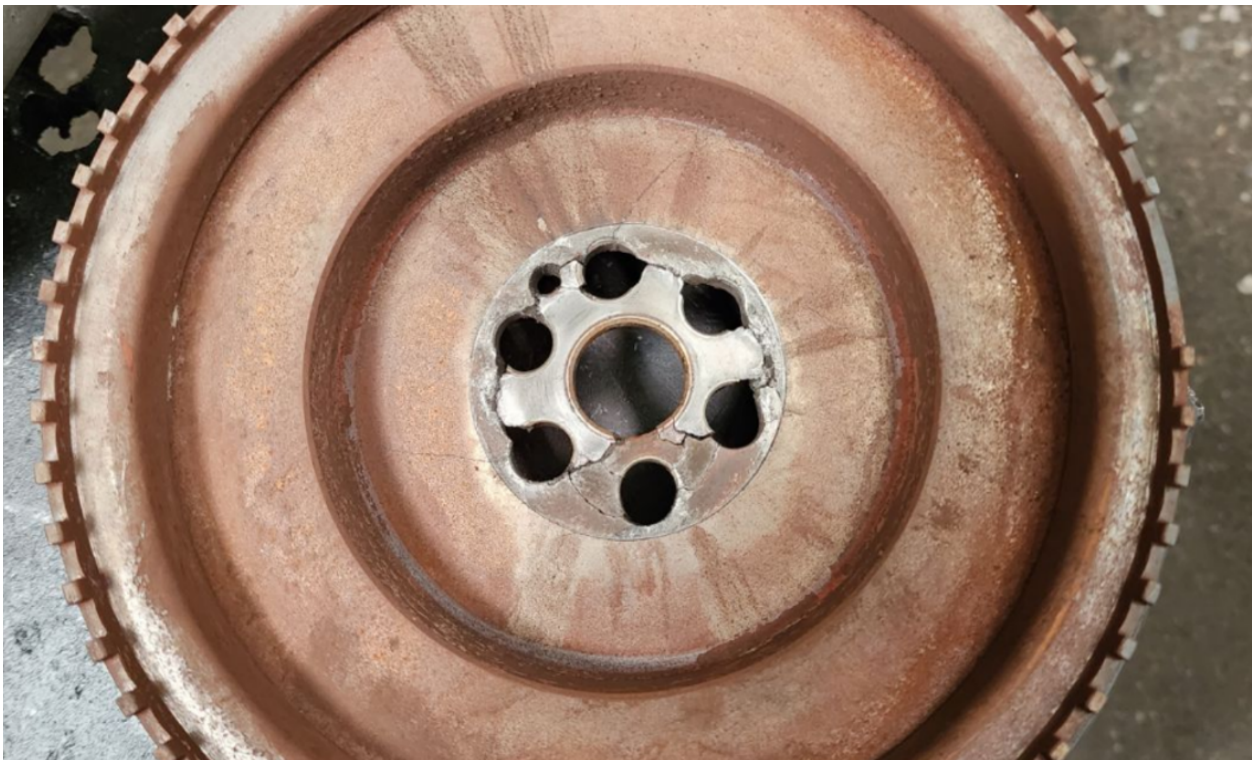
7001387

**Figure 2. Example of Cracked Mounting on the Front of the Crankshaft**

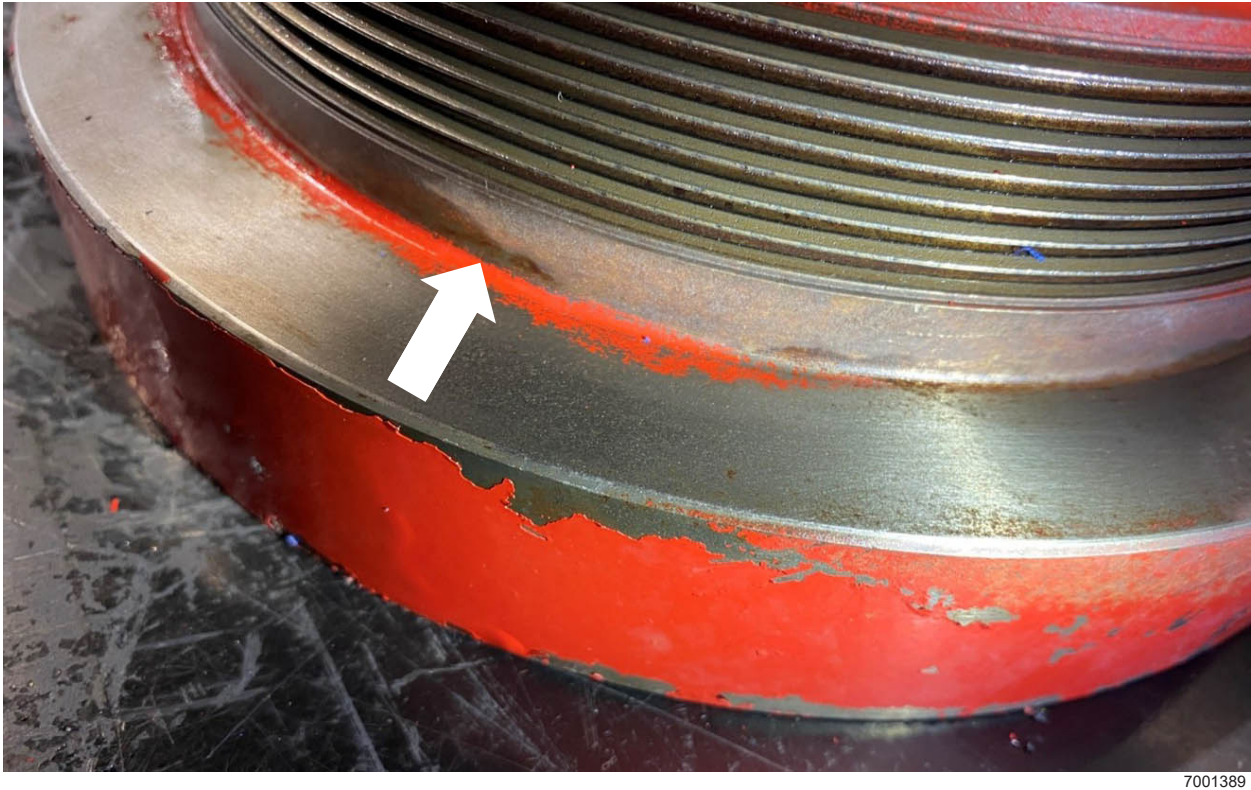
7001389

**Figure 3. Example of Viscous Fluid Leakage from Crack**
