## Condition

| Model(s) | Year(s) | VIN Range | Vehicle Specific Equipment |
|---|---|---|---|
| A3, S3, RS 3 (8Y) | 2022 – 2025 | All | Not applicable |

- The customer complains that the airbag warning lamp lights up.

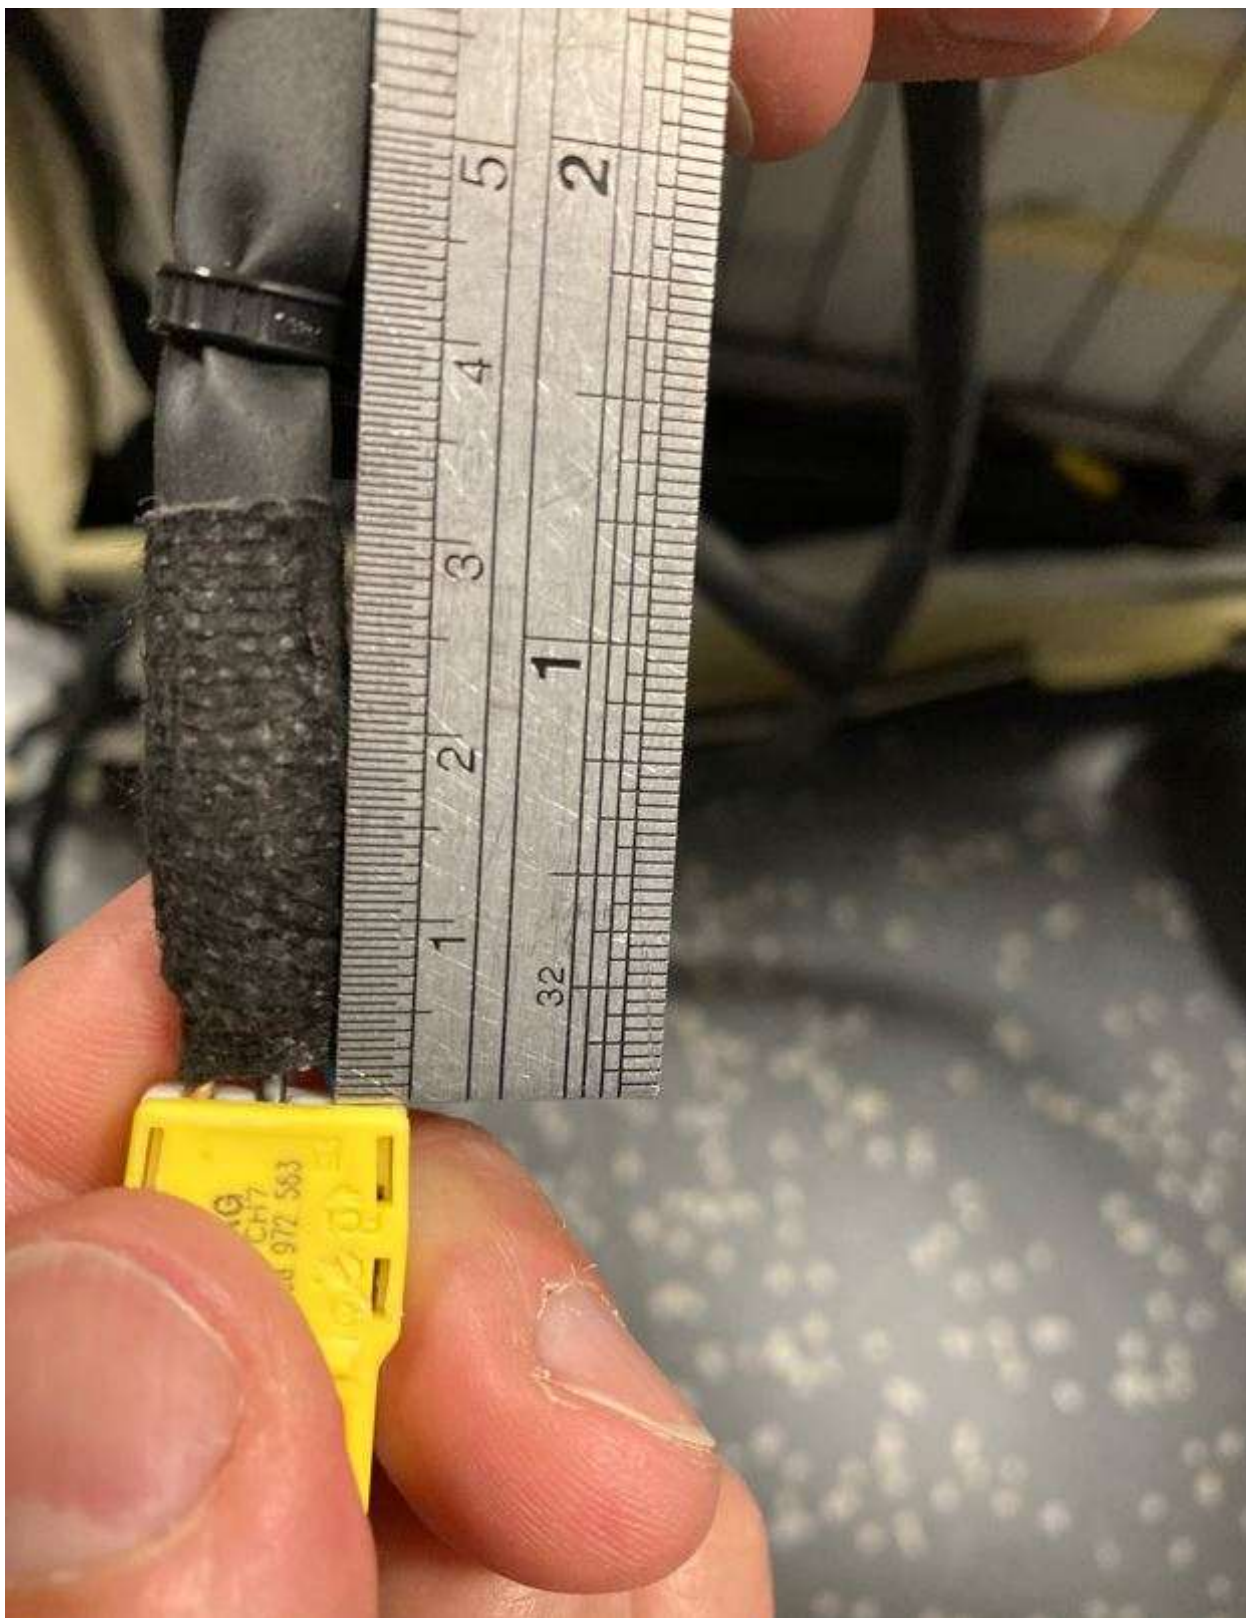
The wiring to the side airbag is too close to the seat foam. The seat foam presses on the wire. The connector also moves, resulting in an increase in resistance.

**Figure 1.** Attach the additional clip as shown.

Then route the wiring harness according to the following images and use the clip N10546701 or 4N0971850A to secure the wire.

1. Unplug the cable and attach the clip as shown (Figure 1).

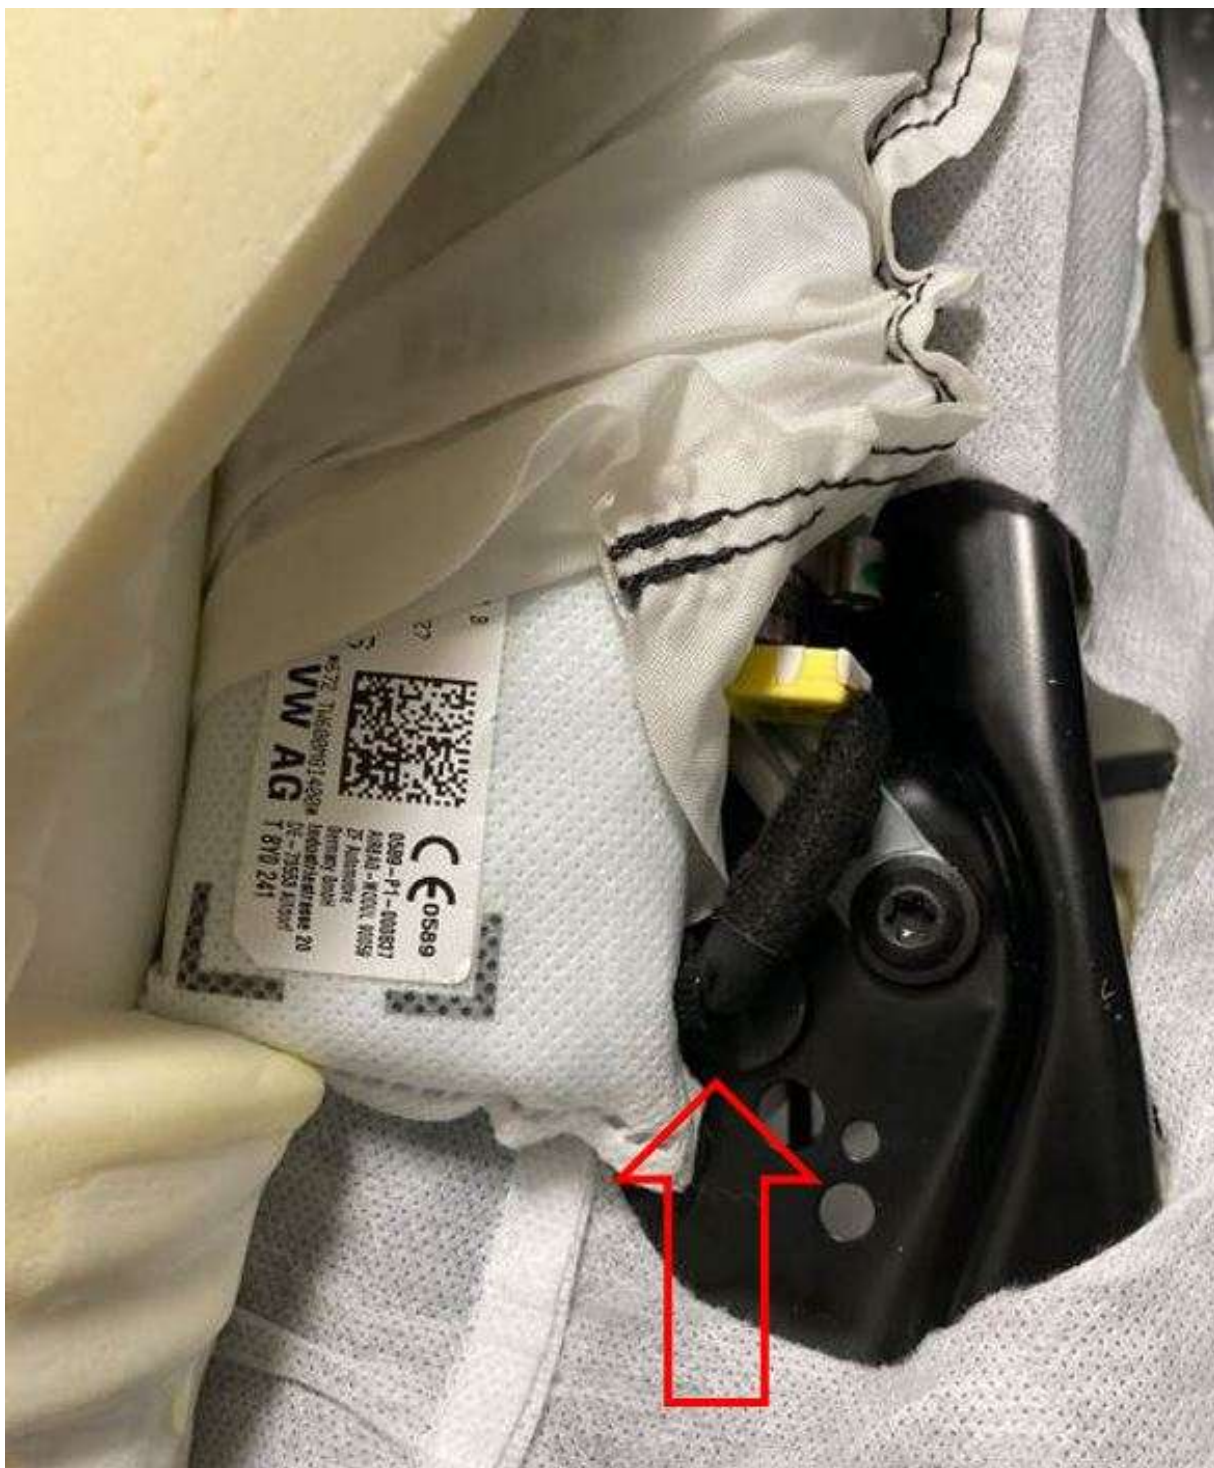
**Figure 2.** Attach the clip to the seat frame as shown.

2. The clip can then be attached to the seat frame, and the connector can be plugged back in and locked (Figure 2).

**IMPORTANT:** Lock connector again afterwards!
