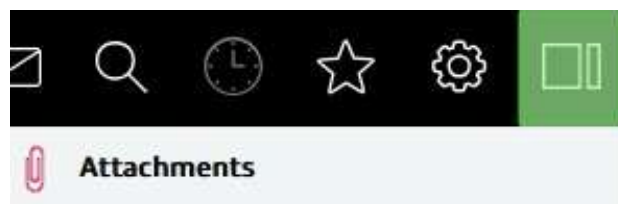
Figure 1. Video attachment tab in ElsaPro.

Figure 2. Attachments window slide in Elsa2Go.
