Vehicle-specific service

Transaction No.: 2079656/3

91 PSS Audi connect: Charging Targets cannot be adjusted

Release date: May 27, 2026

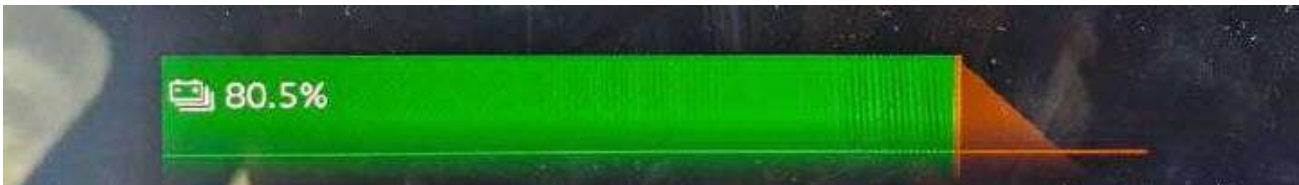
The customer complains that the charging target setting cannot be adjusted.

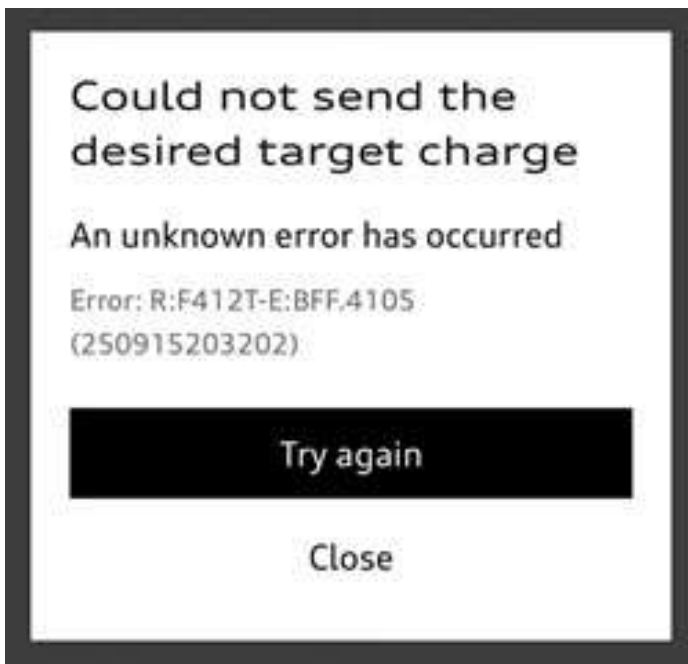
In the context of the issue that the charging target cannot be set, an error message appears in the myAudi app indicating that the set charging target cannot be sent.

Screenshot from app: "The desired charging target could not be sent. An unknown error has occurred."
