# Service Action

## Code: 60BD

**Subject** Panoramic Glass Roof Corner Bonding

Some vehicles with a panoramic glass roof produced during a limited production period may have bonding issues at the corners of the glass roof. Dealers will inspect the roof corner bonding and re-bond the entire glass roof if needed.

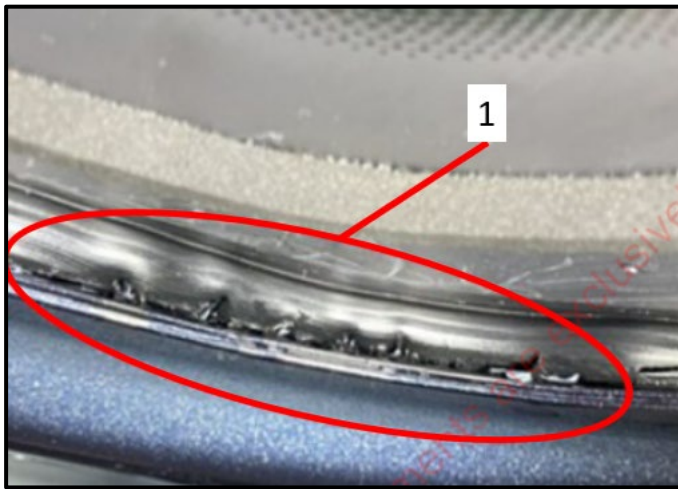
- Check the glass roof panel bonding seal.
- If the glass roof panel is properly bonded in this corner:
  - Reattach the headliner in this corner.
  - Repeat the inspection steps on the remaining glass roof panel corners.
- If the glass roof panel is properly bonded in all four corners:
  - Reassemble the vehicle in reverse order of removal.
  - Work is complete.
- If the glass roof panel is not properly bonded <1> in any of the corners:

The glass roof panel can be reused and does not have to be replaced.

- Create a TAC WEB Ticket and provide clear photos of the improperly applied sealant.
- Wait for a response on the TAC ticket before proceeding with re-bonding the glass roof panel according to the ELSA Repair Manual.
- Proceed to Section C.
