## Complaint Regarding the Camera View (Real Top View) in the PCM Central Display (03/26)

Model Line: **911 (992 I)**

Concerns: **Signal lines and plug contacts for the Real Top View cameras**

Information: **The customer complains that the Real Top View in the central display fails sporadically, partially or completely.**

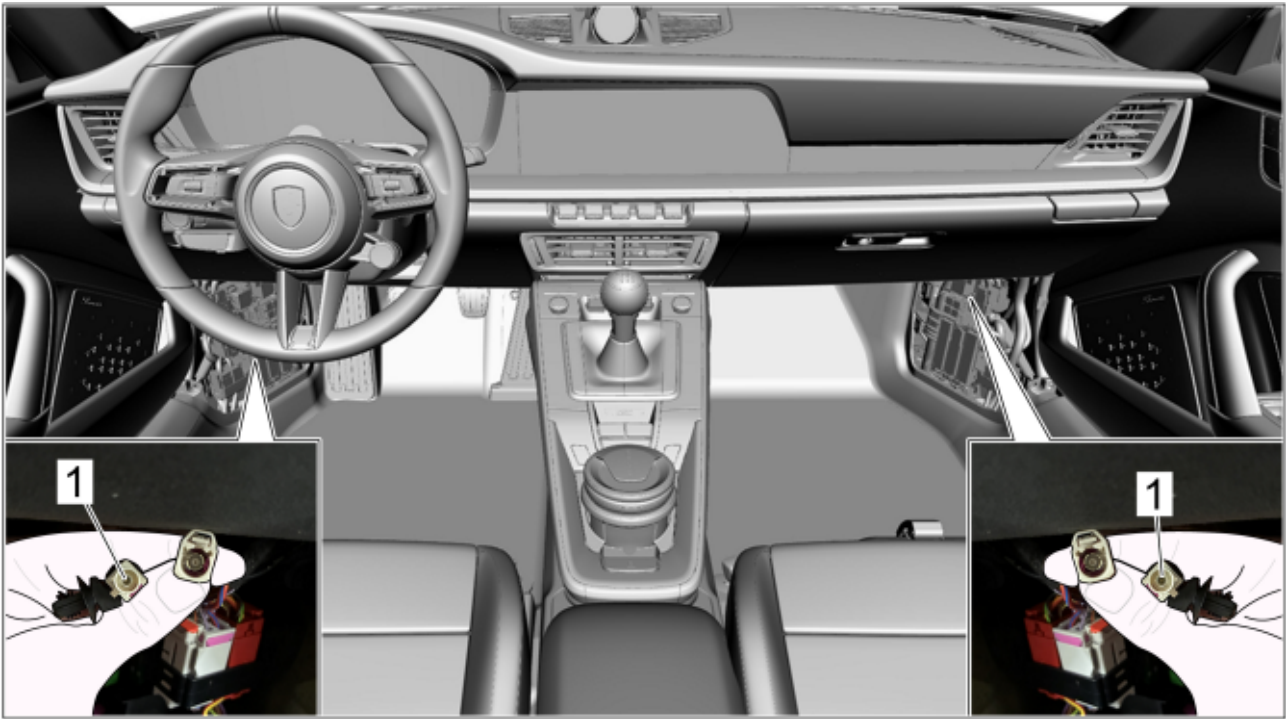
Resistance measurement of the signal lines in the passenger compartment

| Assessment | Action |
|---|---|
| Resistance is <b>335 Ω</b> or <b>less</b> . | <p>The resistance of the signal lines is <b>OK</b>.</p> <p>Connect electric plug connections until connector locks perceptibly.</p> <p>Install front side section and door trim panel<br/>⇒ Workshop Manual '702419A1 Removing and installing front side section trim panel'<br/>⇒ Workshop Manual '705919A3 Removing and installing the front door trim panel'</p> <p>Install front luggage compartment trim panel.<br/>⇒ Workshop Manual '700519A1 Removing and installing front luggage compartment trim panel'</p> <p>Then connect earth strap for battery.<br/>⇒ Workshop Manual '978509A1 Loosen and secure earth strap for battery'</p> |

| | End of action. |
|---|---|
| The resistance value is <b>greater than 335 <math>\Omega</math></b> . | <p>The resistance of the signal lines is <b>not OK</b>.</p> <p>Replace plug contact of a signal line in the passenger compartment.</p> <p>Continue with Step <math>\Rightarrow</math> 2.</p> |

Work Procedure: 1 Fasten the **measuring adapter** to the signal lines ⇒ *Resistance measurement of the signal lines in the passenger compartment -1-* in the passenger compartment on the left and right and perform a resistance measurement using the **P90999 - Porsche Tester 4**.

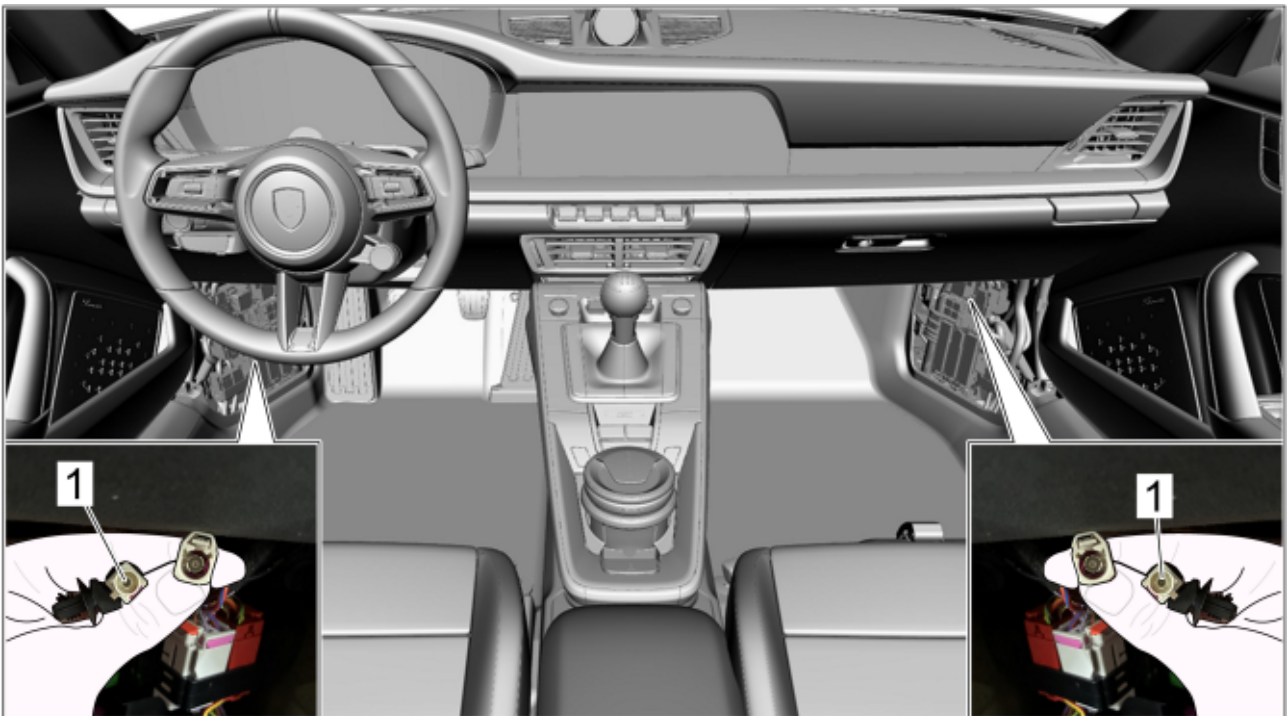
*Resistance measurement of the signal lines in the passenger compartment*

| Assessment | Action |
|---|---|
| Resistance is <b>335 Ω</b> or <b>less</b> . | <p>The resistance of the signal lines is <b>OK</b>.</p> <p>Connect electric plug connections until connector locks perceptibly.</p> <p>Install front side section and door trim panel<br/> ⇒ Workshop Manual '702419A1 Removing and installing front side section trim panel'<br/> ⇒ Workshop Manual '705919A3 Removing and installing the front door trim panel'</p> <p>Install front luggage compartment trim panel.<br/> ⇒ Workshop Manual '700519A1 Removing and installing front luggage compartment trim panel'</p> <p>Then connect earth strap for battery.<br/> ⇒ Workshop Manual '978509A1 Loosen and secure earth strap for battery'</p> <p><b>End of action.</b></p> |
| The resistance value is still <b>greater than 335 Ω</b> . | <p>The resistance of the signal lines is <b>not OK</b>.</p> <p>Replace plug contact of the signal line in the passenger compartment on the <b>right</b>.</p> <p><b>Repeat step ⇒ 2 on the right-hand side and then perform another resistance measurement.</b></p> <p>Install front side section and door trim panel<br/> ⇒ Workshop Manual '702419A1 Removing and installing front side section trim panel'<br/> ⇒ Workshop Manual '705919A3 Removing and installing the front door trim panel'</p> <p>Install front luggage compartment trim panel.<br/> ⇒ Workshop Manual '700519A1 Removing and installing front luggage compartment trim panel'</p> <p>Then connect earth strap for battery.<br/> ⇒ Workshop Manual '978509A1 Loosen and secure earth strap for battery'</p> <p><b>End of action.</b></p> |

- 2 Replace plug contact  $\Rightarrow$  *Plug contact for signal line in passenger compartment -1-* of the signal line in the passenger compartment on the left.  
For work procedure, see:  $\Rightarrow$  *Workshop Manual '912841 Repairing antenna line'*
- 3 Fasten the **measuring adapter** to the signal lines  
 $\Rightarrow$  *Resistance measurement of the signal lines in the passenger compartment -1-* in the passenger compartment on the left and right and perform another resistance measurement using the **P90999 - Porsche Tester 4**.
