AMG models with torque converter 725.0 (NAG3 Classic) and M177/ M279 engine - Harsh shift concerns due to speed sensor installation

| Topic number | LI27.00-P-080462 |
| Reason for change | Updated Remedy - Control unit repair kit made available |

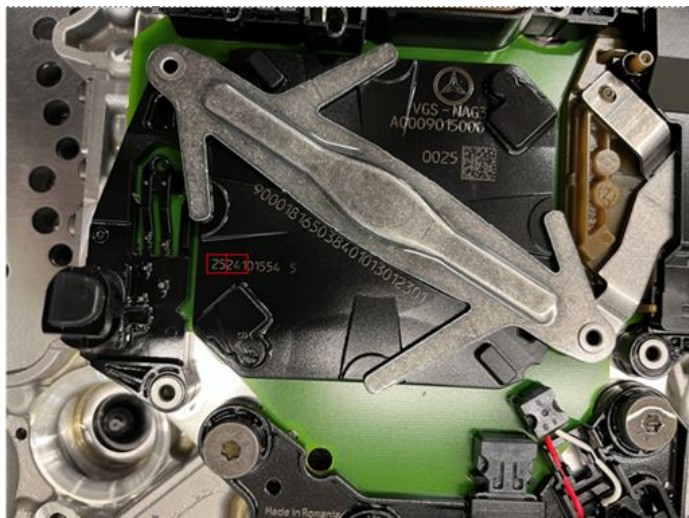
| Attachments | |
|---|---|
| Valve body - ECU serial number and date code.jpg | Figure 2 |

It is possible to check the production date of the VGS through the EEPROM .txt file (Figure 1) or on the VGS hardware (Figure 2).
