## Technical product information

| Topic | Window Drop Glass Operation Continental GT/GTC 19-24MY |
| Transaction No. | 2080375/2 |

Window Drop Glass Operation | Continental GT/GTC |19-24MY

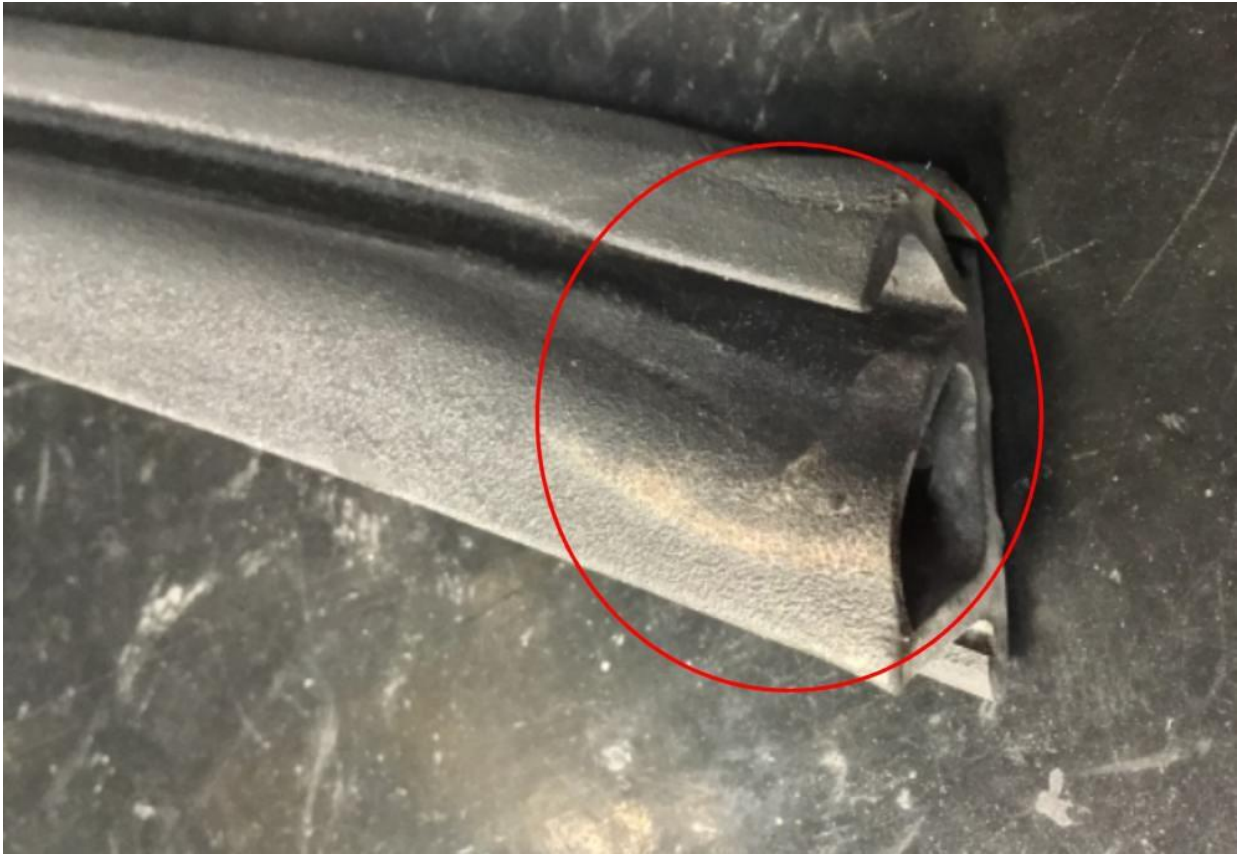
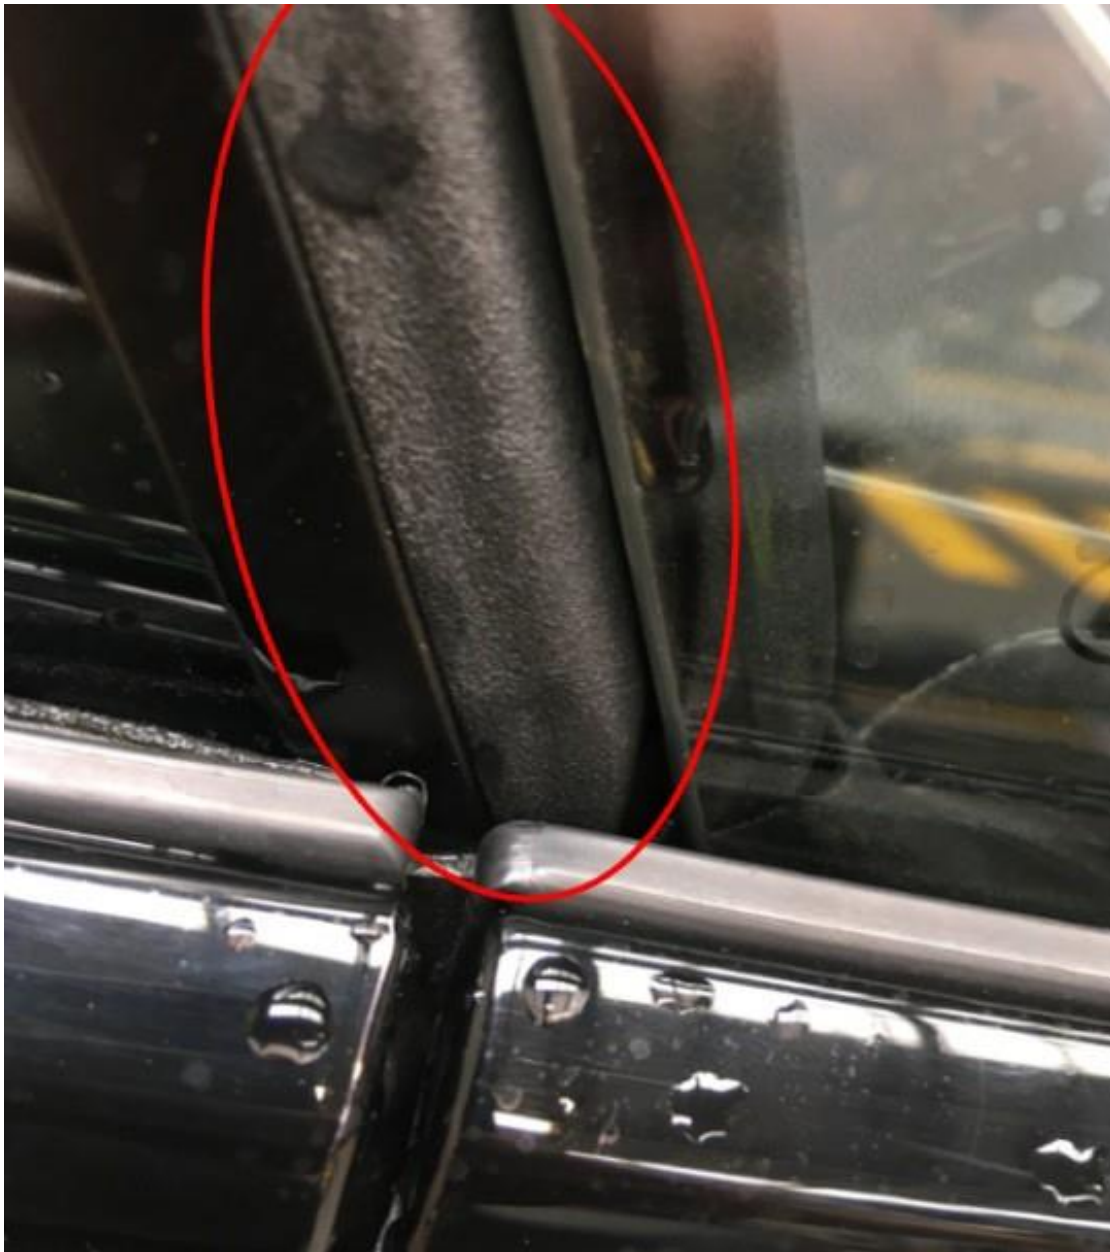
Figure 7

- Damage
- Splits
- Tears
- Misalignment
- Incorrectly fitted / located
- Drop glass seal deformation (see Figures 7 and 8 as examples)

NOTE: Any issues found with the window seals must be rectified before conducting the remaining steps

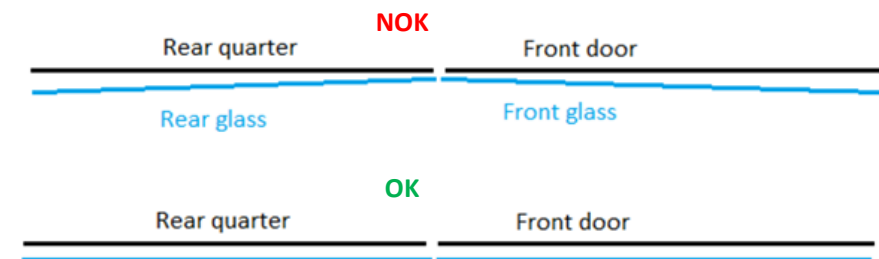
See image below, for OK and NOK after adjustment/checking

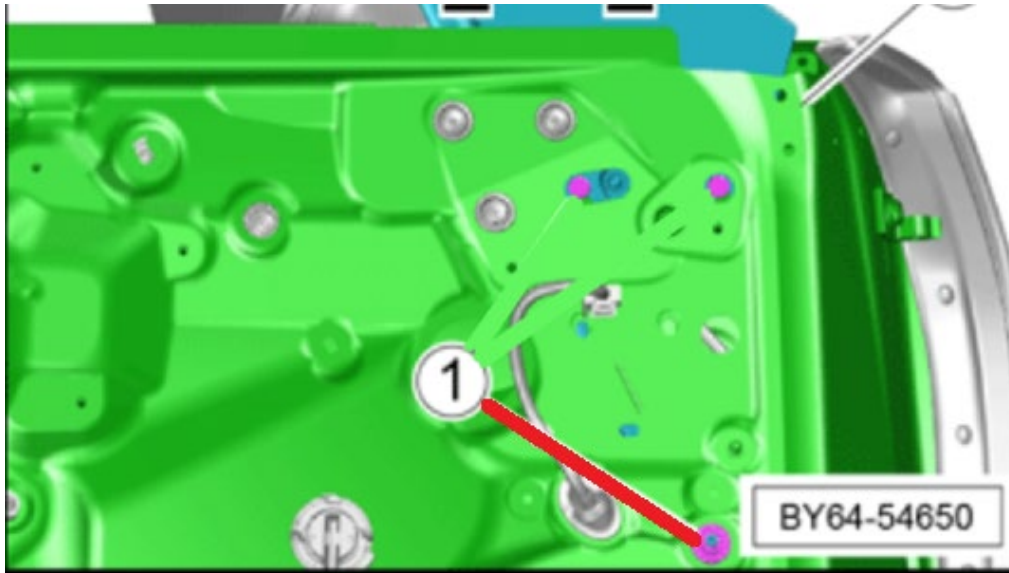
*Figure 1. Image for reference, glass does not require removal from vehicle*

The measurement between the bottom of the mounting washer and division bar frame, is 12.5mm.

1. loosen the lock nut.
2. Screw the adjuster fully clockwise until it bottoms out on the frame.
3. Unscrew the adjuster counterclockwise by four complete turns.
4. Resecure the lock nut.

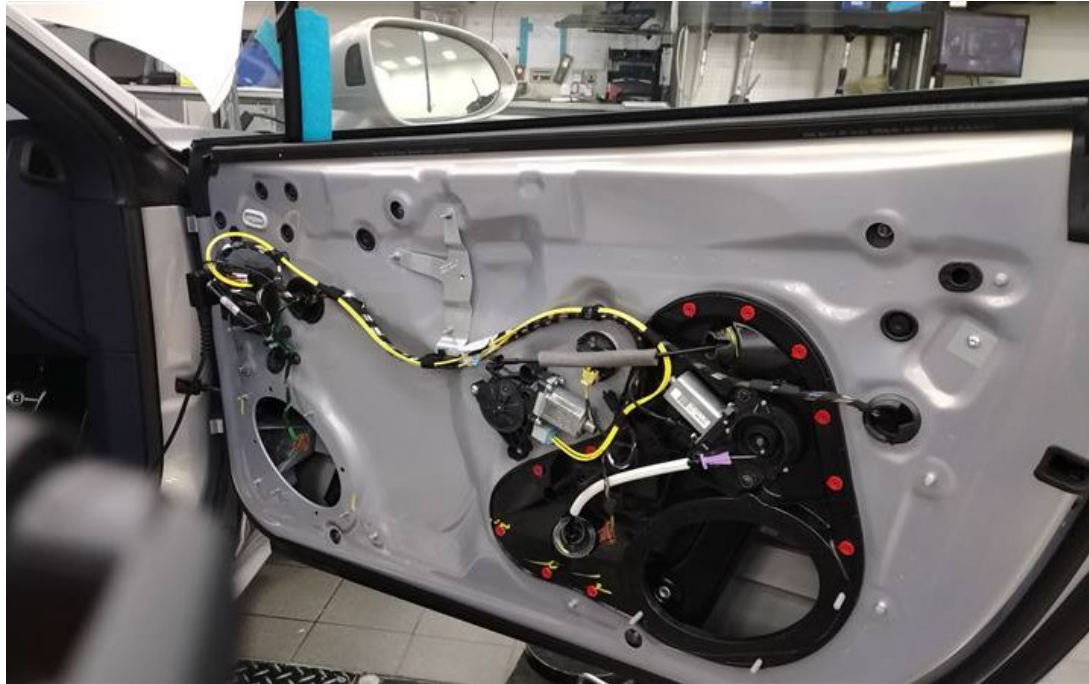
*Figure 8*

After completing the regulator reset procedure, measure the diameter of the motor-to-door ECU feed wires at the motor connector.

If the wires are 1.5mm diameter, carry out the replacement of the original motor-to-door ECU feed wires (yellow in the photograph) with the 2.5mm diameter new wires (part number: 000 979 242 E).

Refer to the information in ElsaPro Repair Group 97 Wiring harness repairs
