HYUNDAI
Technical Service Bulletin

GROUP AUTOMATIC TRANSAXLE	NUMBER 26-AT-003H
DATE MAY 2026	MODEL(S) SANTA FE (MX5A) SANTA CRUZ (NXT)

SUBJECT: LOW IDLE OR EXCESSIVE VIBRATION DTC P050600 – TORQUE CONVERTER REPLACEMENT

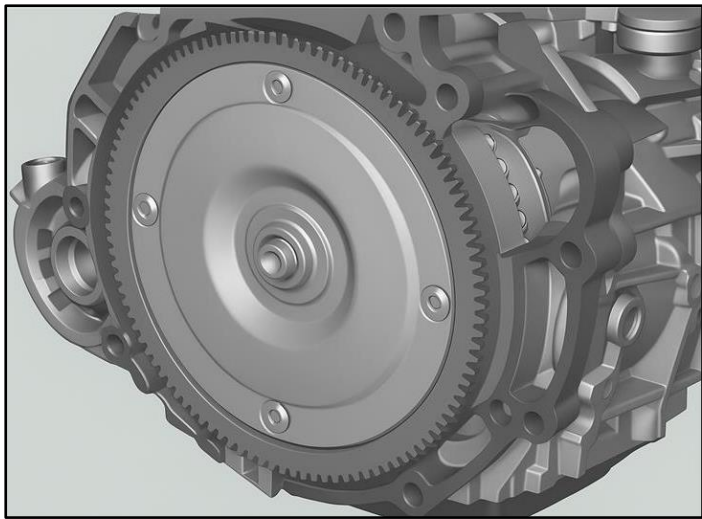
Description: Some Santa Fe (MX5A) and Santa Cruz (NXT) vehicles may exhibit a low idle or excessive vibration while in Drive or Reverse, or DTC P050600 (Idle Air Control System – RPM Lower than Expected) caused by the one-way clutch sprags being misaligned. This bulletin provides instructions to remove the automatic transmission and replace the torque converter.
