HYUNDAI Technical Service Bulletin	GROUP DRIVESHAFT & AXLE	NUMBER 26-TC-001H
	DATE MAY 2026	MODEL(S) PALISADE (LX2)
SUBJECT: 4WD COUPLING NOISE – 4WD ECU SOFTWARE UPDATE

Description: Some Palisade (LX2) vehicles may produce noise from AWD coupling vibrations when making turns caused by a logic error with the All Wheel Drive Electronic Control Unit (AWD ECU). This bulletin provides instructions to update the AWD ECU to reduce the coupling noise.

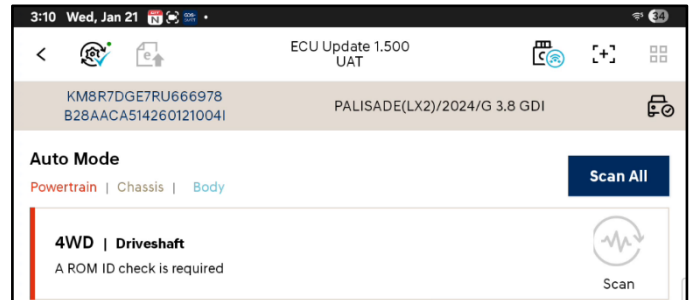
2. Verify the ROM ID by selecting the **4WD** system to scan the vehicle's current ROM ID.

Check the current ROM ID version and compare it to the [ROM ID Information](#) table before attempting to perform the software update.

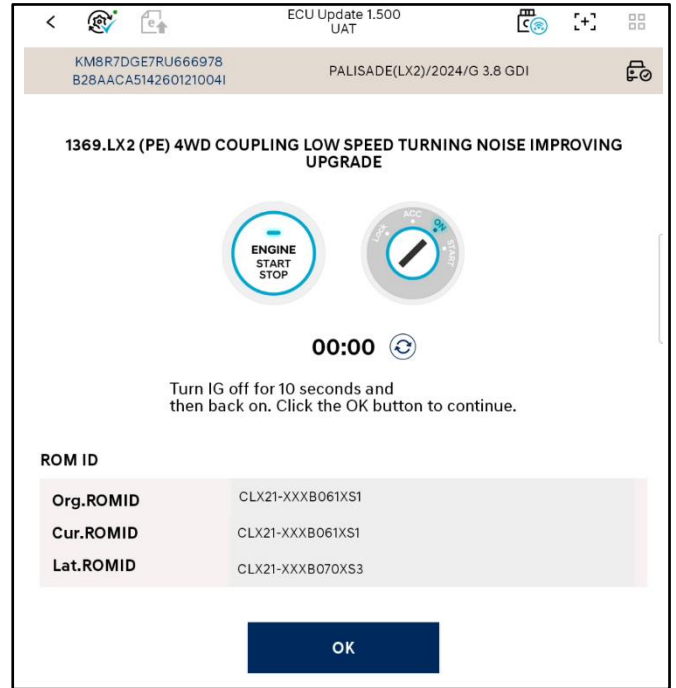
- After the ECU update process shows 100% complete, follow the prompts on the screen to cycle the ignition **OFF** for at least **10 seconds** to reset the control unit (certain models may take up to **30 seconds**).

Use the **Refresh** button to reset the timer.

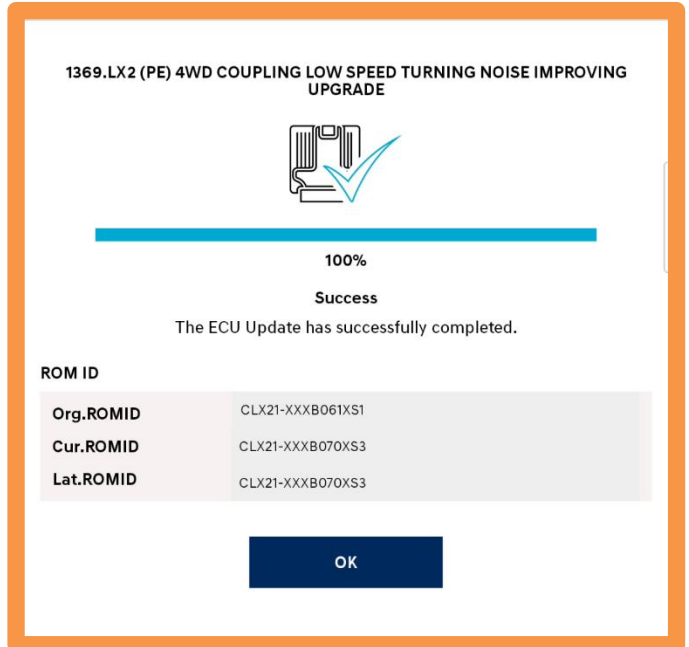
Using the tablet or GDS screen capture function, take a screenshot of the ECU Update “Success” result screen.

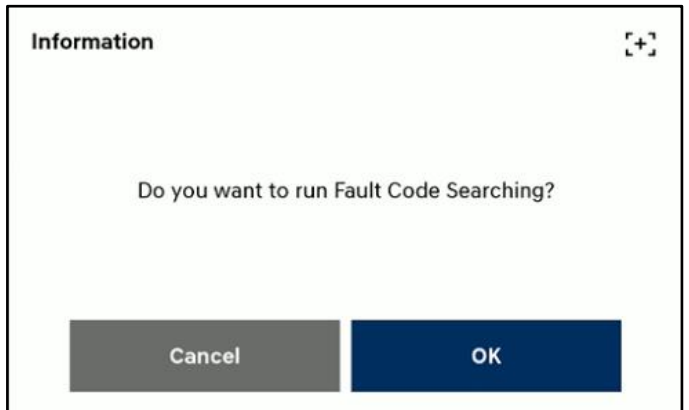
- Perform an **All Systems Fault Code** search and erase DTC history that had incidentally occurred from the ECU update.
