Service Bulletin

Bulletin No.: PIP6033B

PRELIMINARY INFORMATION

Subject: CVT Transmission Noise - Slip or Loss of Motion

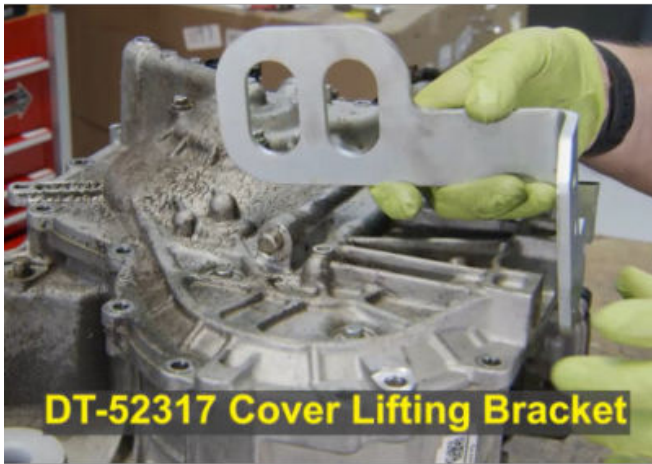
6750280

Note: Only remove the side cover utilizing the GM-52317 lifting tool, failure to do so could result in damage to the transmission or personal injury.

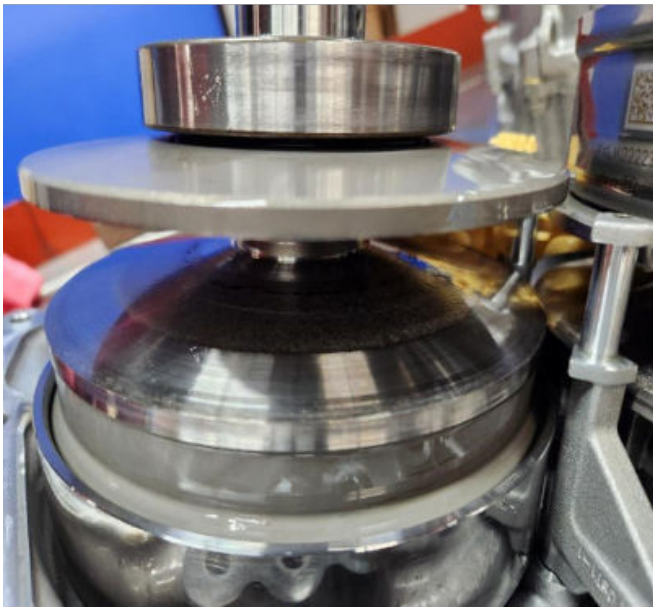
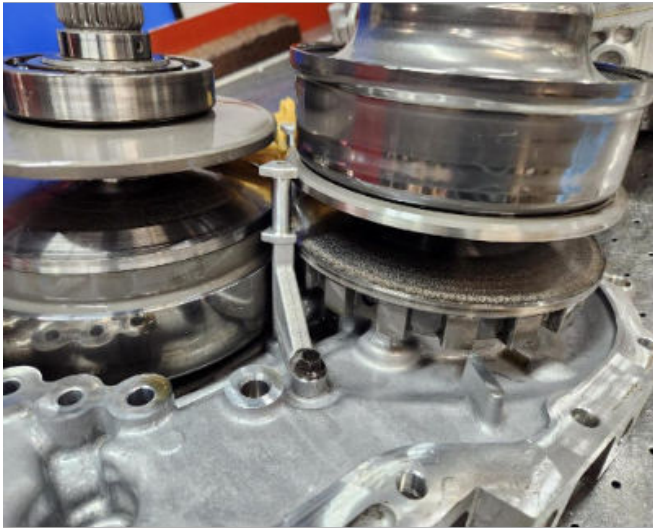
Damage to the pulleys can be seen below:

In the above pictures you can see the rough pulley surface, it is often described as having the appearance of a brake rotor that has gone metal to metal.

If any of the above concerns are found, the transmission will require replacement.

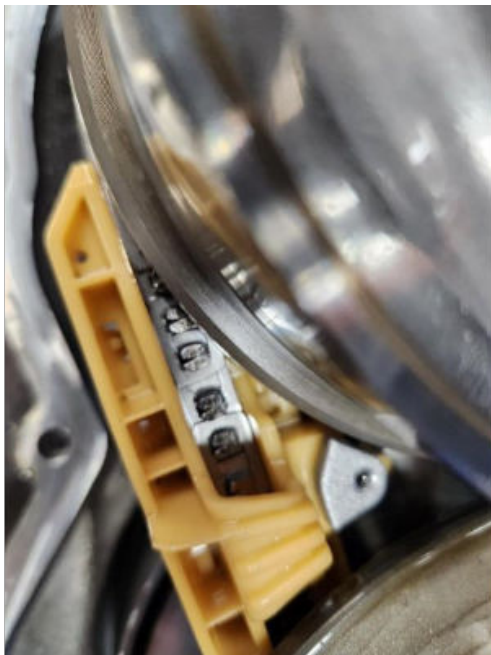
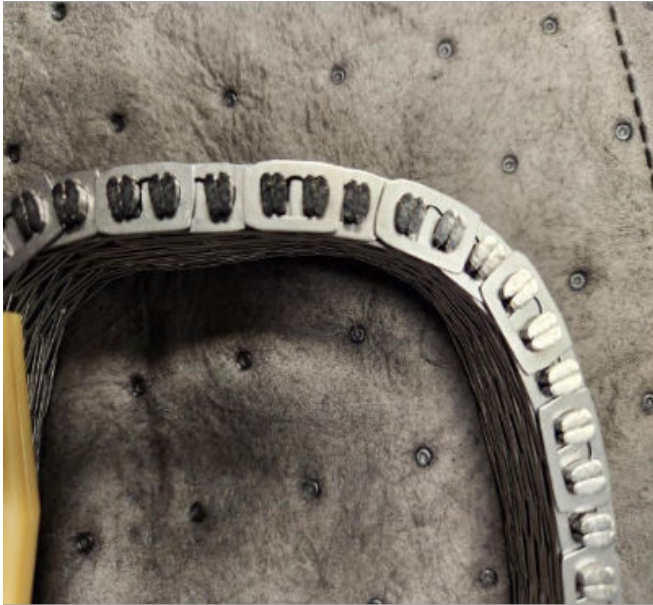
The pictures below show damage to the transmission drive chain and drive chain ends.

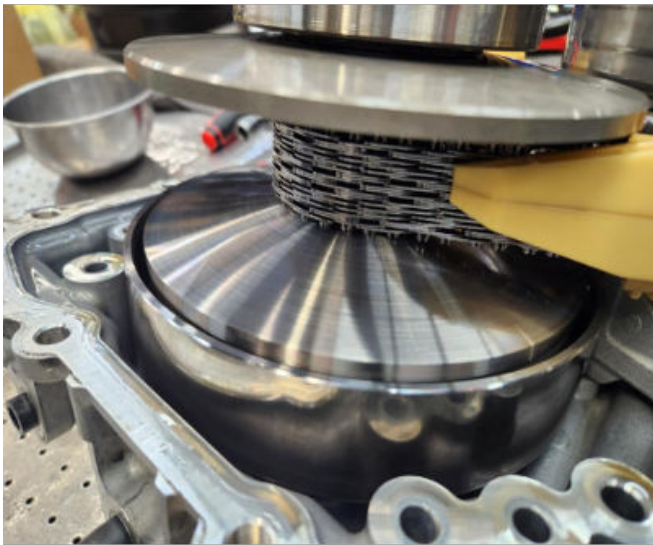
6750281

The picture below show examples of what a good pulley surface looks like, take note of the fine grooves present on the surface.

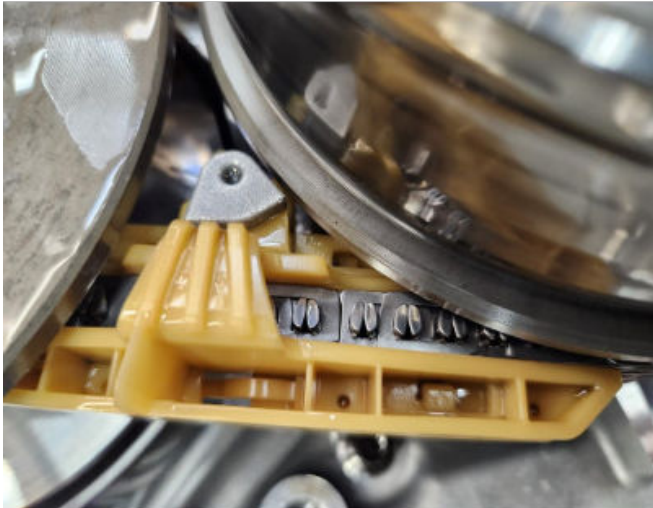
6750282

The Pictures below show examples of a good drive chain.

Take note of how the chain ends (deer hooves) have a polished appearance.

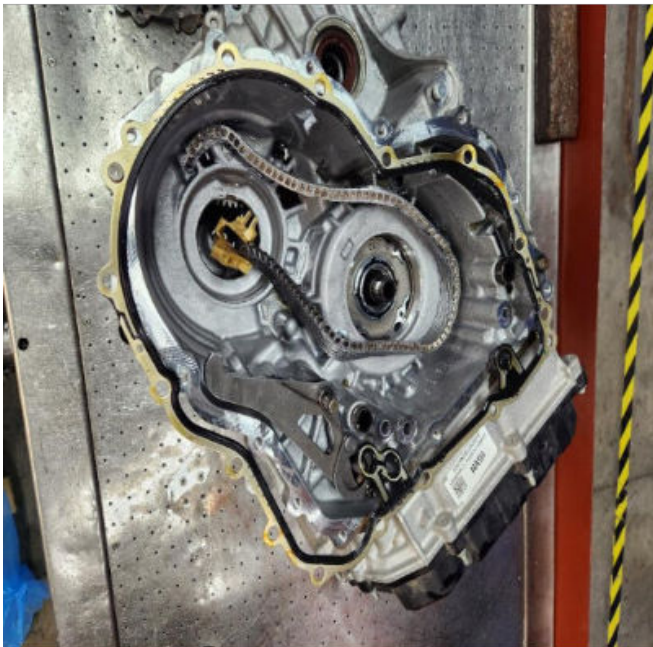
6750292

In some rare cases the chain may be broken.

When this happens when attempting to perform the inspection it may be found the transmission case cannot be removed.

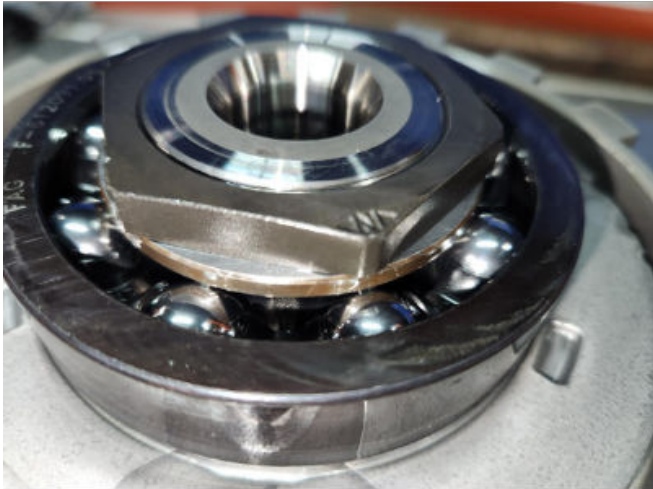
6781798

There have been issues seen with spalling on the bearing race as seen below.

Please follow the appropriate process to obtain and replace the transmission.

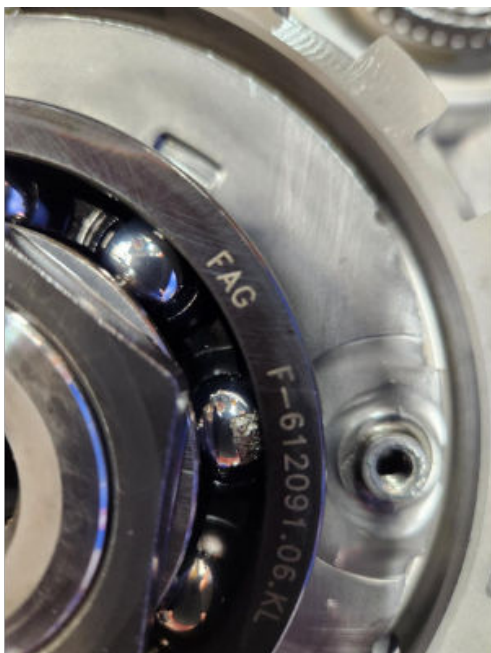
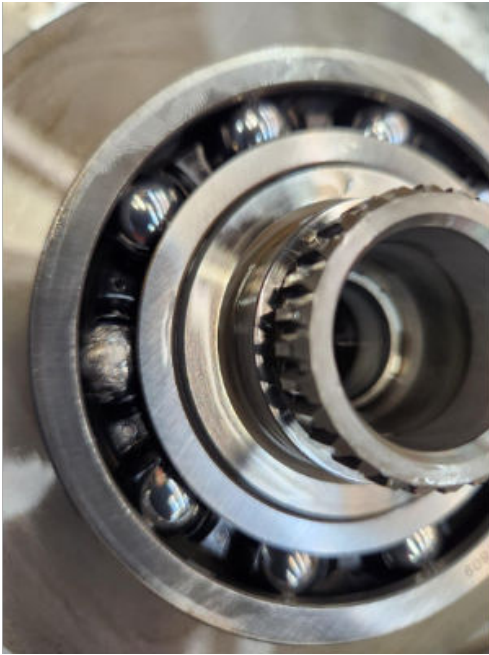
There have also been issues with the ball bearings having spalling on them as well as seen in the examples below.
