Service Bulletin

Bulletin No.: PIP6032C

Subject: CVT Transmission Leaks from the Oil Filter Housing and/or the Cooler Lines

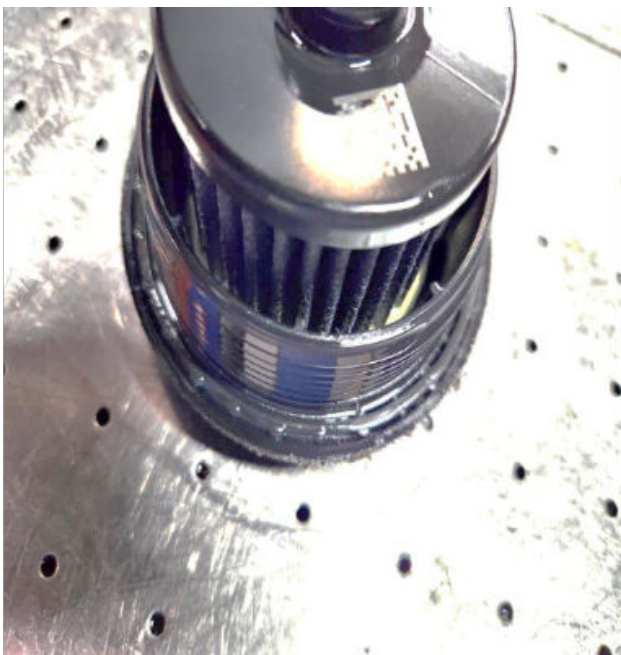
6750285

Damaged/Rolled Oil Filter O Ring.

These Seals should always be lubricated prior to installation.

Failure to do so can cause the O Ring to twist and roll or become distorted.

If this concern is found please replace the oil filter housing and take care to lubricate the O ring Prior to installation.

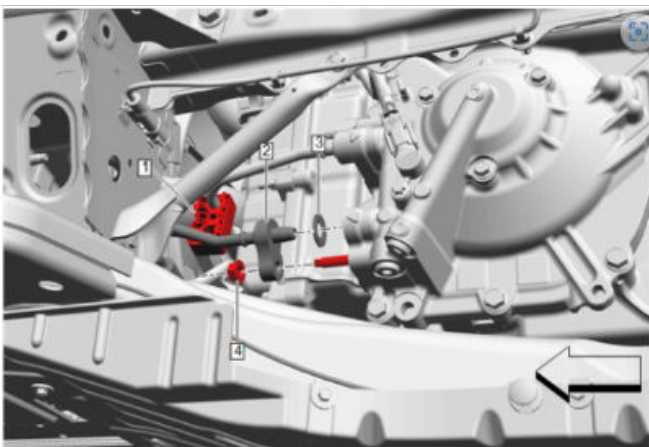
6782717

There have been cases seen where Technicians or assembly plant issues can leave these seals off.

These seals resemble A/C Line seals as they are metal with a rubber sealing surface internal.

An example of these seals is seen below Item 3 is the seal.

Take care when removing the lines from the transmission to verify the seals are on the line.

If a leak is found in this location replace the damaged or missing seals, drive the vehicle and verify there are no leaks.
