Volvo Car USA LLC

Technical Journal

Technical Journal Title Electric System Temporarily Limited Message		Ref. No. TJ 37478.1.2	
Issuer (Dept.) Technical Service		Issue Date 5/5/26	Status Date 5/5/26
Car Market United States and Canada	Partner 3 US 7510 Volvo Car USA	Function Group 3229	
Function Description Miscellaneous		Page Page 1 of 6

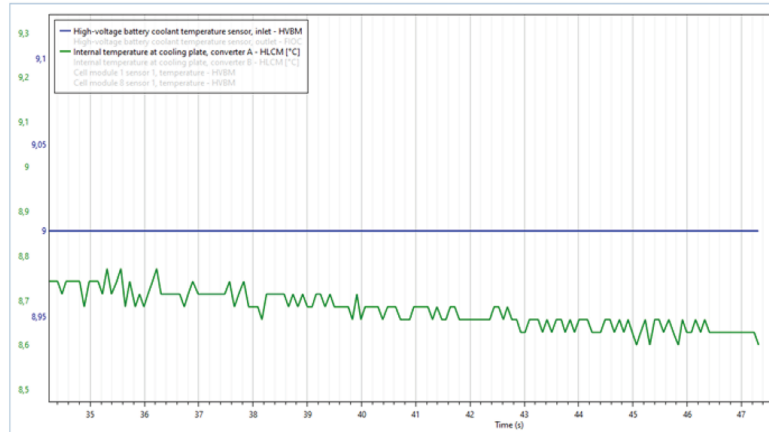
- 3.1. The HLCM cooling plate temperature and the HV battery coolant inlet temperature are about the same. See page 3.1 of the attachment TJ_37478_1.pdf.

No further action required. The HLCM cooling system is not blocked. Continue the fault tracing according to VIDA.

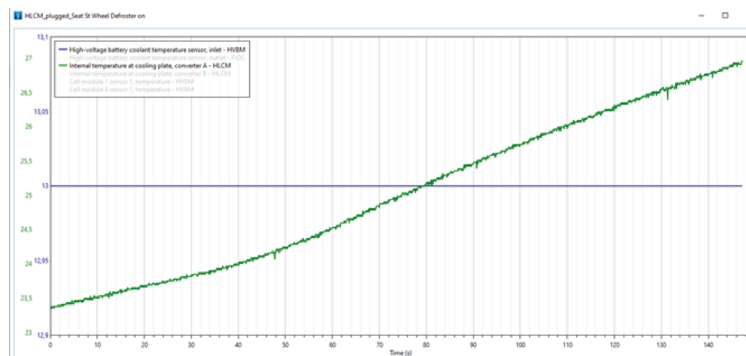
- 3.2. The HLCM cooling plate temperature is increasing significantly faster compared to the HV battery coolant inlet temperature. See page 3.2 of the attachment TJ_37478_1.pdf.

4. Check the function of the HV battery coolant pump by monitoring the requested speed vs the actual speed. The two speeds shall be the same. See page 4 of the attachment TJ_37478_1.pdf.
5. If the pump is working properly, the HLCM cooling problems are likely caused by blocked coolant flow inside the high-voltage battery. The battery will need to be exchanged.
