SUBJECT:	<b>Potential for Partial or Complete Separation of Translucent Roof from Trailer Wall Structure</b>	TSB No:	<b>TSB-2026-001</b>
		ISSUE DATE:	<b>June 1, 2026</b>
		EFFECTIVE DATE:	<b>June 1, 2026</b>
MANUFACTURER NAME & ADDRESS:		<b>Novae LLC, 1 Novae Parkway, Markle, Indiana 46770</b>	
WMI CODE:	<b>5JW</b>	PHONE NUMBER:	<b>(260) 758-9838</b>
		CONTACT:	<b>Scott Pinkley, Director of Quality</b>

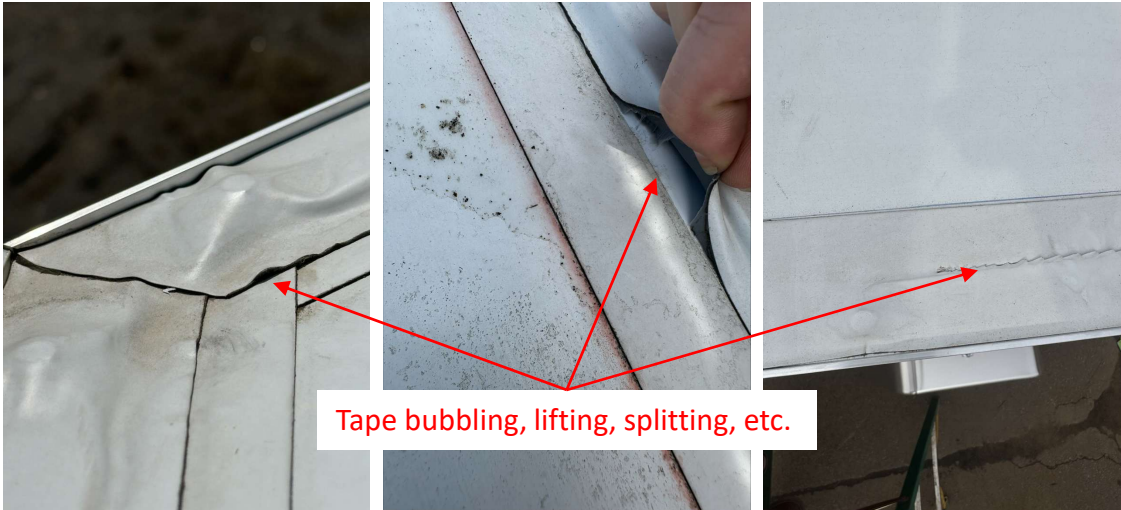
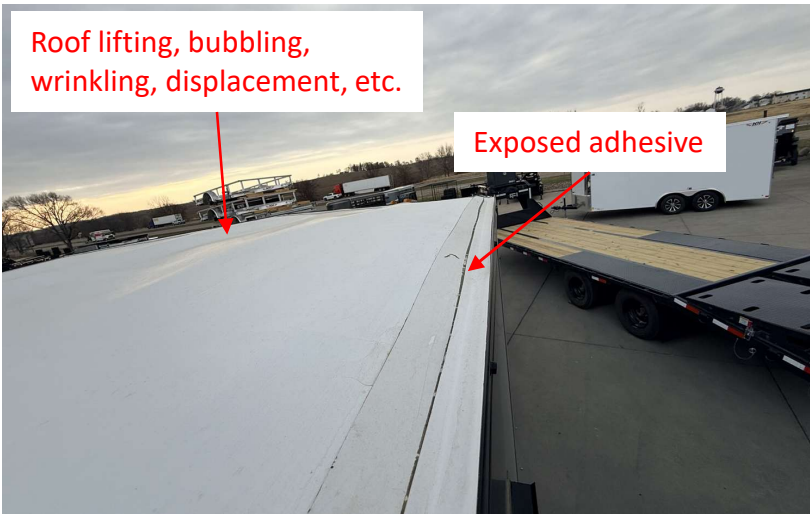
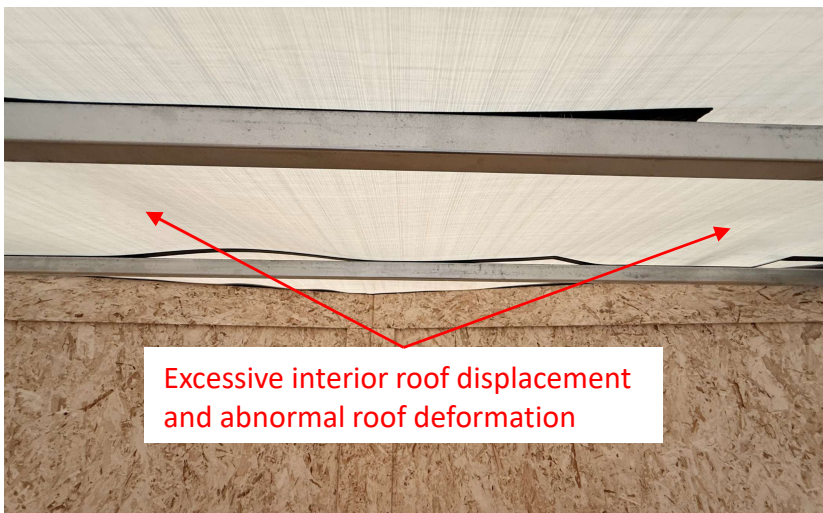
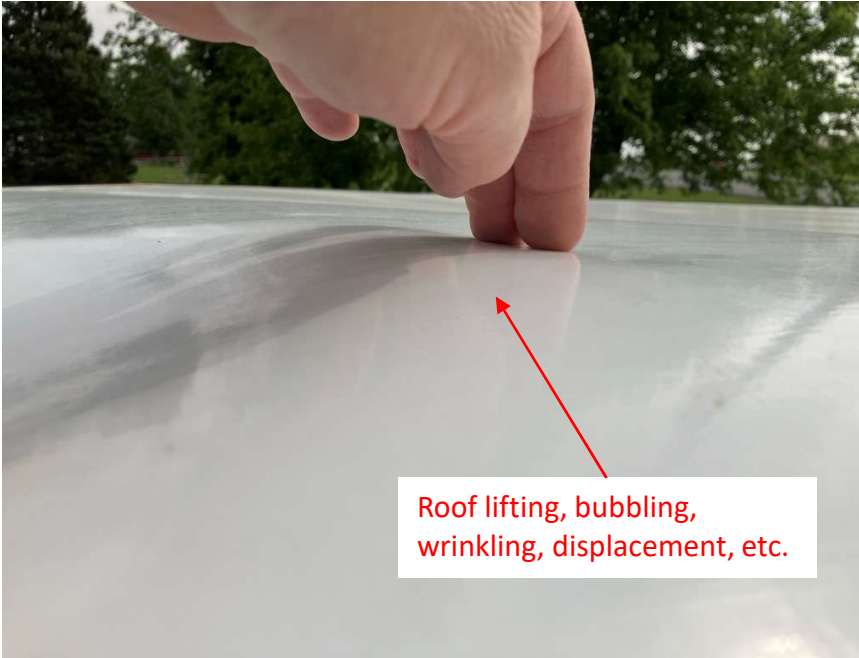
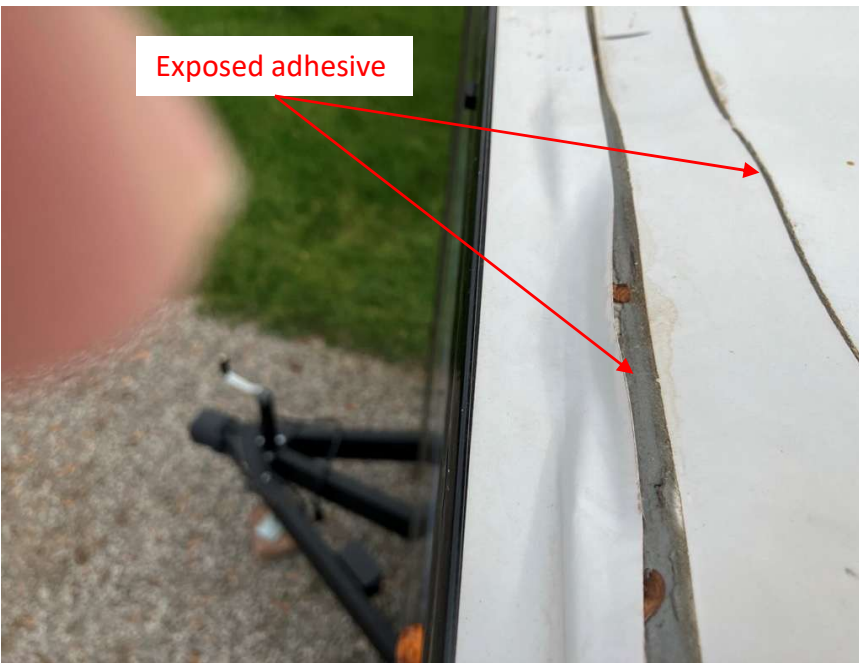
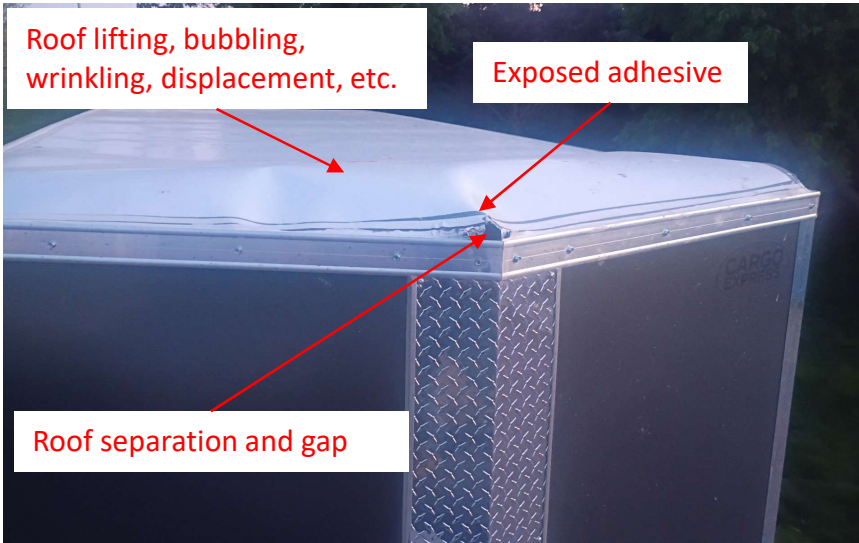
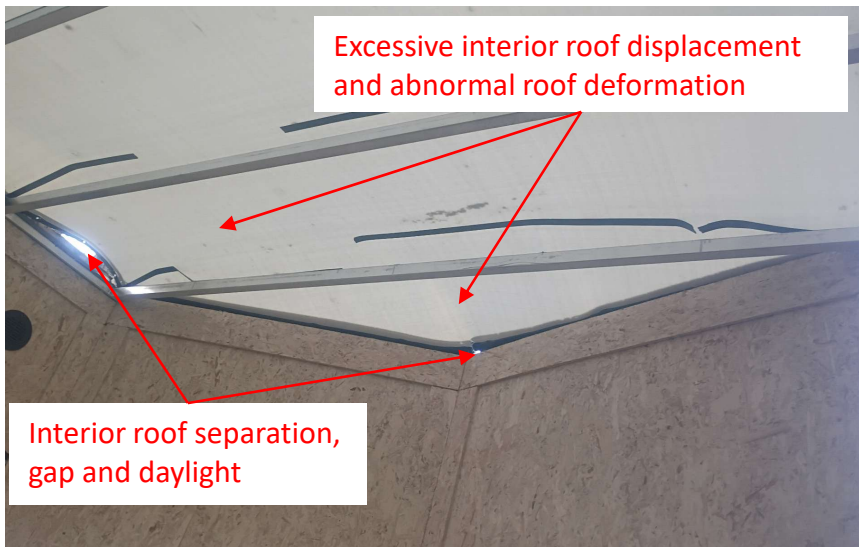
**ATTACHMENT A - Inspection Reference Photos and Examples**

- Roof perimeter sealing tape bubbling, lifting, wrinkling, cracking, splitting, separation, or delamination;
- Exposed adhesive or adhesive displacement from beneath roof perimeter sealing tape;
- Roof lifting, bubbling, ballooning, wrinkling, tearing, cracking, displacement, or deformation of roof material;
- Visible exterior separation or gaps between roof panel and trailer wall structure along roof perimeter attachment areas;
- Loose, lifted, distorted, or displaced roof edge trim;
- Excessive interior roof displacement or abnormal roof deformation;
- Visible interior separation, gaps, or daylight intrusion at the roof-to-wall attachment interface; and
- Evidence of water intrusion originating from roof perimeter attachment areas.

Trailers exhibiting roof lifting, roof displacement, visible roof-to-wall separation, or loss of roof attachment retention should not be returned to service or transported until the condition can be evaluated and corrective action determined by Novae LLC can be taken.
