GENERAL MOTORS  
DCS7515  
URGENT - DISTRIBUTE IMMEDIATELY

Subject: N262560540 - Service Update  
Rear Wheel Hub Bolt Replacement

Models: 2027 Chevrolet Bolt

## N262560540 Rear Wheel Hub Bolt Replacement

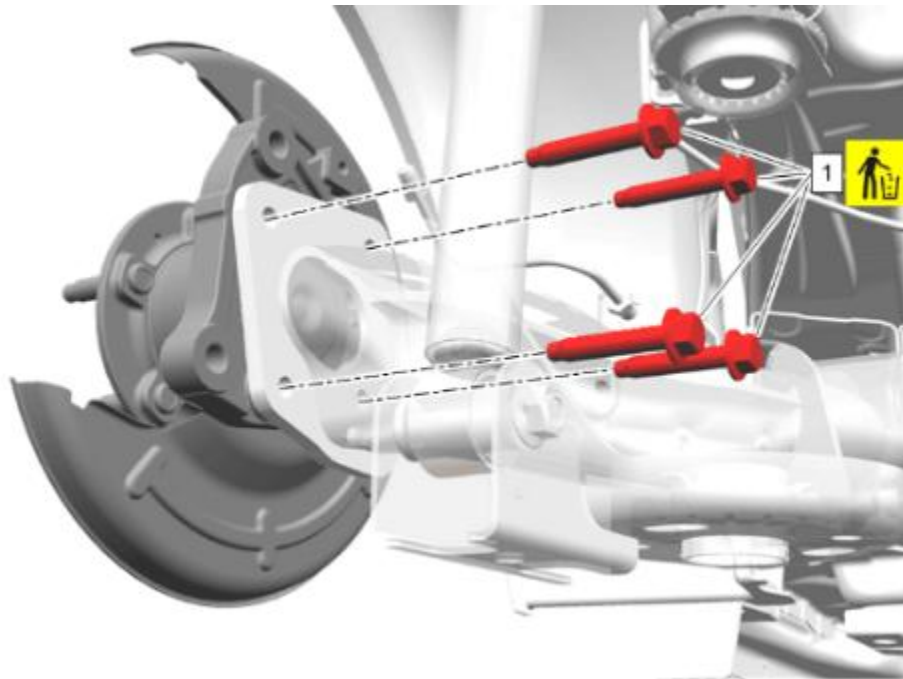
6978078

<b>Condition</b>	Certain vehicles listed above may have a condition in which a bolt(s) on the left or right side of the rear wheel hub may be incorrectly torqued.
<b>Correction</b>	Dealers will inspect, and if necessary, replace the rear wheel hub bolt(s).

3. Verify the applicable side Rear Wheel Hub Bolts are not missing or loose. Use a torque wrench set to **76 Nm (56 lb ft)** to verify bolt torque. The lower front bolt is accessed through a hole in the rear axle.
4. If a bolt is found to be missing or loose, install a NEW Rear Wheel Hub Bolt and torque to specification:
  - First Pass: **58 Nm (43 lb ft)**
  - Final Pass: **30-45 degrees**
