## TECHNICAL SERVICE BULLETIN

### Horn Sounds When Turning The Steering Wheel

**26-2280**  
10 June 2026

| <b>Ford</b><br>2025-2026 Expedition |

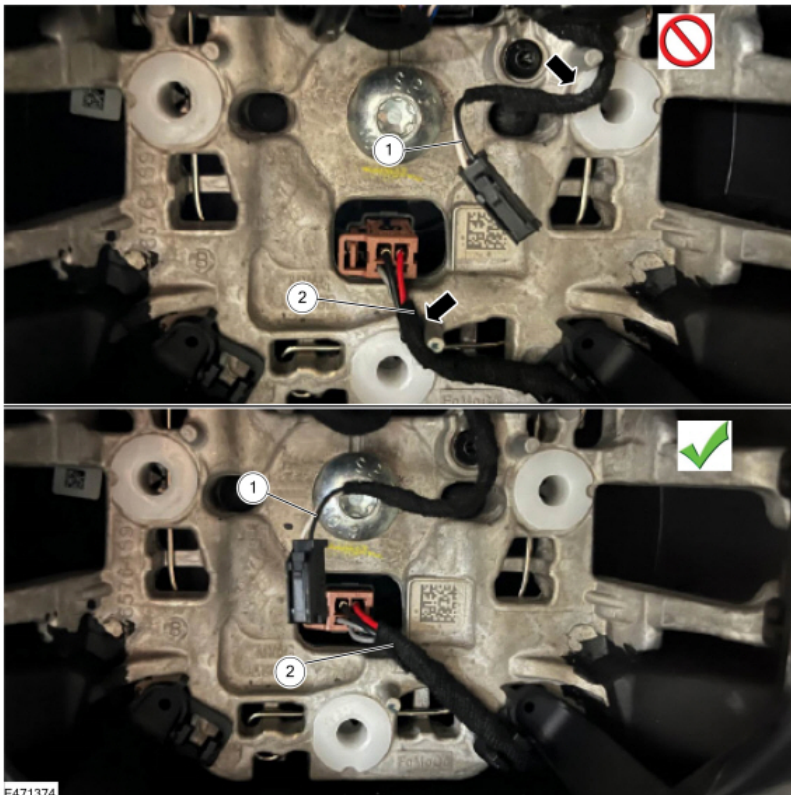
Figure 1

1. Remove the driver airbag. Refer to the [WSM](#), Section 501-20B Supplemental Restraint System > Removal and Installation > Driver Airbag.
2. Carefully inspect for impressions on the horn wire harness (Figure 1, Callout 1) and heated steering wheel (if equipped) wire harness (Figure 1 Callout 2) that would indicate the harness was pinched under one of the airbag mounting springs. Repair the harness if damaged. Refer to Wiring Diagram, Cell 005.
  - (1). Make sure that the horn wire harness is routed to the left of the cast aluminum locator pin, and the heated steering wheel harness (if equipped) is routed to the right of the cast aluminum locator pin to keep the harnesses away from the airbag springs. Correct the harness routing as needed (Figure 1).

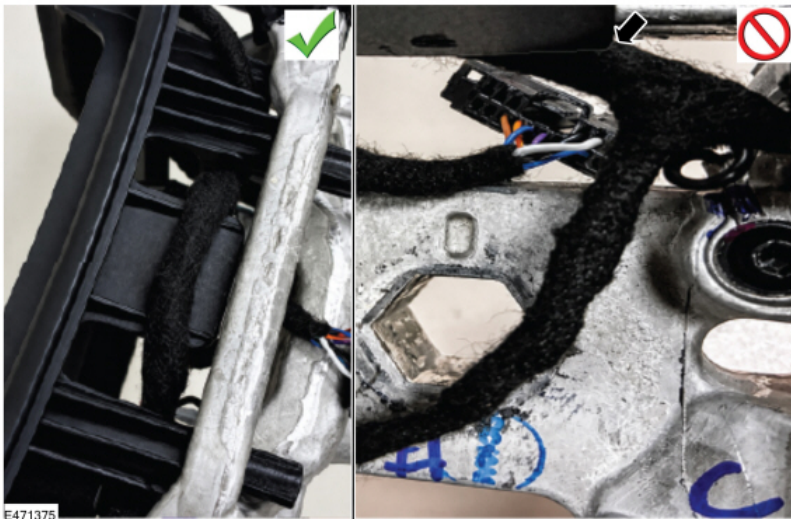
Figure 2 - Left side shows the harness routed properly over the steering wheel flange, right side shows the harness routed improperly under the steering wheel flange.

3. Confirm that the upper main steering wheel harness is routed over the top of the plastic steering wheel flange as shown in Figure 2. Make sure the harness is not pinched between the plastic flange and the cast aluminum frame of the steering wheel. Repair as needed.
