## Technical Service Bulletin

| GROUP<br><b>BODY ELECTRICAL</b> | NUMBER<br><b>26-BE-015H</b> |

**SUBJECT:** NOISY DRIVER FRONT SEAT MOTOR – TUBE REMOVAL

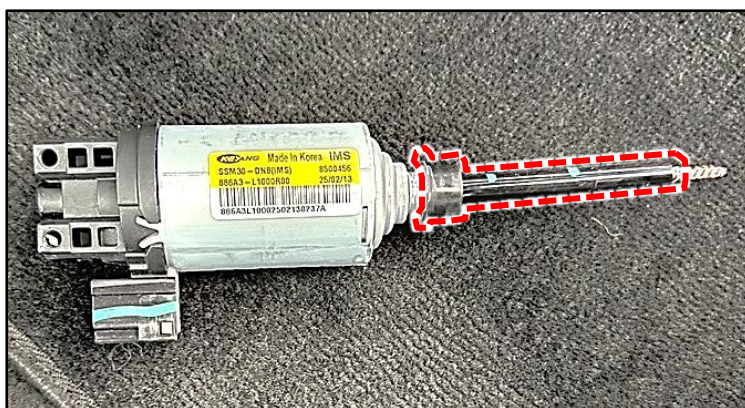
**Description:** Some Santa Fe (MX5A) and Santa Fe Hybrid (MX5A HEV) vehicles equipped with power seats with or without Integrated Memory System (IMS) may produce buzz, squeak, rattle noises when the driver's front seat is adjusted forward or backwards due to friction within the motor's tube. This bulletin provides instructions to remove the motor tube.
