## Technical Service Bulletin

**GROUP****BODY ELECTRICAL****NUMBER****26-BE-016G****DATE****JUNE 2026****MODEL(S)****G70 (IK)****SUBJECT:**

### FRONT PARKING DISTANCE WARNING (PDW) SENSOR FALSE DETECTION

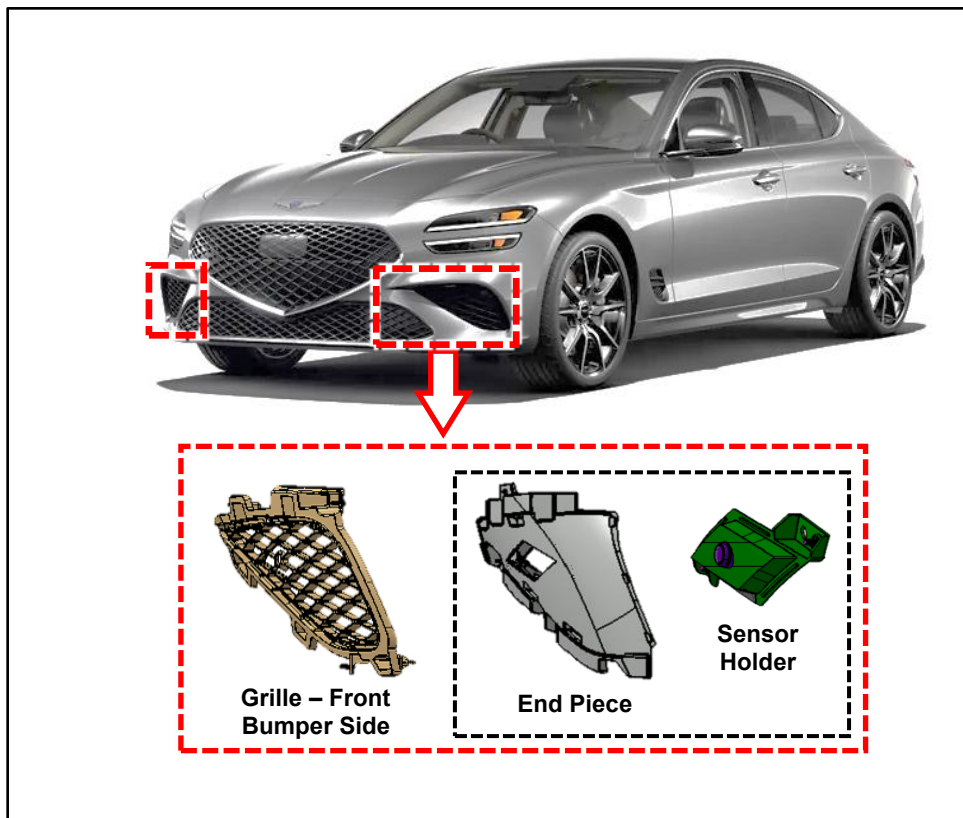
**Description:** Some G70 (IK) vehicles may exhibit a false notification from the front Parking Distance Warning (PDW) sensors when there is no object nearby. This may occur when the parts housing the sensor become loose, causing the sensor to falsely detect objects. There is no functional effect on the vehicle other than the false notification. This bulletin provides the procedure to inspect the vehicle and apply repair(s) as needed.

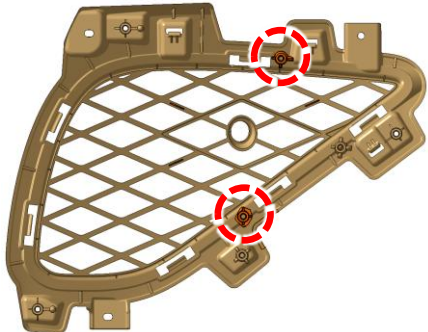
| Grille – Front Bumper Side | End Piece | Sensor Holder |
|---|---|---|
| 2 mounting screws added | 2 holes for mounting screws added | 2 holes for mounting screws added |

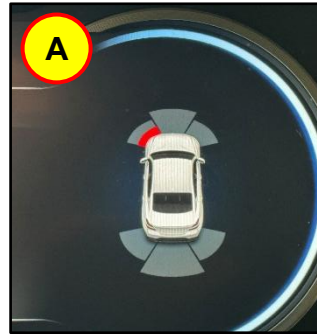
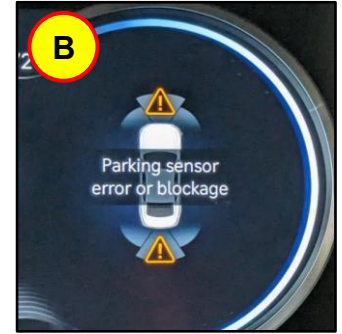
1. Check for the following Parking Distance Warning (PDW) notifications on the instrument cluster:
  - A: **Red** PDW sensor warning (with **NO** object or obstruction present).
  - B: “**Parking sensor error or blockage**” message.

If either notification is present, proceed to **step 2**.
