| <b>HYUNDAI</b><br><b>Technical Service Bulletin</b> | GROUP<br><b>BODY</b> | NUMBER<br><b>26-BD-004H</b> |
| <b>SUBJECT:</b> LOOSE WINDSHIELD SIDE GARNISH REPLACEMENT | | |

**Description:** Some Elantra (CN7), Elantra Hybrid (CN7 HEV), and Elantra N (CN7 N) vehicles may exhibit loose windshield side garnishes. This bulletin provides instructions to replace the windshield side garnishes with improved parts to correct the condition.

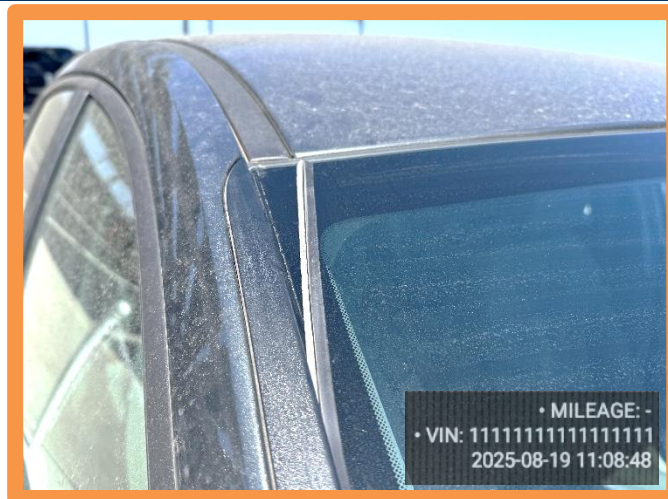
Using the STUI camera function, take a photo(s) of the original damaged/loose windshield side garnish(es).
