**Technical Service Bulletin (TSB)**  
**ENGINE – 1.5 GSE T4 MHEV**  
**- Malfunction Indication Light (MIL) P0016**

| REFERENCE: | TSB: 09-011-26<br>GROUP: 09 - Engine | Date: | June 6, 2026 | REVISION: | — |
| CONCERNED VEHICLES: | 2022 - 2025 (BV) Jeep Renegade<br>2022 - 2025 (MV) Jeep Compass<br>This bulletin applies to vehicles equipped with the 1.5L I4 DOHC Turbo MHEV Engine (Sales Code EYP). | | | MARKET SPECIFICATIONS:<br><div><input type="checkbox"/> NA<input type="checkbox"/> MEA</div> <div><input type="checkbox"/> SA<input type="checkbox"/> IAP</div> <div><input checked="" type="checkbox"/> EE<input type="checkbox"/> CH</div><br><b>NOTE:</b> This bulletin applies to Enlarged Europe markets. | |

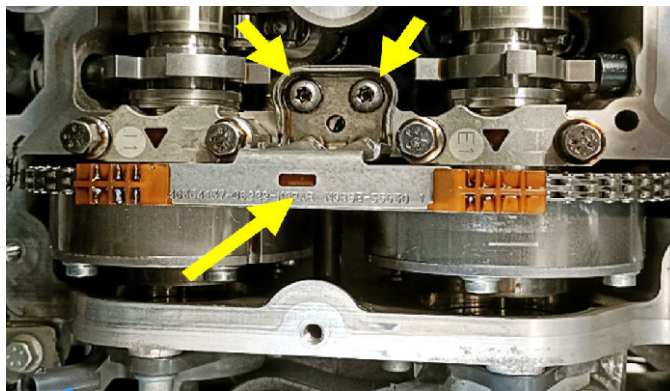
**Fig. 15**

| CAUSE: | Engine timing loss resulting from a tooth jump on the Variable Camshaft Timing (VCT) sprocket | | | | |

23. Remove the flywheel locking pin and the 9 mm diameter pin from the crankshaft pulley.  
24. Lower the vehicle.  
25. Remove the old guide rail (“snubber”) [Fig 15](#).
