**Technical Service Bulletin (TSB)**  
**Whistling Noise Heard From Left Side Mirror While Driving**

| REFERENCE: | TSB: 23-018-26 REV. A<br>GROUP: 23 - Body | Date: | June 6, 2026 | REVISION: | 23-018-26 |
| VEHICLES AFFECTED: | 2025 - 2026 (DT) RAM 1500 Pickup<br>This bulletin applies to vehicles built on or after May 26, 2025 (MDH 0526XX) and on or before February 11, 2026 (MDH 0211XX) equipped with Blind Spot And Cross Path Detection (Sales Code XAN) and one of the following: <ul style="list-style-type: none"><li>• Accent Color Premium Power Mirrors (Sales Code GT4).</li><li>• Black Base Power Mirrors (Sales Code GT6).</li><li>• Chrome Premium Power Mirrors (Sales Code GU4).</li><li>• Black Premium Power Mirrors (Sales Code GUK).</li></ul> | | | MARKET APPLICABILITY:<br><div><input checked="" type="checkbox"/> NA<input type="checkbox"/> MEA</div> <div><input type="checkbox"/> SA<input type="checkbox"/> IAP</div> <div><input type="checkbox"/> EE<input type="checkbox"/> CH</div><br><b>NOTE:</b> This bulletin applies to the North America markets. | |

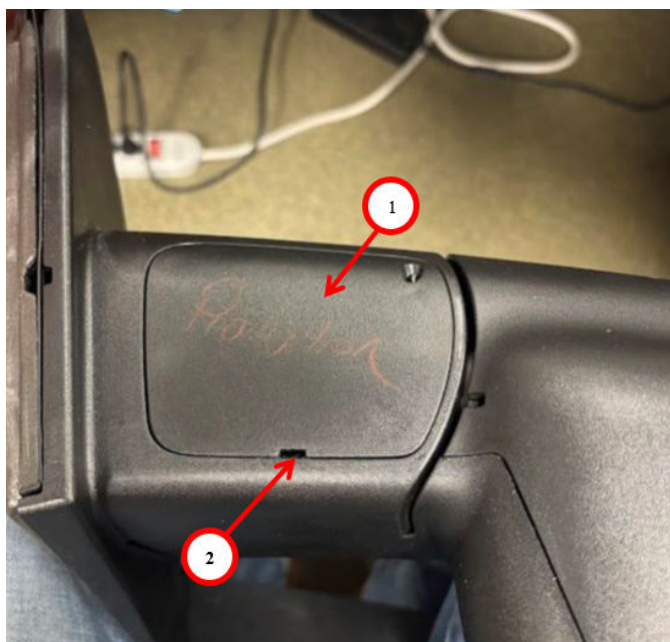
**Fig. 1**  
Mirror Access Cover Location

1 - Mirror Access Cover  
2 - Mirror Access Cover Insert Slot

1. Locate the mirror access cover on the underside of the driver door mirror [Fig. 1](#).
