Product Improvement  
Campaign2022-2026MY  
Carnival (KA4) and  
2025-2026MY Carnival  
Hybrid (KA4 HEV)

PI2602

June 2026

2ND ROW SEAT (LH & RH) FOLDING  
TENSION SPRING REPLACEMENT (PI2602)

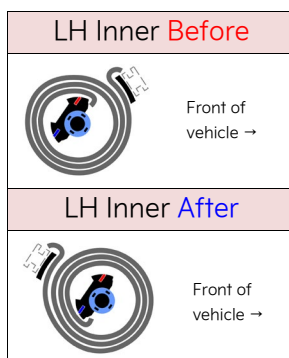
LH (Driver) Seat Sample: Inner and outer tension springs shown for reference.

Reverse the orientation of the Inner Tension Spring.

The orientation of the 'new' inner recliner spring tensioner ends are different from that of the removed tension spring. The new inner spring tensioner is not marked by any coloring however, notice the larger diameter size of the new spring tensioner vs. the removed spring. **Carefully follow the outlined installation instructions. Refer to page 2 for RH seat orientation view.**

26. 7 and 8 Passenger: Install the new inner spring in the reverse direction and order of removal using a zip-tie (refer to page 2).

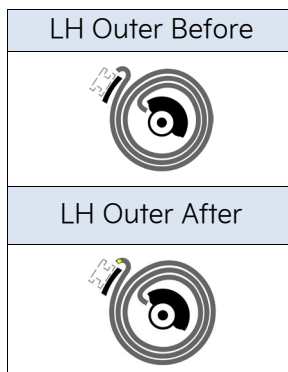
LH Seat Sample: Inner and outer tension springs shown for reference.

Colored spring applied  
Blue or Yellow  
Refer to Step 29.

The orientation of the 'new' outer recliner spring tensioner do change. The new outer spring tensioner marked in either yellow or blue and are noticeably larger in diameter size vs. the old removed spring. Carefully follow the outlined installation instructions. Refer to page 2 for RH seat orientation view.

29. 7 and 8 Passenger: Install the 'new' outer spring in the reverse order of removal using a zip-tie **however**, note that the new tension springs are marked as follows:

7- Passenger (Seat Outer) **Blue marking**

8- Passenger (Seat Outer) **Yellow marking**

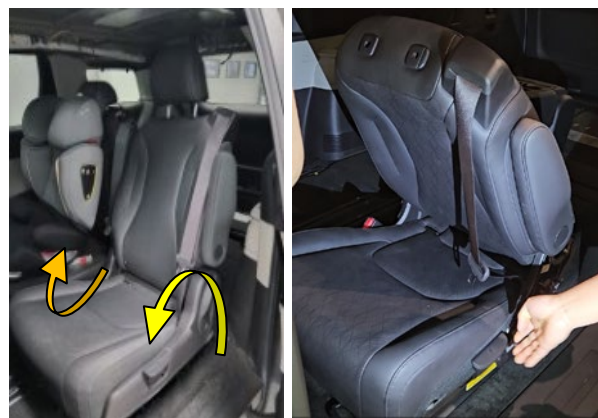
The new tension springs will cause the seat back to tilt forward at a slower speed. If the seat back does not fold down flat to the seat cushion, then the spring tensioner(s) were not installed correctly.

The seat back should not require manual force to fold down to the seat cushion.

31. Verify normal operation by lifting the side lever to allow the seat back to automatically fold forward.
