| REFERENCE: | TSB: 23-007-26 REV. A<br>GROUP: 23 - Body | Date: | June 13, 2026 | REVISION: | 23-007-26 |
| VEHICLES AFFECTED: | 2019 - 2022 (DT) RAM 1500 Pickup<br>This bulletin applies to vehicles built on or after August 01, 2018 (MDH 0801XX) and on or before July 25, 2022 (MDH 0725XX). | | | MARKET APPLICABILITY:<br><div><input checked="" type="checkbox"/> NA<input type="checkbox"/> CH</div> <div><input type="checkbox"/> EE<input type="checkbox"/> IAP</div> <div><input type="checkbox"/> SA<input type="checkbox"/> MEA</div><br><b>NOTE:</b> This bulletin applies to the North American markets. | |

This bulletin involves inspecting and possibly replacing the instrument panel cover.

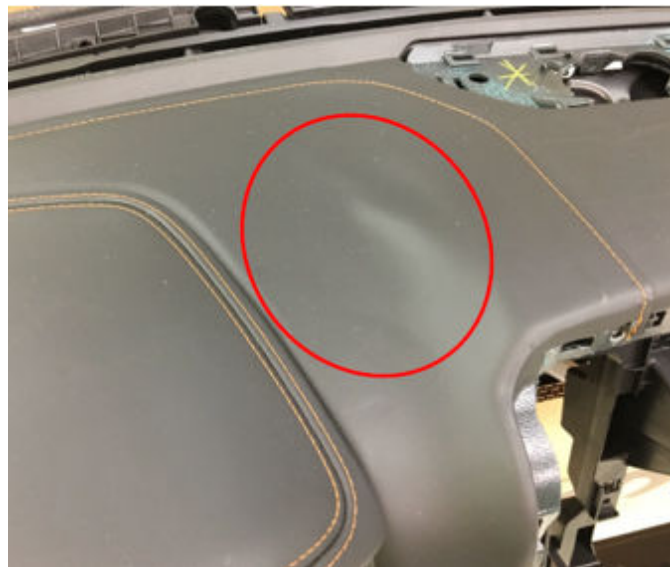
| CUSTOMER SYMPTOM: | Customers may comment on the following: <ul style="list-style-type: none"><li>Wrinkles or bubbles in the instrument panel cover <a href="#">Fig. 1</a>.</li></ul> | | | | |
| CAUSE: | Manufacturing defect | | | | |

**Fig. 1**  
Wrinkles Or Bubbles In The instrument Panel Cover

1. Replace the instrument panel cover. Refer to the detailed procedures available in DealerCONNECT > Service Library> under: 23 - Body / Instrument Panel / Cover, Instrument Panel / Removal and Installation.
