**Technical Service Bulletin (TSB)**  
**Door Nameplate Missing**

<b>REFERENCE:</b>	<b>TSB:</b> 23-022-26 <b>GROUP:</b> 23 - Body	<b>Date:</b>	June 10, 2026	<b>REVISION:</b>	—
<b>VEHICLES AFFECTED:</b>	<b>2026 (WS) Wagoneer / Grand Wagoneer</b> This bulletin applies to vehicles built on or before April 25, 2026 (MDH 0425XX).			<b>MARKET APPLICABILITY:</b> <input checked="" type="checkbox"/> NA <input type="checkbox"/> MEA <input type="checkbox"/> SA <input type="checkbox"/> IAP <input type="checkbox"/> EE <input type="checkbox"/> CH <b>NOTE:</b> This bulletin applies to the North America market.	
<b>CUSTOMER SYMPTOM:</b>	<b>Customers may comment on the following:</b> <ul style="list-style-type: none"> <li>The door nameplate is missing on the right and/or left front door.</li> </ul>				
<b>CAUSE:</b>	Parts shortage

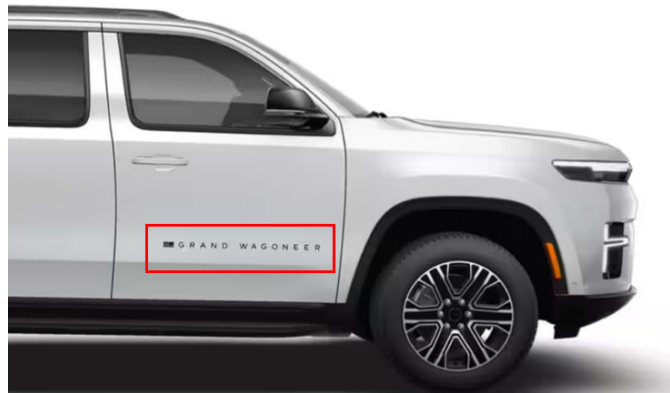
**Fig. 1**  
Door Nameplate Location

1. Inspect the left front door and the right front door to ensure the door nameplate is installed [Fig. 1](#).

2. Is the door nameplate missing from either front door?
  - YES >>> Proceed to [Step 3](#).
  - NO >>> Use Inspect LOP (23-01-18-9L) to close the active RSU.
3. Install the door nameplate on the left and/or right front door. Refer to the detailed service procedures available in DealerCONNECT/Service Library under: Service Info> 23 - Body / Exterior / Nameplate / Removal and Installation.
