STAR ONLINE PUBLICATION

Case Number: S2523000019

Models Affected: 2024-2026 Jeep Cherokee and Wagoneer S - (KM)
2025-2026 Dodge Charger – (LB)

Symptom/Vehicle Issue: If The Hood Will Not Fully Release When Button On The Dash Is Pressed Or The Hood Will Not Fully Latch.

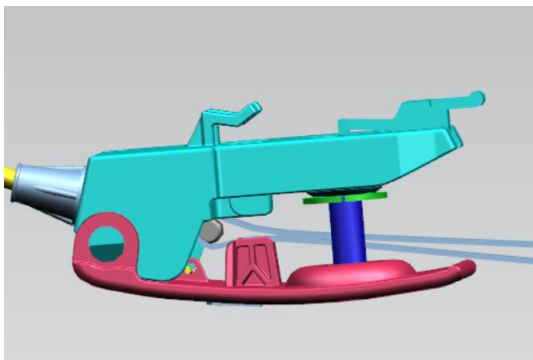
Fig #1

Figure #1 - shows the release strap in its normal home position.

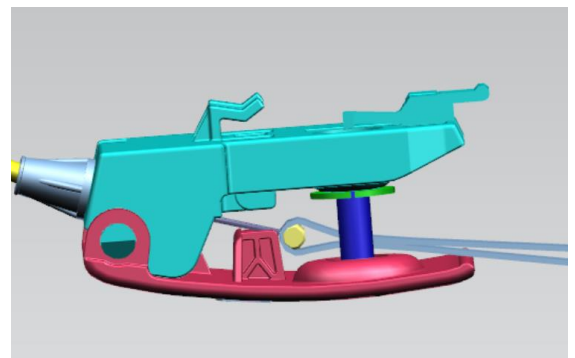
Fig #2

1) If the ¼ turn screw is not released and the strap is pulled, it will create a binding condition in the hood release system.

Figure #2 - shows a jammed/pre-stroked condition due to forcing cable strap through a closed handle. If this condition is detected, perform repair in step 2.

2) Release ¼ turn screw and make sure to pull handle cover down. Verify strap can be fully actuated and it returns fully after each pull. Once function is verified, stow strap so it is not accessible with cover closed and secure ¼ turn screw. See Fig #3.

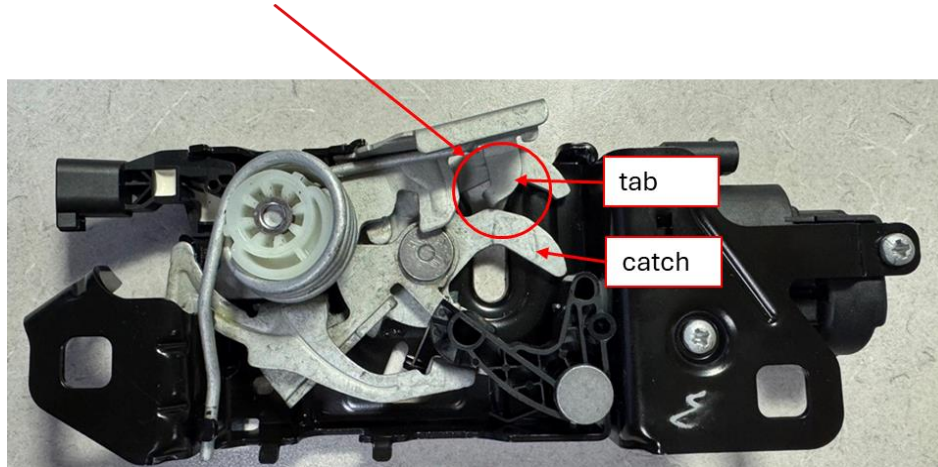
Figure #4

3) If latch is closed by hand (without the striker), releasing the latch will cause the catch to bypass the tab, resulting in a stuck condition. This condition can also occur if Inside Release Handle is used incorrectly (not rotating ¼ screw on handle before using). See Fig #4.

4) To reopen the catch, manually release the latch and simultaneously rotate the catch to its open position. You may also need to pull the tab aft slightly to get it past the catch and back to home position. See Fig #4.
