| BOD | 2026MY<br>EV9 (MV1a) |
| 355 | June 2026 |

## TECHNICAL SERVICE BULLETIN

### FRONT SEAT SLIDE MOTOR NOISE (CA2603)

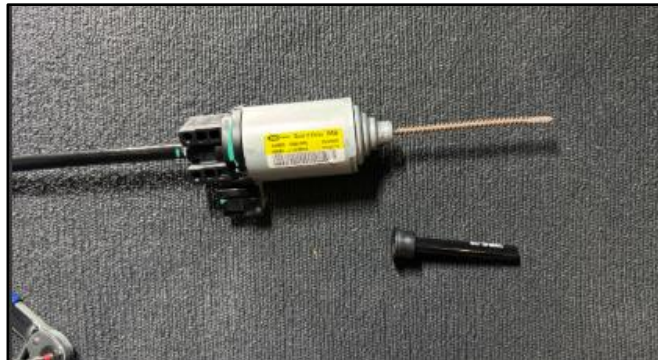
This bulletin provides information to remove the seat slide motor tube from the power front seats on certain 2026MY EV9 (MV1a) vehicles produced from January 2, 2025, through January 3, 2026. The subject vehicles may exhibit a buzzing noise while the user operates the front power seat slide (forward and rearward) functions. This condition does not affect seat functionality. Follow the procedure outlined in this publication to remove the seat slide motor tube from both front power seats of the applicable vehicle. Before performing the repair, verify that the vehicle's VIN is included in the affected range.
