Service Bulletin

Bulletin No.: PIT6493C

Subject: Wind Noise From Driver Front Door

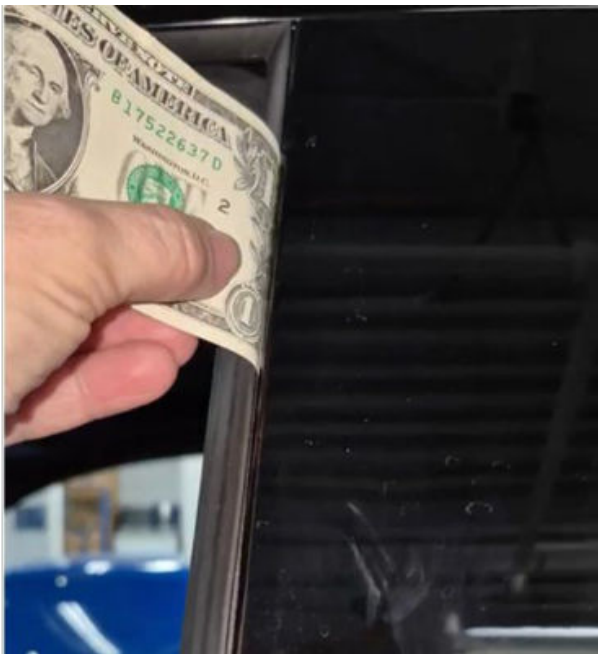
Involved Region or Country	North America
Condition	A customer may comment on hearing wind noise from the driver front door area while driving above 30 MPH.
Cause	The cause may be a gap between Front Side Door Window Frame Rear Applique and the Front Side Door Window Weatherstrip/Glass run channel (as shown below)

Verify the window run channel is fully seated into the door and adjust the Front Side Door Window Frame Rear Applique forward to close gap using the following procedure.
