Service Bulletin

Bulletin No.: PIT6132E

Subject: Hum Buzz Vibration Type Noise From HVAC When Set To Defrost Or Floor Positions

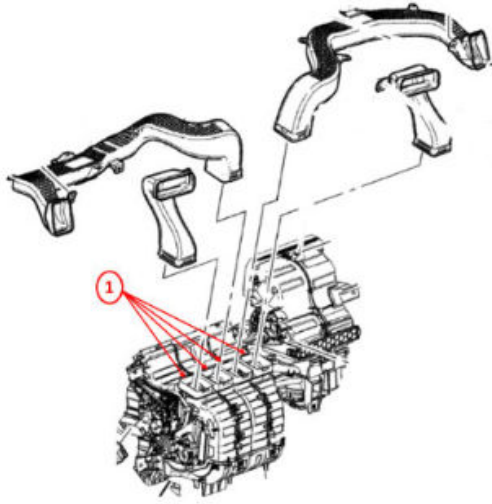
6727886

Involved Region or Country	North America
Condition	<p>Some customers may comment of a hum, buzz, or vibration type noise coming from the HVAC when the mode is set to the defrost or floor positions along with higher blower speeds and higher temperature settings. If the HVAC mode is changed to include the instrument panel dash vents the noise will be gone.</p> <p>Note: Replacing the HVAC case will not correct this condition and if the HVAC case is replaced the new case will need the repair shown below to resolve the noise.</p>
Cause	<p>The cause of this concern could be the HVAC instrument panel dash vent door seals (2) vibrating against the HVAC case, shown below. This concern only happens when the HVAC instrument panel dash vent doors (2) are in the closed position along with the HVAC set to a higher temperature and blower speed.</p>
