GROUP	MODEL
ELE	2025-2026MY K5 (DL3) w/2.5L GDI THETA III
NUMBER	DATE
419	June 2026

SERVICE ACTION: BATTERY WIRING HARNESS COVERING INSPECTION/REPLACEMENT (SA645)

This bulletin provides information for inspecting the 12V battery wiring harness on certain 2025-2026 MY K5 (DL3) vehicles equipped with the Theta III 2.5L GDI engine, produced from February 20, 2024, through March 13, 2026. The subject vehicles may exhibit an illuminated Malfunction Indicator Lamp (MIL) along with a low engine oil warning light and/or battery warning light displayed on the instrument cluster, caused by abrasion of the wiring harness over time. One or more of the Diagnostic Trouble Codes (DTCs) listed on page 2 may be stored. Follow the procedure outlined in this publication to inspect the battery wiring harness and replace the battery harness bracket, or, if required, replace the battery wiring harness assembly. Before performing this procedure, confirm that the vehicle is included in the affected VIN range.

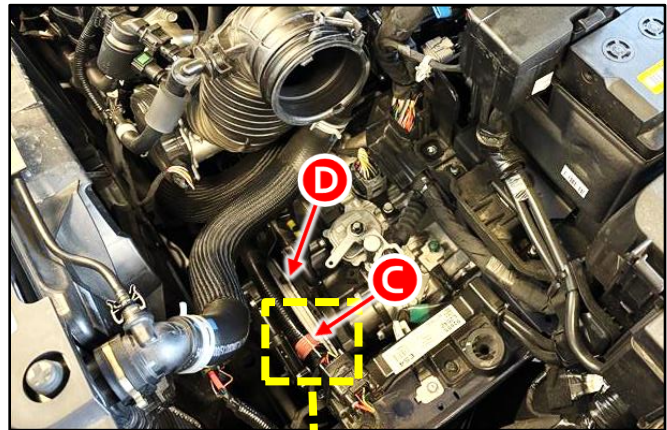
- 3a. Locate the ATF warmer (D) and inspect the battery wiring harness (C) for damage where it may make contact against the ATF warmer (D).

Inspect the bottom area of the battery wiring harness (C) using a telescoping mirror closest to the ATF warmer.

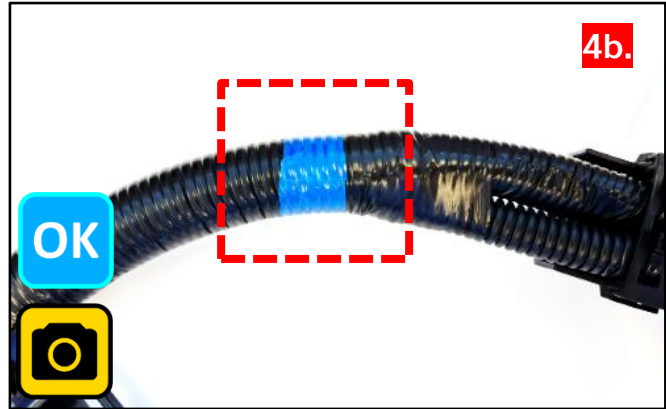
4b. • If there is NO visible damage to the battery wiring harness (C) covering (OK). Using KDS Tablet 'Warranty Claim Attachment' tab, take one (1) clear photo of the battery harness inspection area.

4d. If either conditions described above are (OK), proceed to the 'Replacement Procedure: (Battery Harness Bracket)' on page 5 and replace the existing wiring harness retaining bracket with an improved part.

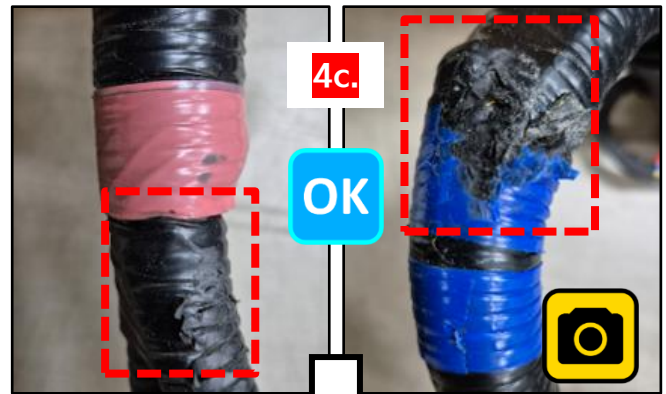
4c. • If there IS minor abrasion to the battery wiring harness (C) covering (OK). If there is no internal damage to wiring, then apply electrical tape to cover the affected area. Using KDS Tablet 'Warranty Claim Attachment' tab, take one (1) clear photo of the battery harness (C) affected area.

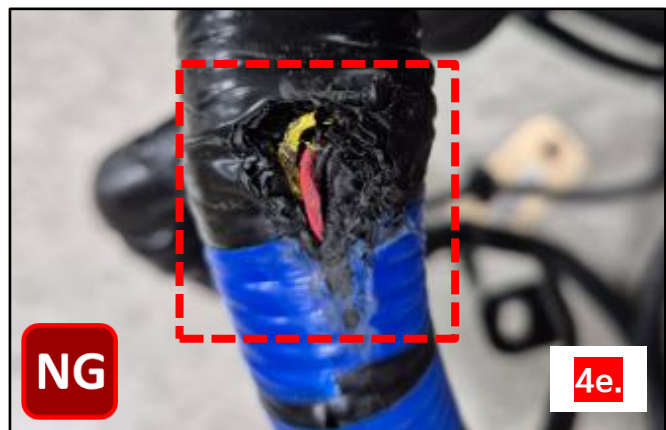
4e. • If there IS visible damage to the internal wiring of the battery harness (C) (NG), the internal wiring is exposed as shown, then proceed to the 'Replacement Procedure: (Battery Wiring Harness Assembly)' on page 6.
