GROUP	MODEL
ENG	2020-2025MY Telluride (ON)
NUMBER	DATE
266	June 2026

## TECHNICAL SERVICE BULLETIN

SUBJECT: **OIL FILTER HOUSING GASKET REPLACEMENT (WTY045)**

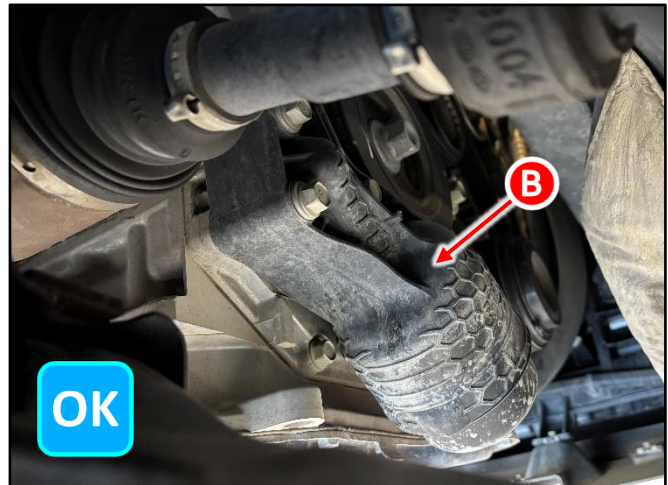
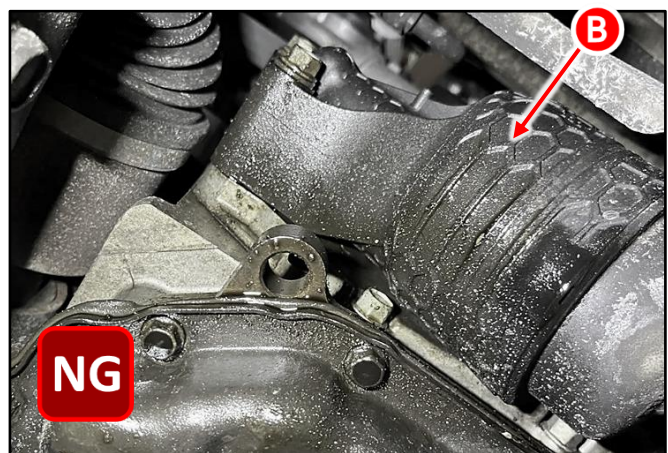
**Note:** Visible oil leaking from the oil filter housing mounting gasket area.

- Engine oil **IS** leaking from the oil filter housing (NG). Proceed to the 'Repair Procedure' on page 3 to replace the oil filter housing gasket.
