GROUP	MODEL
TRA	2027MY Telluride Hybrid (LQ2 HEV)
NUMBER	DATE
116	June 2026

## TECHNICAL SERVICE BULLETIN

### SUBJECT: SERVICE ACTION: TRANSAXLE ASSEMBLY REPLACEMENT (SA648)

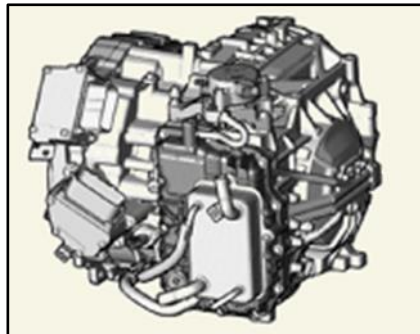
This bulletin provides information to replace the transaxle assembly on certain 2027MY Telluride Hybrid (LQ2 HEV) vehicles produced from February 02, 2026, through March 20, 2026. The affected vehicles may exhibit a rough 3rd → 4th gear upshift and/or 5th → 4th gear downshift accompanied by an illuminated malfunction indicator lamp with DTC P073500 stored. Follow the procedure outlined in this publication to replace the transaxle assembly on the applicable vehicle. Before conducting the procedure, verify that the vehicle is included in the list of affected VINs.

**P073500 - Gear 5 Incorrect Ratio - No Sub Type Information**
